Project Name	Project Number	Project Date
10793 Barrington Close Kingswood Report	10793	04/10/2023

Street: Barrington Close
Town or City: Kingswood
County: Bristol
Post Code: BS15 4QD

Company: Solum Surveying Ltd
Contact: Adam Smothers
Department: Operations Manager
Street: The Old Stables, Pines Courtyard
Town or City: Stone
County: Berkeley
Post Code: GL13 9LE
Phone: 01454 568725
Email: asmothers@solumsurveying.com

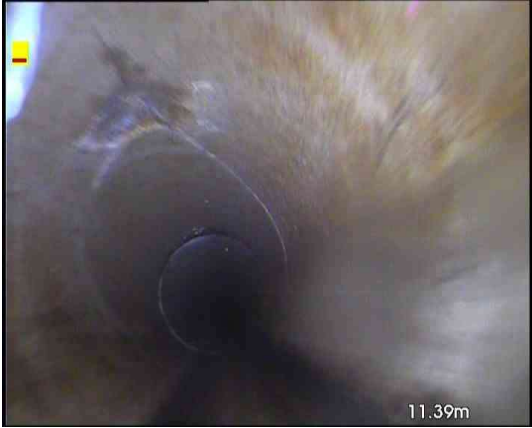
MH12X_79d11ca6-e9fb-4ecf-b7cf-a9e6f7051d44_20231005_091439_599.jpg, 00:00:42, 11.39 m

11.39	CC	CC	Crack, circumferential from 12 o'clock to 12 o'clock	00:00:42		2 / 2
11.39	H	H	Hole in drain or sewer from 10 o'clock to 11 o'clock	00:00:42	MH12X_7 9d11ca6-e 9fb-4ecf-b	4

Hole in drain or sewer from 10 o'clock to 11 o'clock

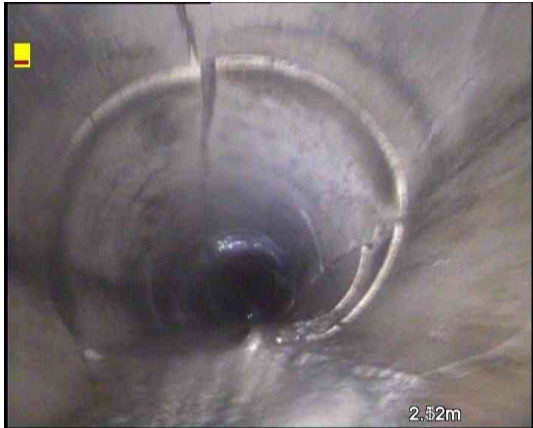
MH109X_4b2bd999-5c50-4281-97c5-ff718d8d337c_20231010_124514_836.jpg, 00:00:08, 2.52 m
Broken pipe from 12 o'clock to 12 o'clock, start

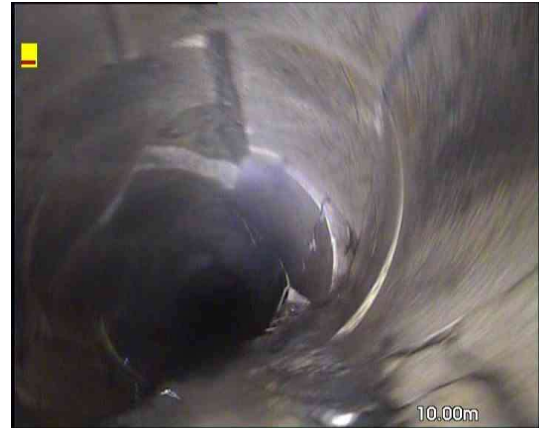
MH109X_0fd30f89-2d30-4b81-8da3-756a7e1c8300_20231010_124744_483.jpg, 00:00:28, 10.01 m
Broken pipe from 12 o'clock to 12 o'clock, start

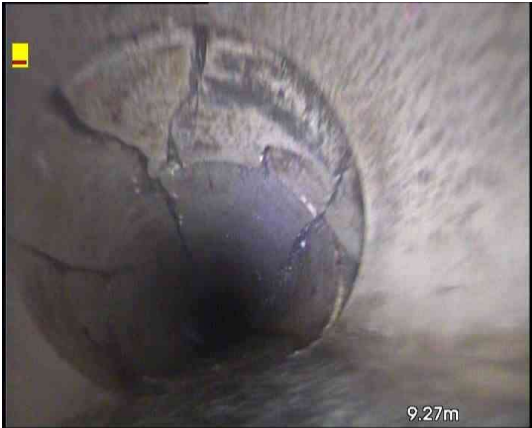
MH110X_89f44c82-90f9-47f9-b718-c8fdcbcd1237_20231010_130203_874.jpg, 00:00:22, 9.27 m
Broken pipe at joint from 11 o'clock to 3 o'clock

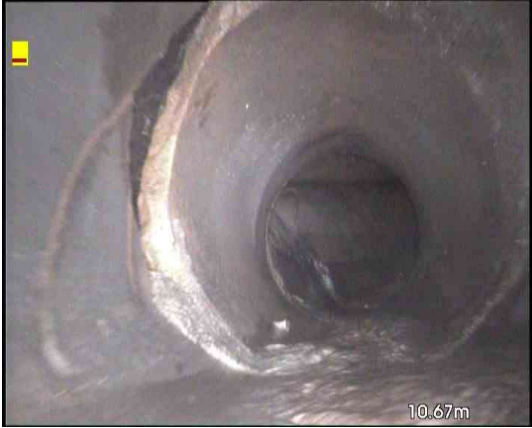
MH111X_24ed393f-d370-4503-8dd2-ed27a5e1a155_20231010_130829_433.jpg, 00:00:39, 10.67 m
Hole in drain or sewer from 8 o'clock to 11 o'clock, AT JOINT

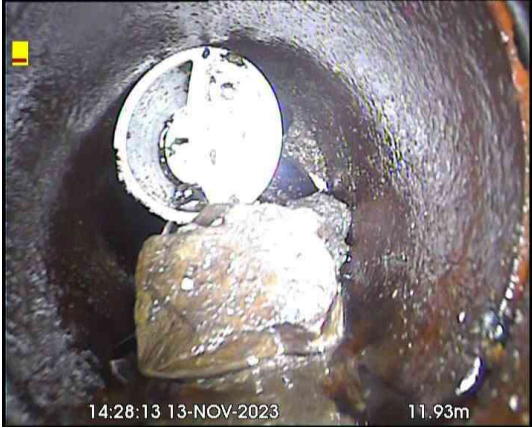
USX_01b41d0b-e175-4bf8-9f72-47c53c03f0bb_20231129_075333_931.jpg, 00:00:48, 12.28 m
Settled deposits, other, 90% cross-sectional area loss
