Potash Farm and adjacent agricultural buildings, Holbrook, Suffolk.

Heritage Report, Summer 2023

By J Parker MSc.

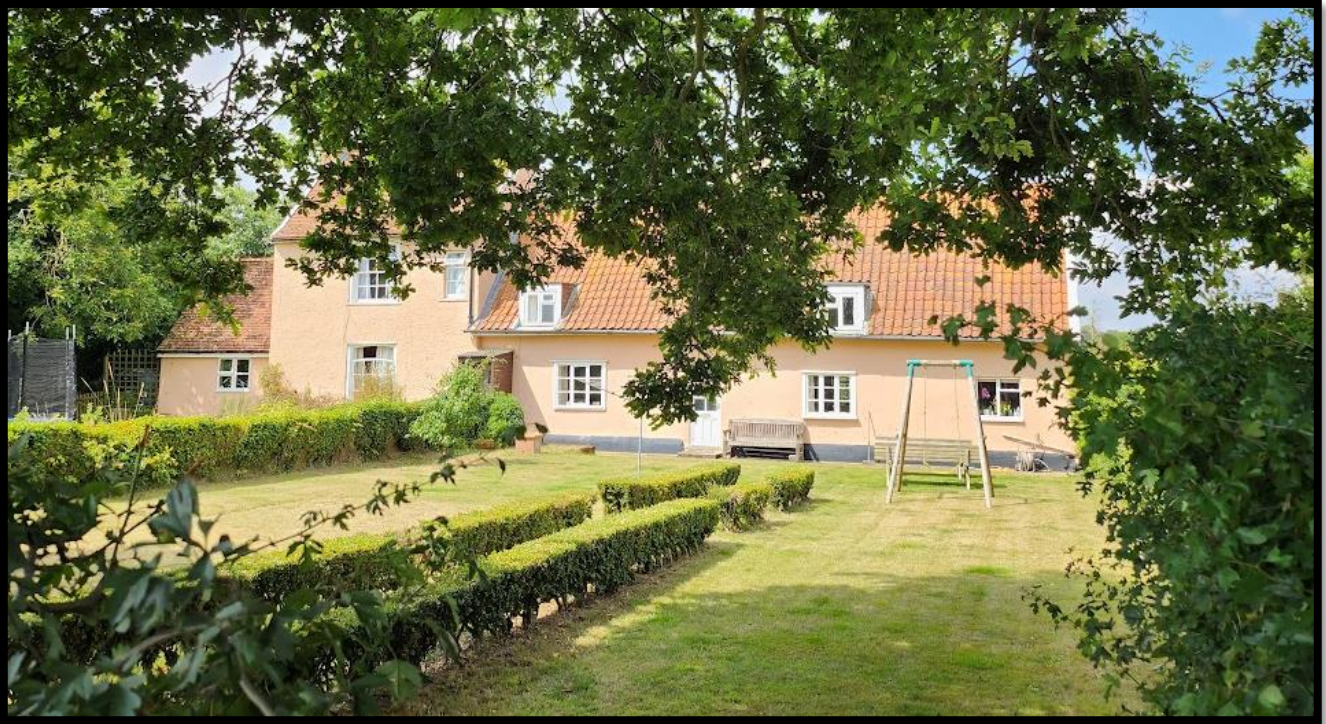
Building 1.

From Summer 2023.

Starting at the base and working upwards. The concrete path is always a concern as it holds moisture at the base of the building where originally the cill beam would be, or a brick plinth designed to let moisture escape from the lime mortar joints. Additionally, it allows rain to splash up against the lower section of the building.

At the base of the wall is a black painted plinth, this evidence of a now superseded C20 repair, cementing over the brick plinth then painting in a bituminous paint. In practice this held more moisture in the exterior wall making the problem worse. Current practice is to remove the cement to reveal the red brick plinth wall, remove any cement mortar and replace it with a breathable lime mortar, allowing the interstitial moisture to evaporate away as originally intended.

The wall has signs of large crack repairs prior to being painted. The cracking suggests a cement render beneath. As cement render holds moisture in the building the timber frame will be suffering. It is recommended the cement render is carefully removed and replaced with timber laths prior to being rendered in a minimum of 2 coats of lime render prior too coats of fine lime that is then decorated in either colour matched lime was or breathable paint.

If the wall is solid brickwork or timber frame the conservation advice would be the same. Remove the waterproof paint to investigate the render material. Should the render be lime, either limewash or decorate with a breathable paint to allow the wall to breath out any trapped moisture.

The listed house is in overall good condition yet has modern materials that would benefit the building by being carefully removed and replaced with historically sympathetic materials. The movement in the roof appears historic, yet further investigation would be prudent. The replacement of the cement render with a lime render and breathable paint would be the most beneficial conservation work to aid the timber frame.

- The removal of the black cement plinth render.
- The removal of the concrete path at the front of the property.
- The UPVC windows, fascias and barge boards may be unauthorized works yet as they only last for 20 to 25 years a notice to ensure their replacements are approved timber items may suffice.

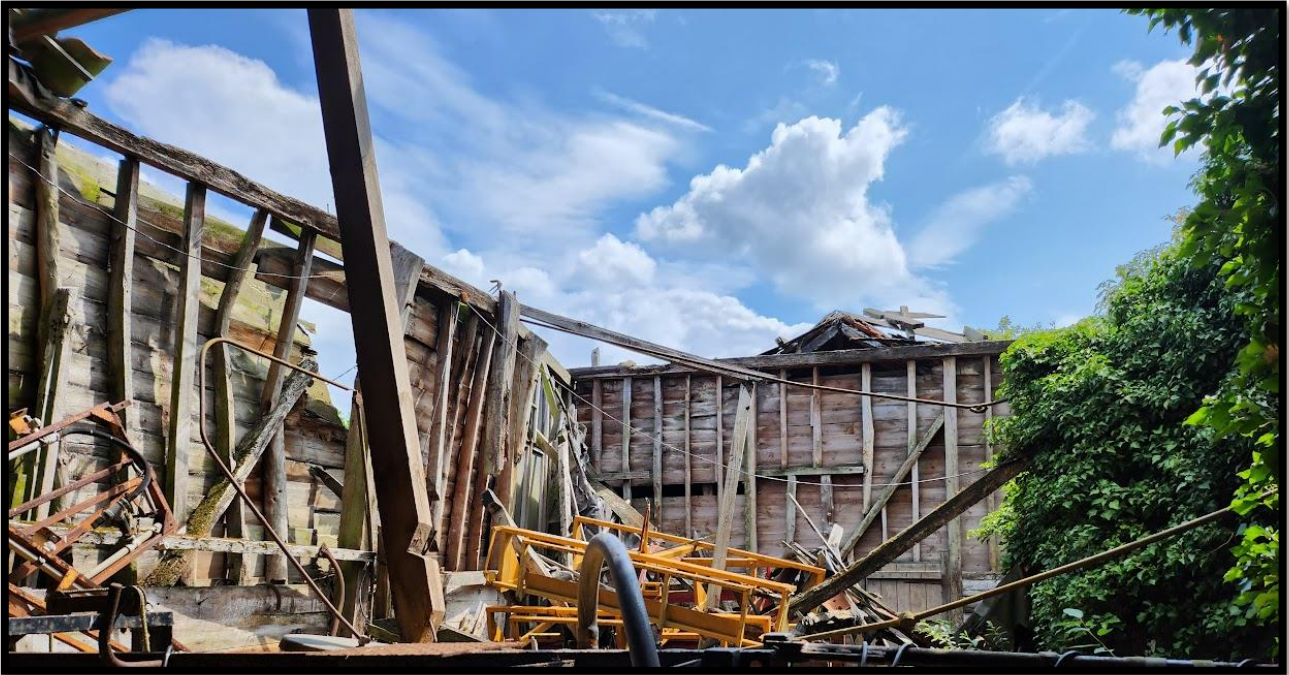
The interior facing East from the centre of the building.

The Roof will be discussed later in the report as the interior pictures clearly show the replacement roof structure and the compelling evidence for its failure.

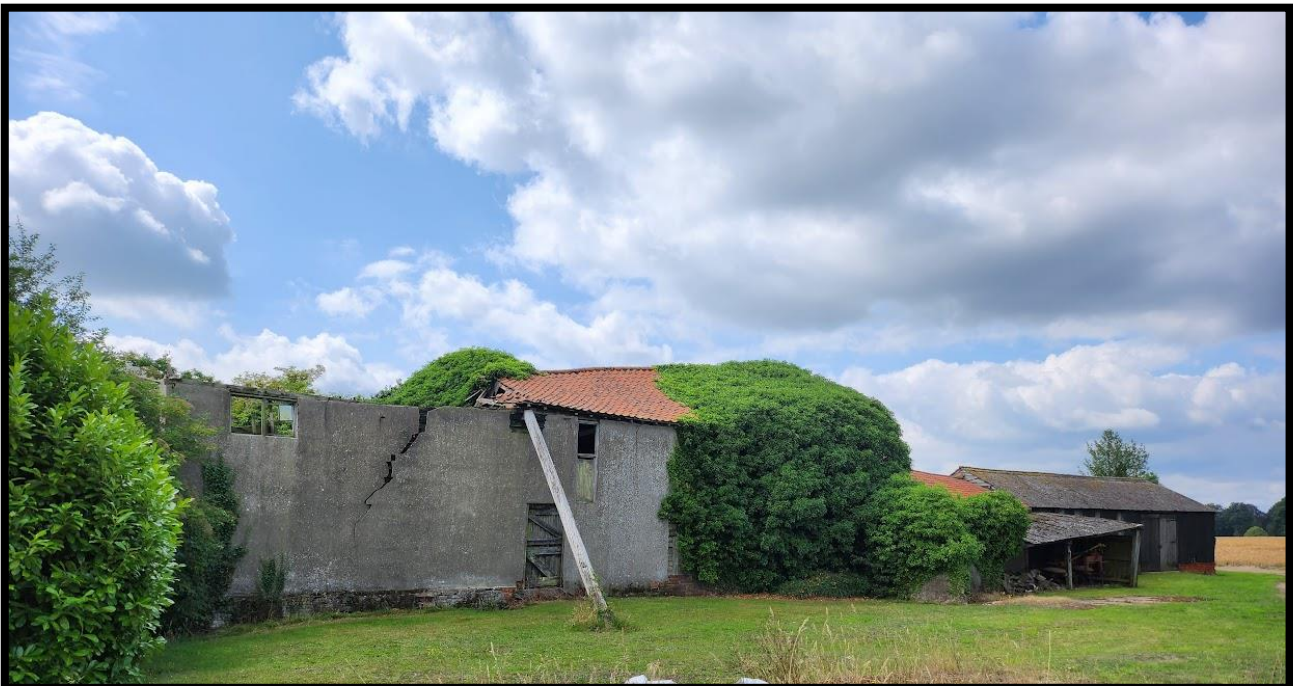
The North elevation exterior facing Southwest.

A large proportion of the wall needs repointing. Small sections have been repointed in cement that has caused spalling of the bricks.

Above the plinth wall is timber frame that has had cement render applied directly onto the feather-edge boarding, though this has proved detrimental to the building the finish is smooth. The render has added additional weight to the wall which has aided its failure by trapping water in the timber frame which has then weakened the timber behind. The collapsing of the roof destabilised the wall requiring the large timber post to be utilised as a brace.

The plinth wall will benefit from any cement mortar being carefully removed and replaced with the correct lime mortar, preferably using local sand to get a colour match.

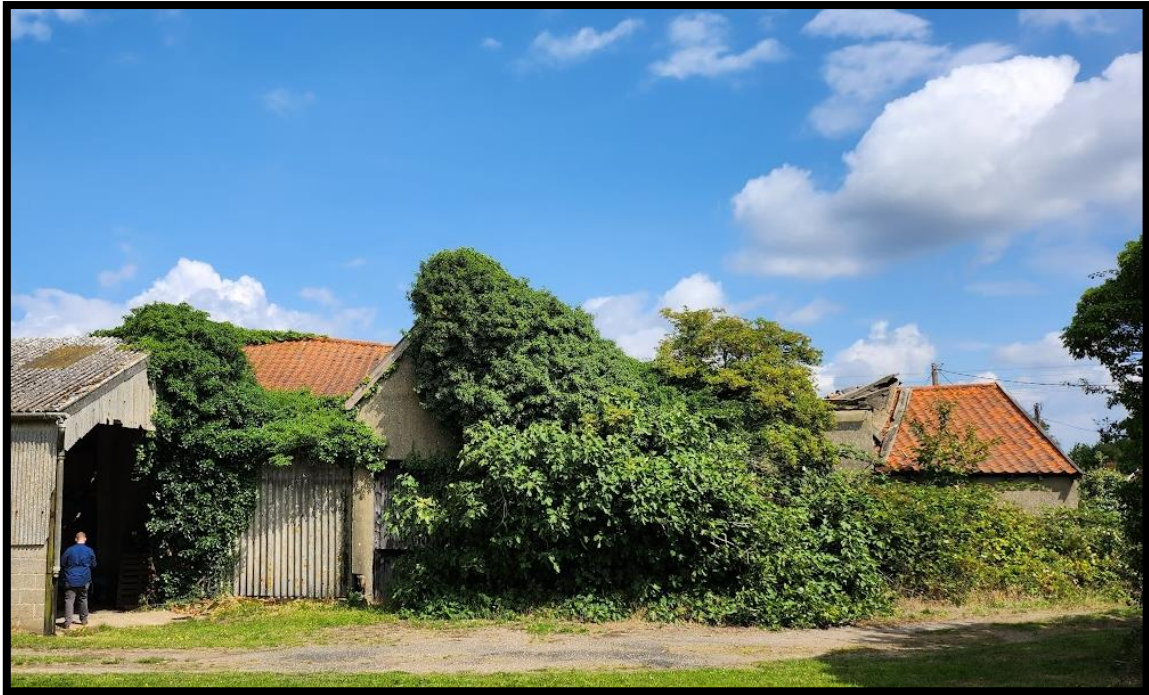
The South elevation.

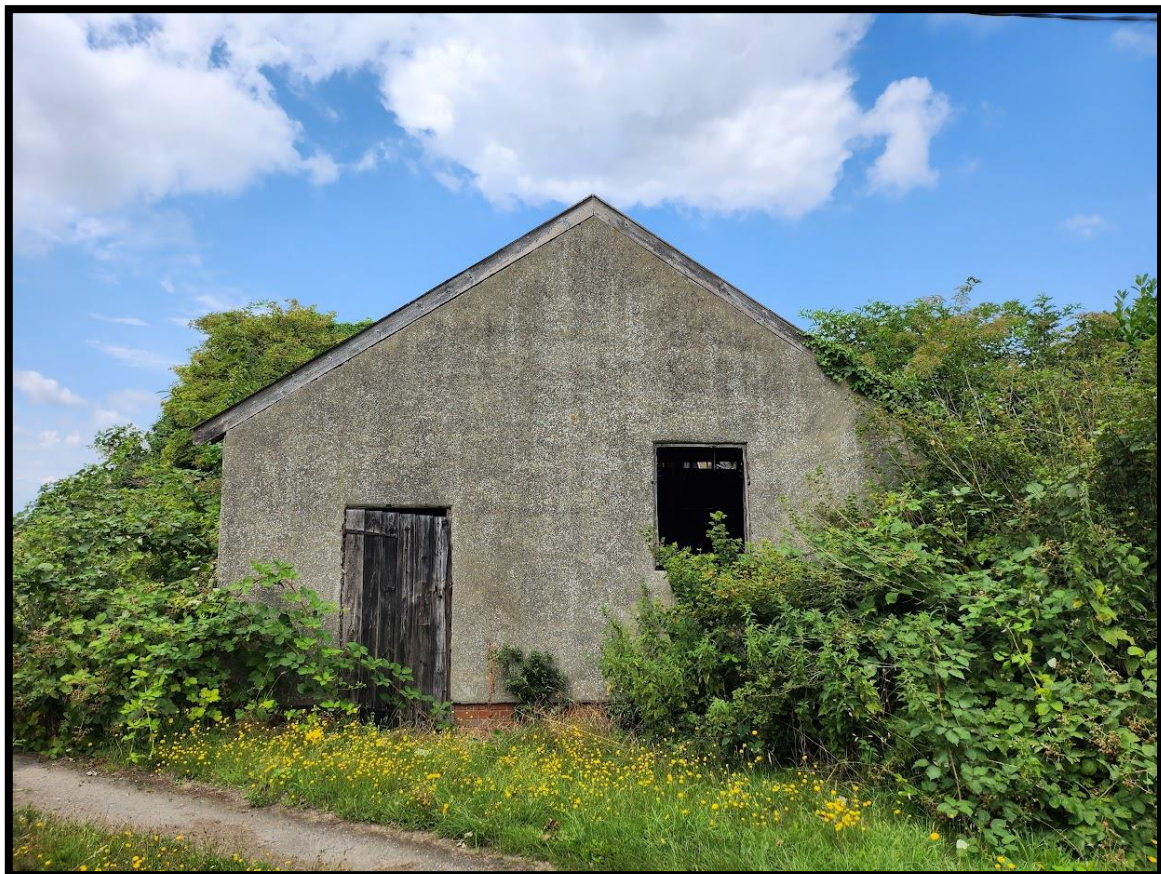
The East elevation.

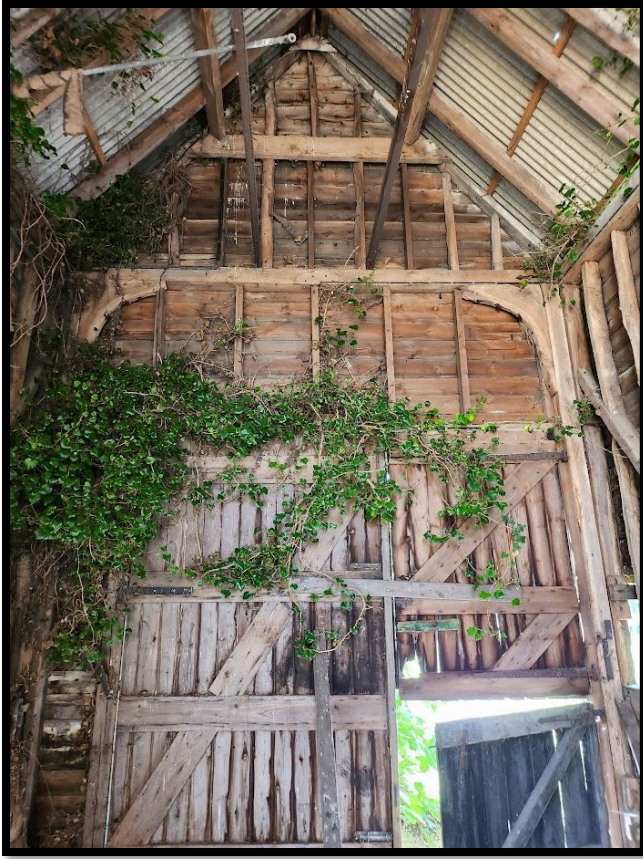
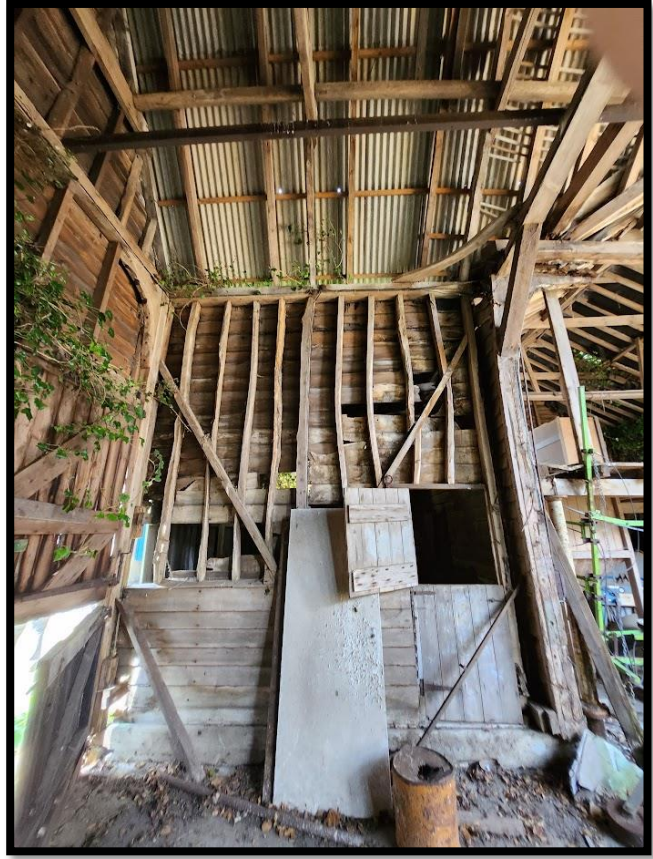
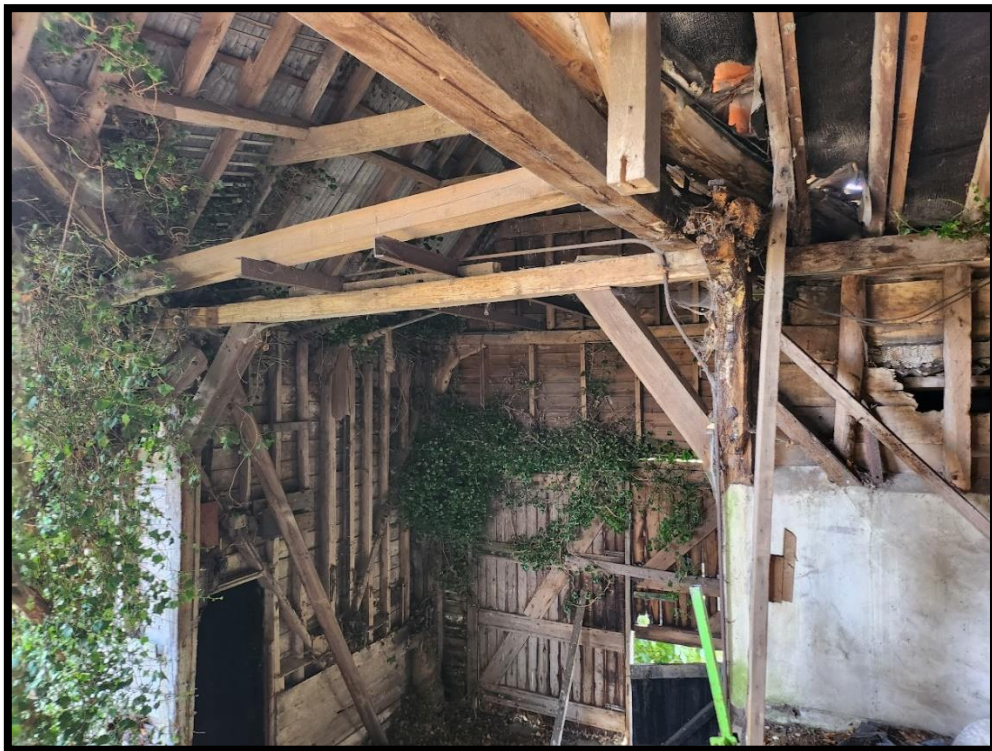
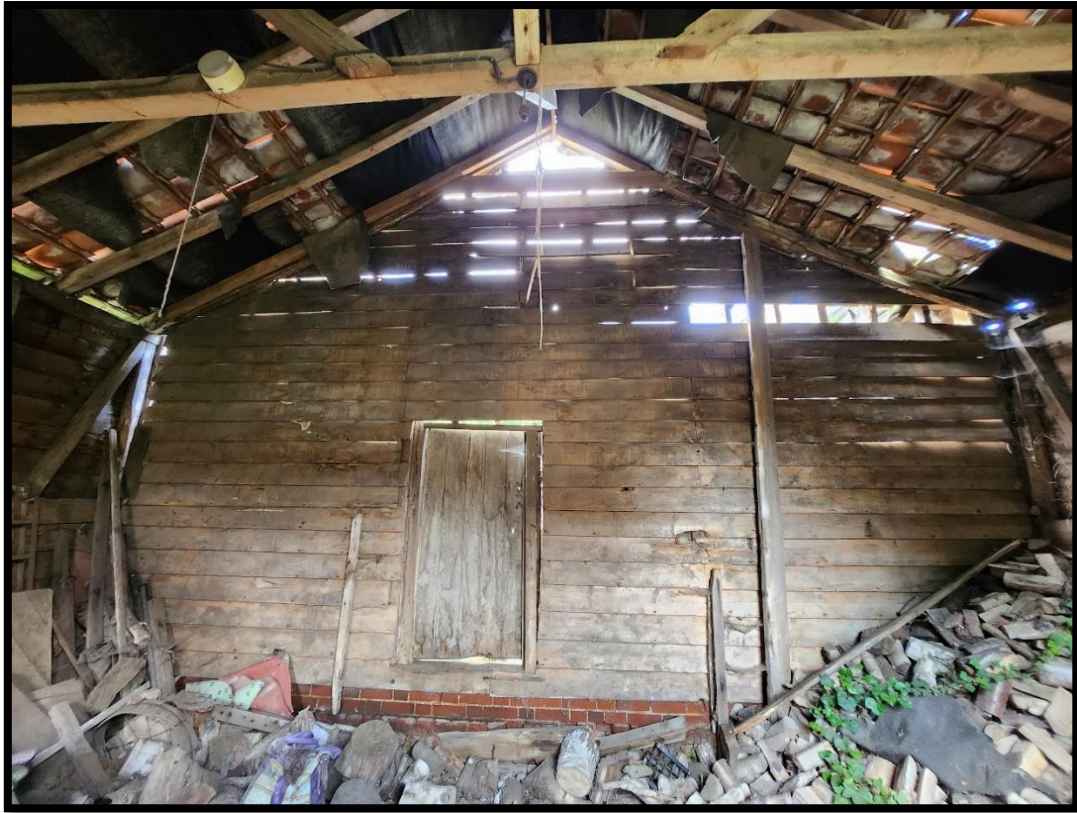
The Midstrey of Building 3.

From inside the C20 extension the original exterior wall is present.

Starting with the walls, the carpentry style is dependant on nails rather than pegs as would be seen on older barns, this would be in common with carpentry practices in the 19th and 20th century, the diagonal bracing looks to have been a later addition as the timbers are clearly machined. This may have been a later repair as it was a common style of stud walling up to the intervention of sheet materials in the mid C20.

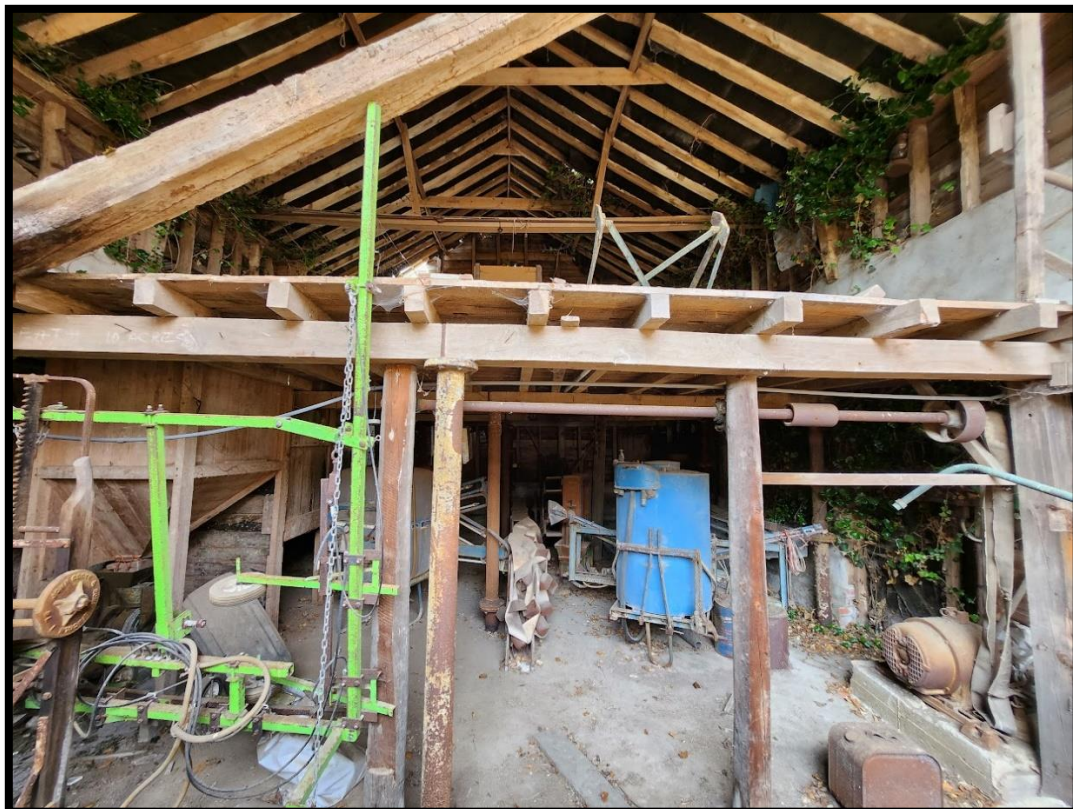
The wall carpentry is unsurprisingly the same as the Midstrey, mid to late Victorian with suspected later repairs. On the first floor of the mezzanine floor the base of the wall has been cemented, though this time as reinforcement to stop crops from pushing the walls out as they wait to go through the hopper on the left.

The Roof. The 20th century saw the cement and concrete become the go to materials for almost all buildings, now we know the damage it causes to breathable buildings the majority of conservation repair works are as a result of the idea that we knew better and the new cements and concretes were the answer. Less common is this theory when it comes to carpentry, yet this building follows the familiar pattern of C20 intervention. The new roof clearly ignores the ideas of the past and has collapsed as a result.

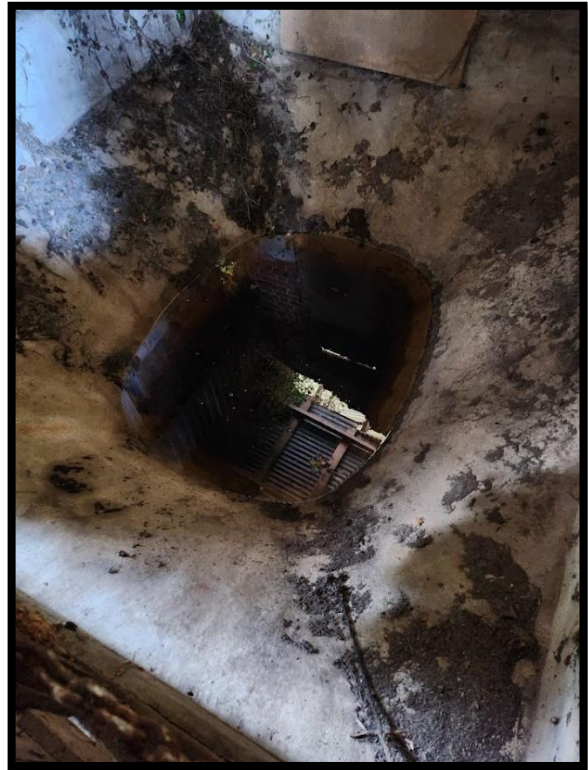
C

Pic C. The floor with some form of either water holding or former drainage gully/hopper.

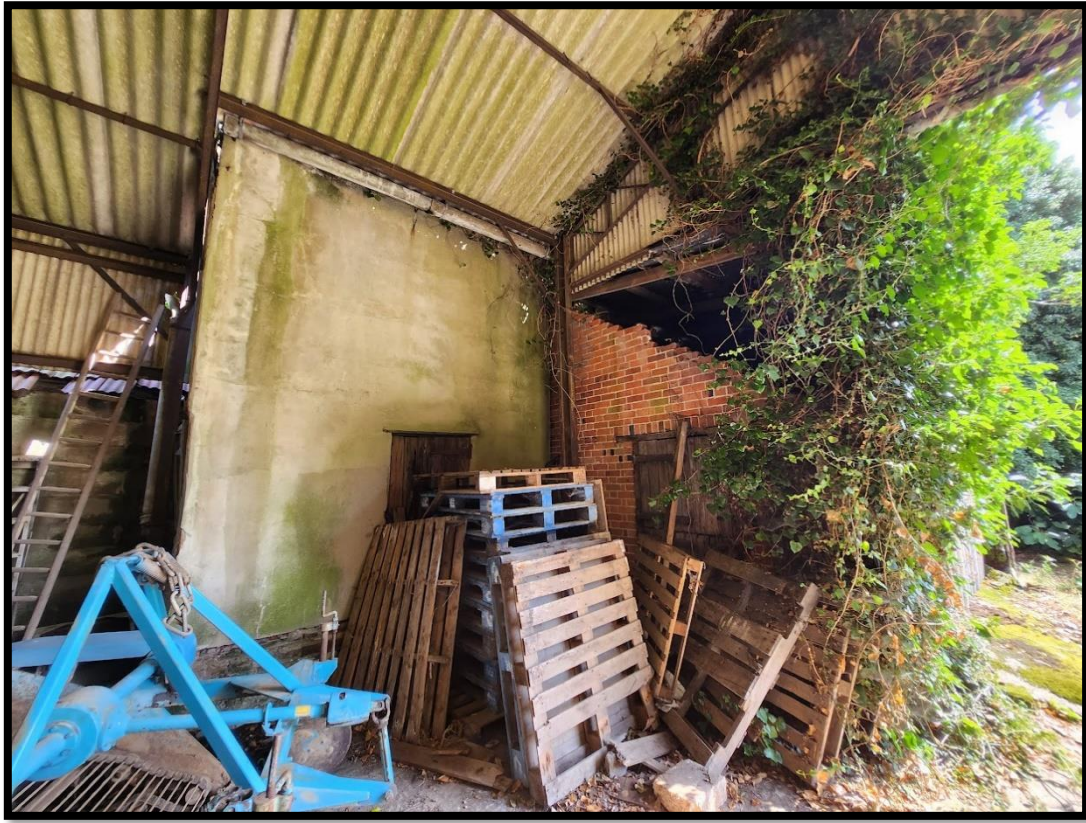
When viewed from the other side in building 7 the cleanliness of the brickwork shows this as a former exterior wall as the excess mortar seen on the inside has been washed off. We also see the exterior left-hand end of the original barn with the cement render has been applied up to the brick wall confirming the this was applied after this room was created.

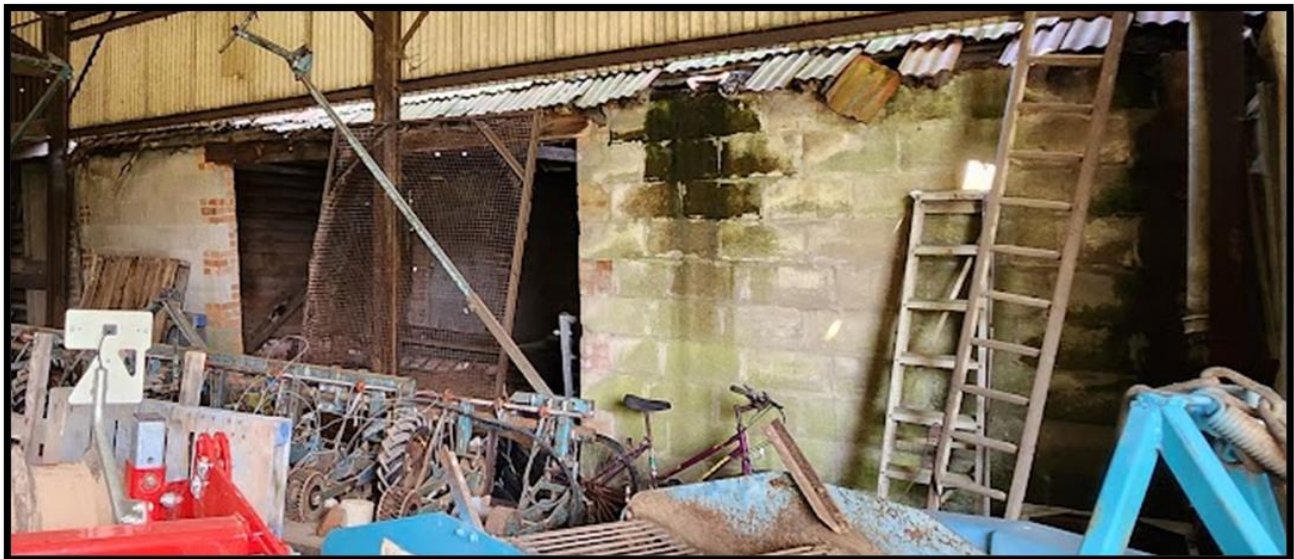
The building is still accessed from building 7 where we can see the back wall of building 5. The other end wall is the end wall of building 3 making this building an infill. The historic maps show this building being in position as far back as 1882 which confirms this is a later replacement building.

The roof is timber construction covered in red triple radius pantiles.

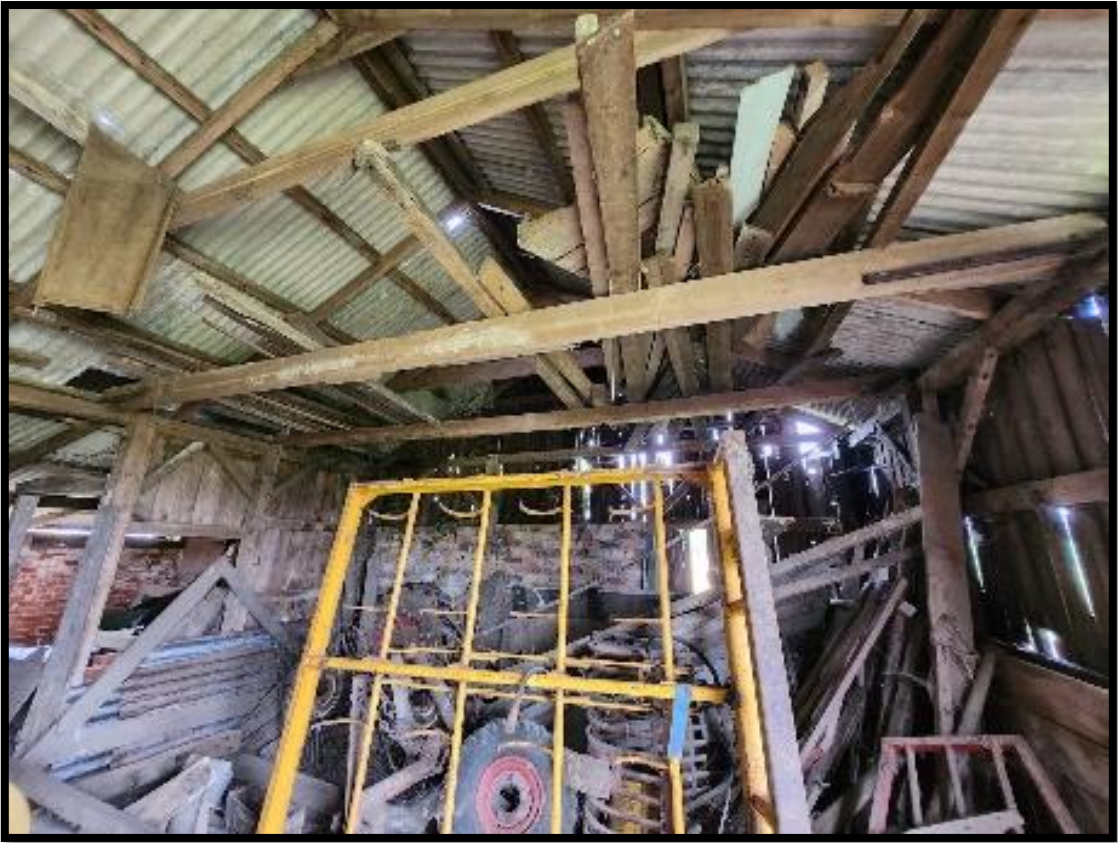
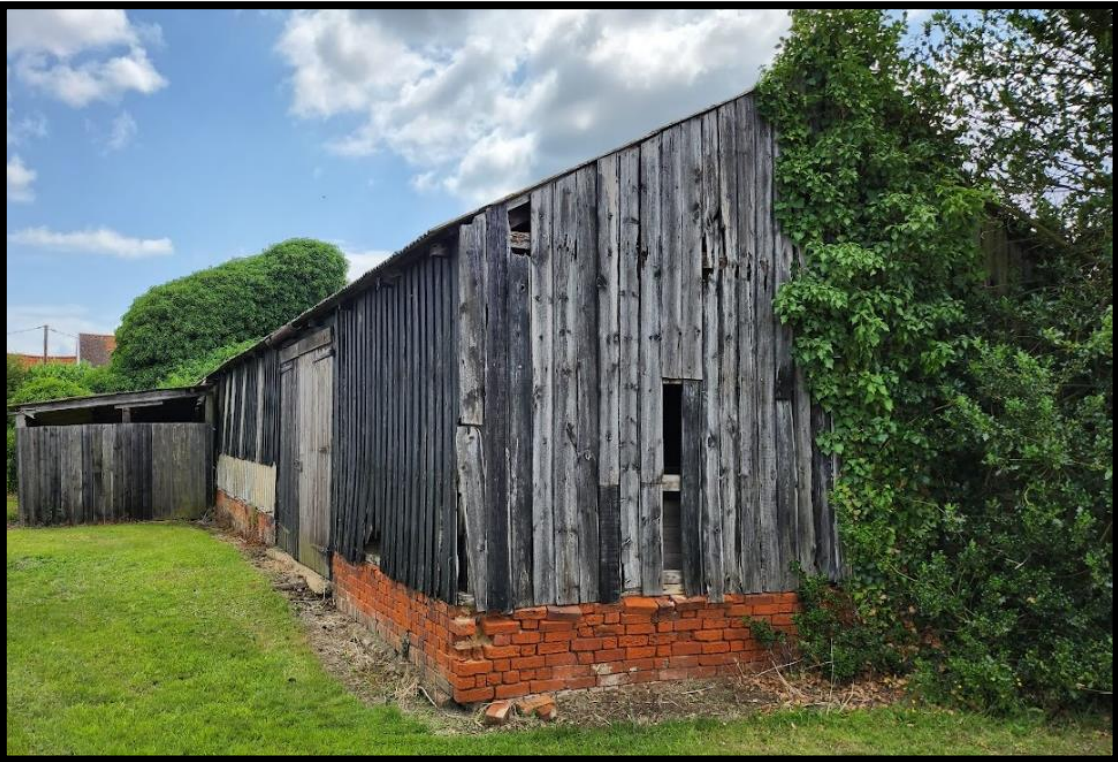
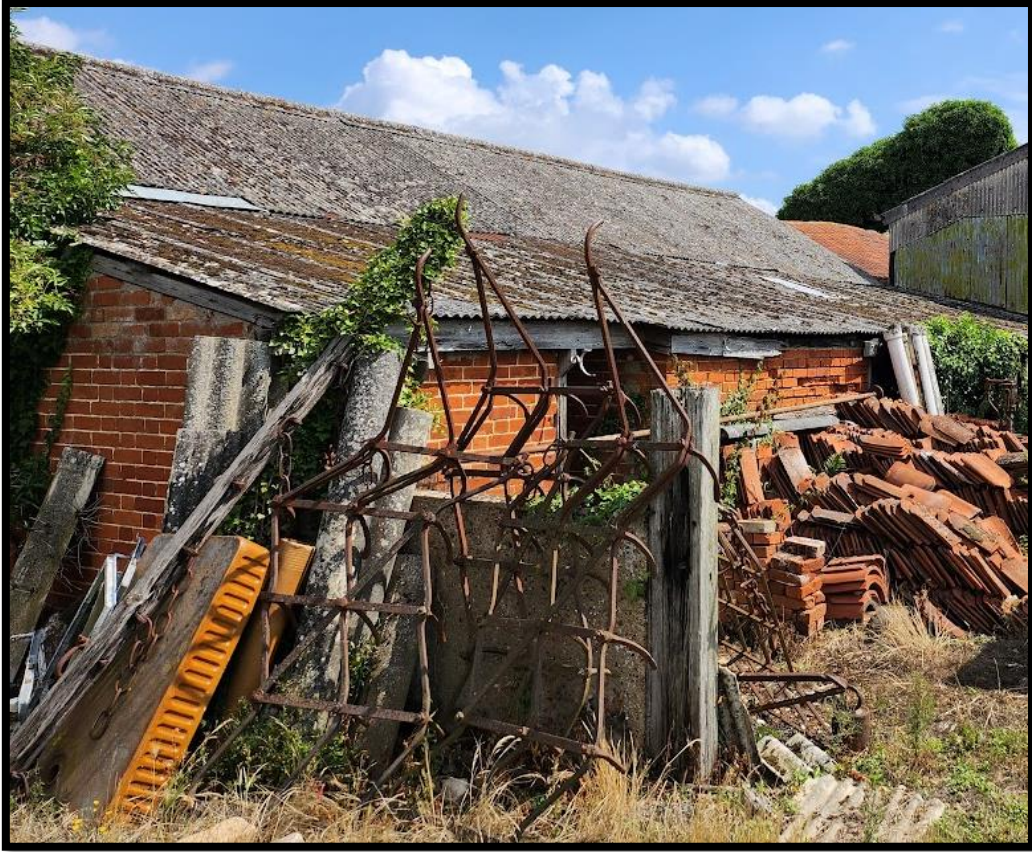
The solid brick lean-to section is built similarly to earlier pig styes, yet these are usually only half roofed this may well have been their original use with a full-length roof being added when their purpose changed to storage attached to the main building. The heaps of pan tiles may have been from the previous roofs.

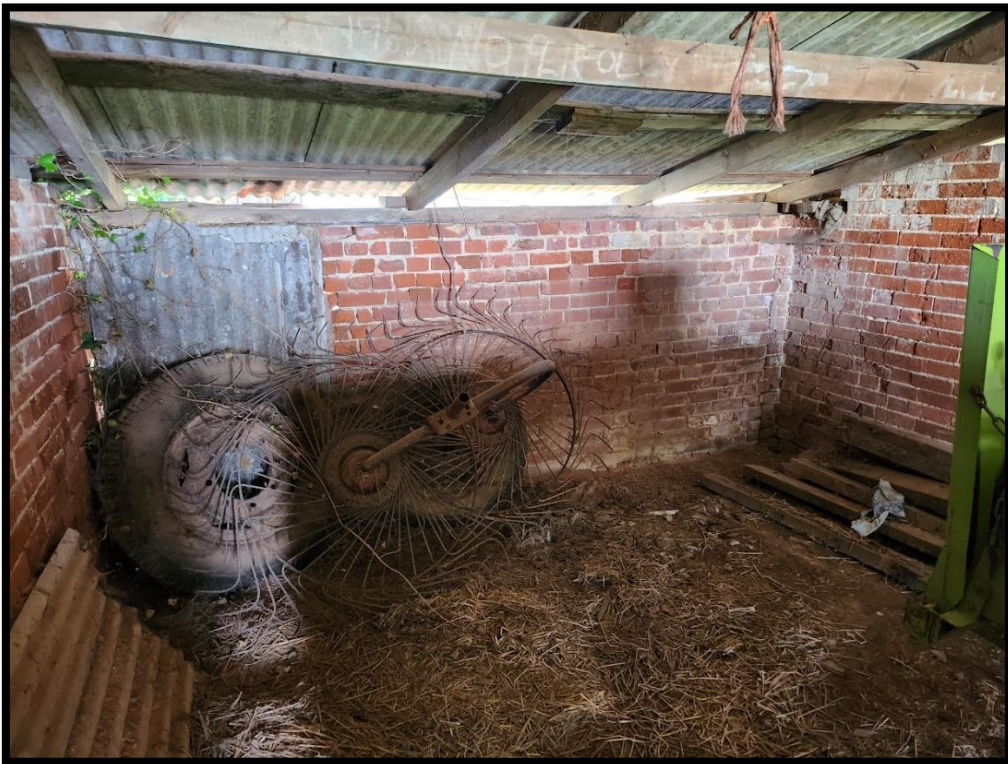
Interior bay of lean-to section of former pig pens.

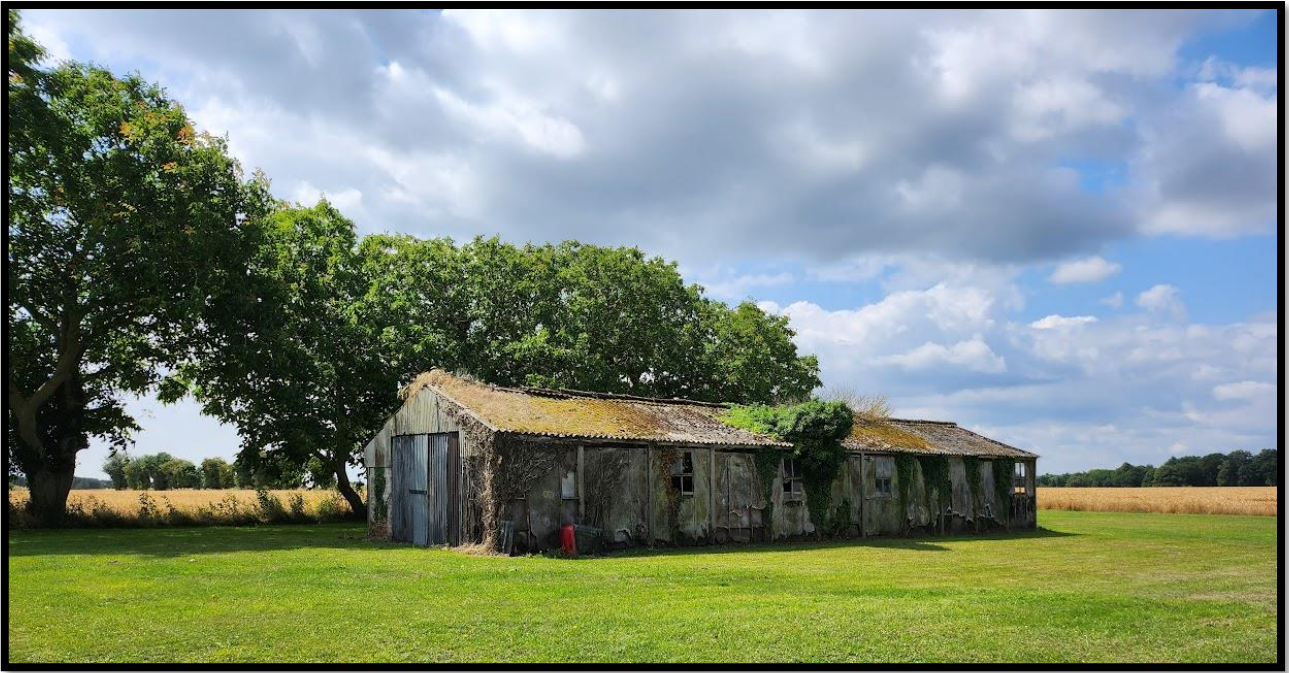
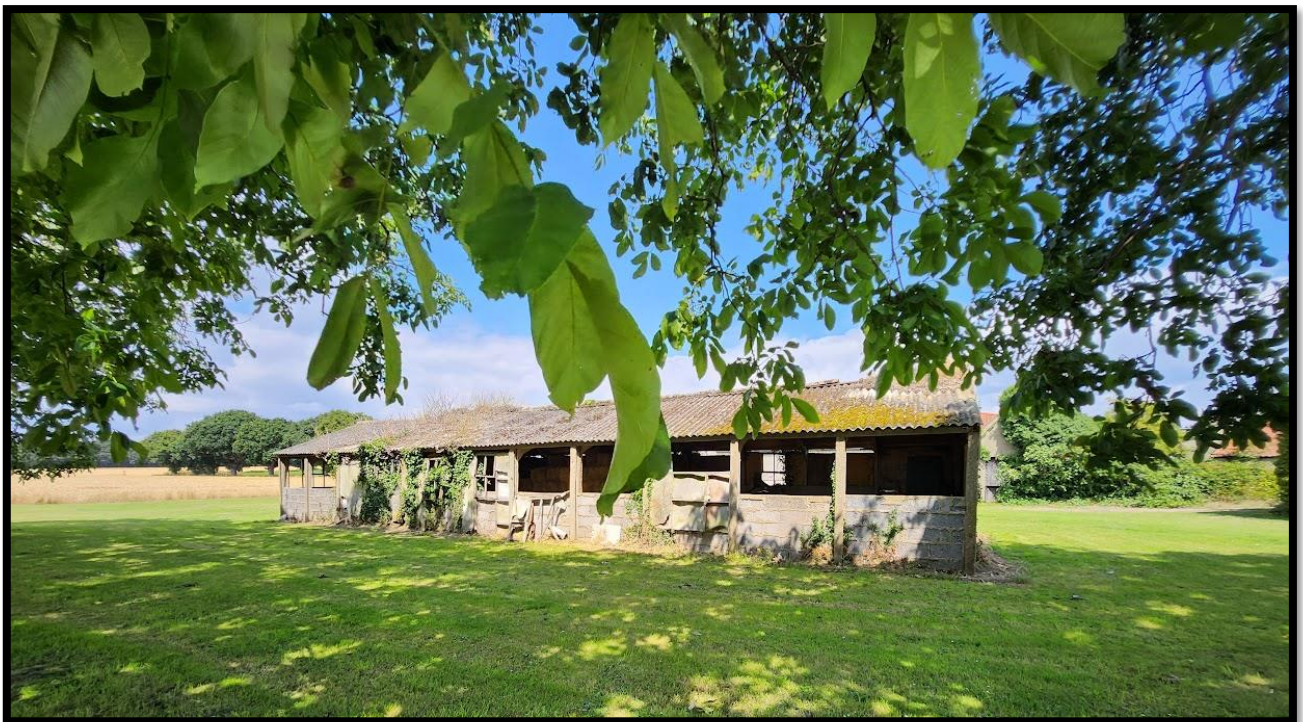
Building 8 viewed looking South Westerly.

Buildings 8 & 9 are reported as being ex MoD buildings purchased at the end of WWII. Above is building 8.

The structure of the building is concrete bolt together frames with concrete kneeler bracing forming bays. Between the bays are a mix of full and half height blockwork walls that are cement rendered on the interior of the building. Beyond this in some of the bays are the remains of timber stud walling. A few of the bays also have cement render applied to them. There are also the remains of timber casement windows in a Victorian style with top horizontal openers. These have all lost their glazing and are economically beyond repair.

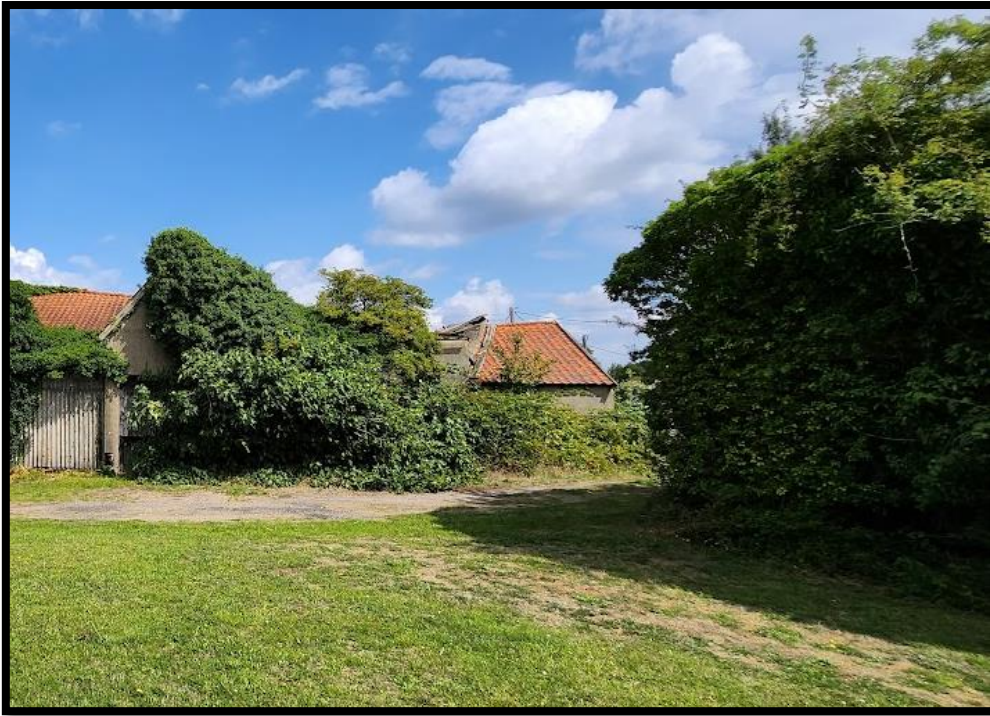
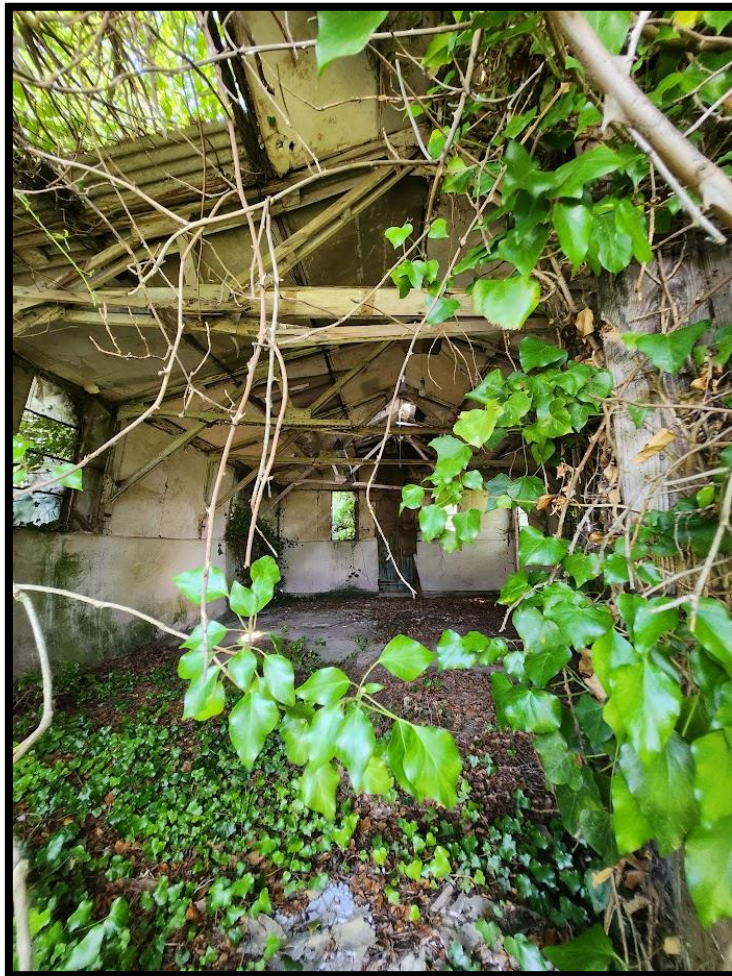
Building 9 is under the foliage in the right of the picture.

Peering through the foliage the building within is revealed.

The windows are steel framed Crittall type casements in poor condition.

Above this we have timber engineered trusses that are in differing states of disrepair, these support steel purlins above.

The roof is covered in corrugated asbestos type sheeting that is failing in places.
