**PROTECTED SPECIES (BAT) SURVEY OF  
THE GINEVERS  
BAWTRY ROAD  
BLYTH  
WORKSOP  
S81 8HG**

**Derek Kitson Architectural Technologist Ltd**

**December 2019**

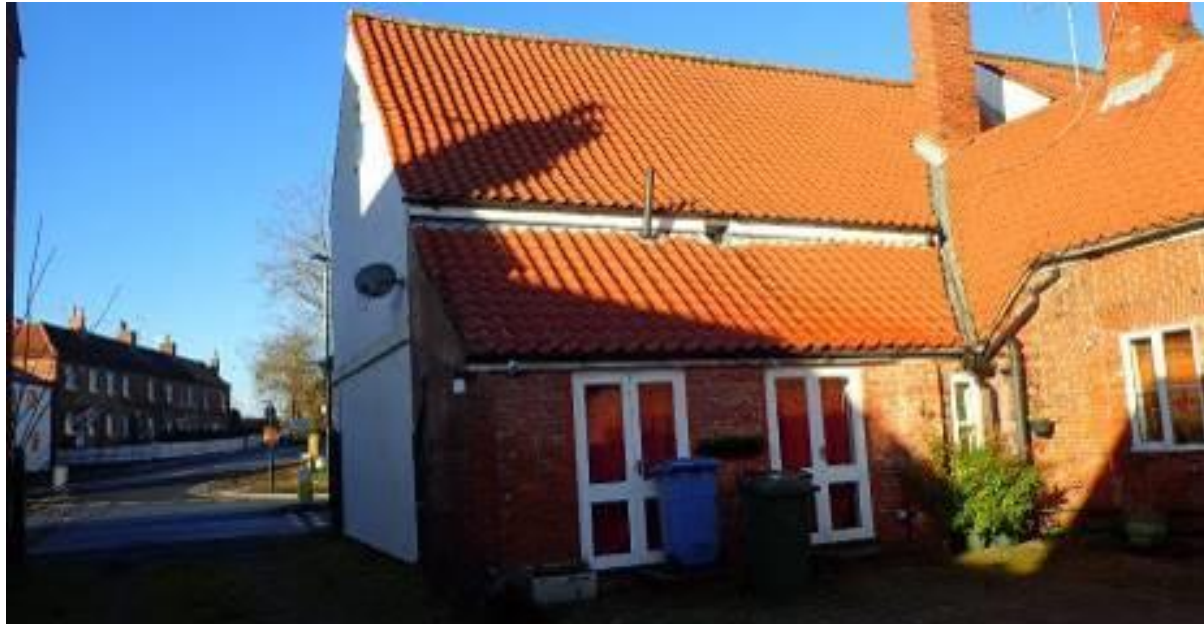
**Photograph 3: East and south aspects of house at Ginevers**

The roof covering of the dwelling is in good condition and appears to have been reroofed relatively recently compared to the outbuilding. One broken pantile was noted along with occasional gaps in the bedding mortar beneath the ridge tiles.

It is the owner's intention to undertake minor roof repairs such as the replacement of missing or broken tiles on the house. As these features are deemed to be of low roost potential it is recommended that a minimum of one emergence and activity survey for bats is undertaken in the active season from May to end of August prior to any roof repairs.

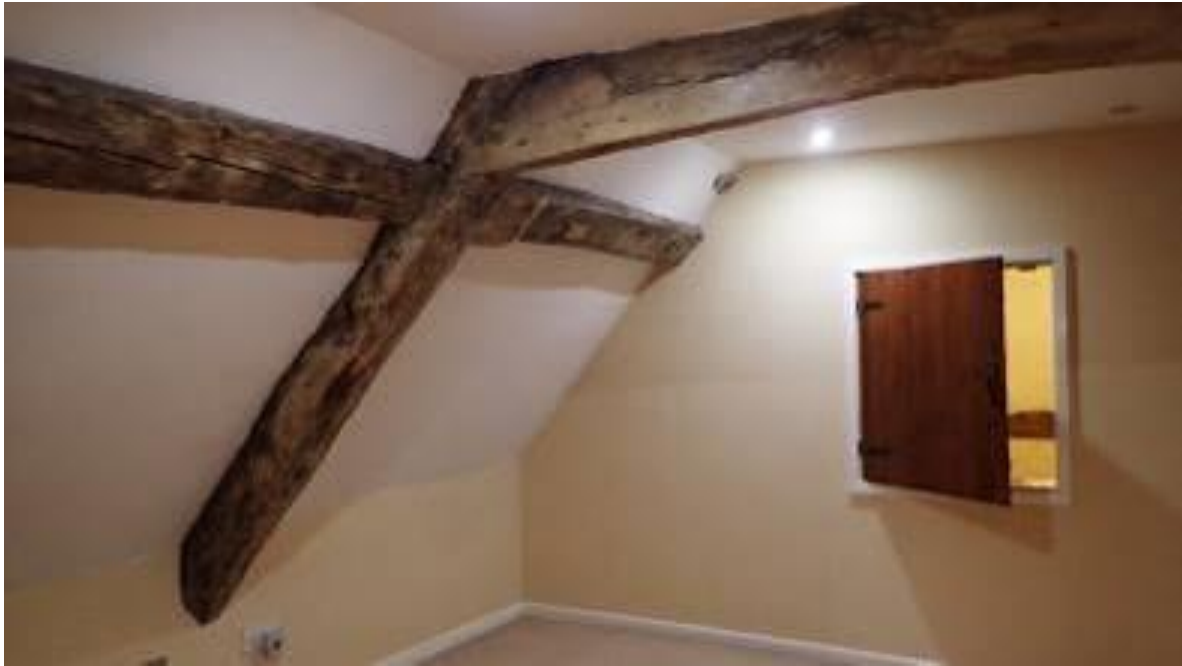
**Photograph 4: Interior of first floor room of west section of house showing purlin and tie beam of roofing frame**

The first floor rooms of the dwelling contain vaulted ceilings showing the original timber roofing frame. Above the ceilings is a very shallow roof void which is inaccessible and only likely to offer crouching height at least.

No evidence of use by bats was found during the visual inspection. There is no available access to the interior of the roof void above the vaulted ceilings. Judging by height of the window at the south gable the roof void above is likely to be too shallow to appeal to attic dwelling species. Features with potential of supporting crevice dwelling bat species were identified on the exterior fabric of the house.

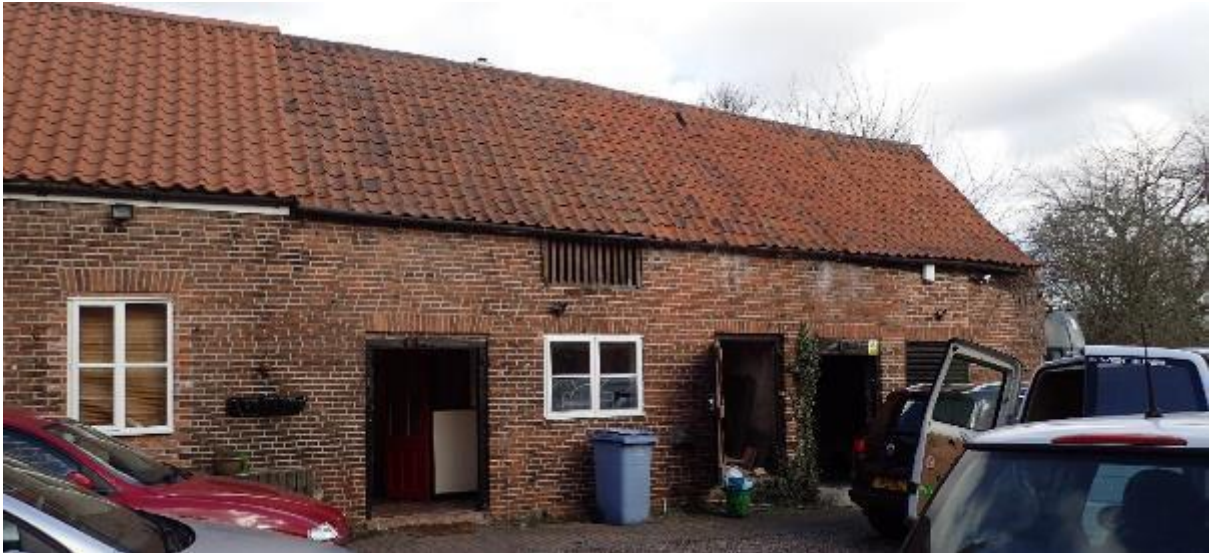
**Photograph 5: South aspect of outbuilding attached to east aspect of dwelling**

The outbuilding is a former butcher's workshop attached to the east aspect of the dwelling. It consists of 1.5 storeys with attic space. The east and south walls are constructed from solid brick, the north wall is constructed from a combination of stone and brick.

The pitched roof is covered with clay pantiles. Most of the roof is underlined with bitumen felt however there is one area that is unlined. The timber roofing frame is visible from the first floor. It is a traditional purlin and rafter structure resulting in an uncluttered space beneath the ridge beam. The eaves are finished with timber barge boards. The rafters of the east gable are partially exposed. At this elevation the wall is rendered from the ground to wall plate height.

No evidence of use by bats was found during the visual inspection. The outbuilding does contain features that have potential to support roosting bats. The clay pantile roof covering has numerous gaps between the tiles enabling a bat to roost between the pantile and the bitumen felt liner where it is present. The gaps between the tiles of the unlined roof section have potential to enable access to the interior of the building. There is one area of missing roof covering in the south pitch close the ridge.

No evidence of use by bats was found during the visual inspection of the outbuilding. The interior and exterior of the outbuilding has features with potential to support roosting bats. No work should commence to this building until a bat emergence and activity survey has been undertaken to establish whether roosting bats are present. In accordance to the national survey guidelines emergence and activity surveys can only be carried out between May to the end of August in weather conditions that are conducive to bat activity.

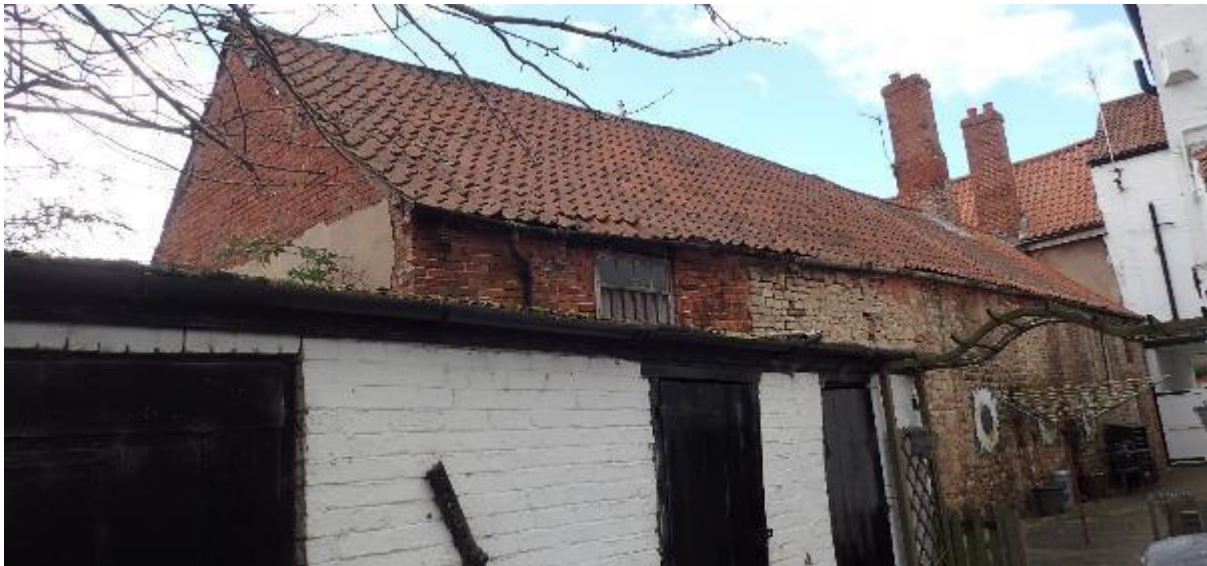
**Photograph 6: East gable and north elevation of outbuilding**

At the east gable the exposed timber roofing frame has started to shrink resulting in numerous gaps between the brickwork and timber which have potential to appeal to crevice dwelling bat species. Cracks in the brickwork and the verge mortar are also present at this gable providing more potential roosting opportunities.

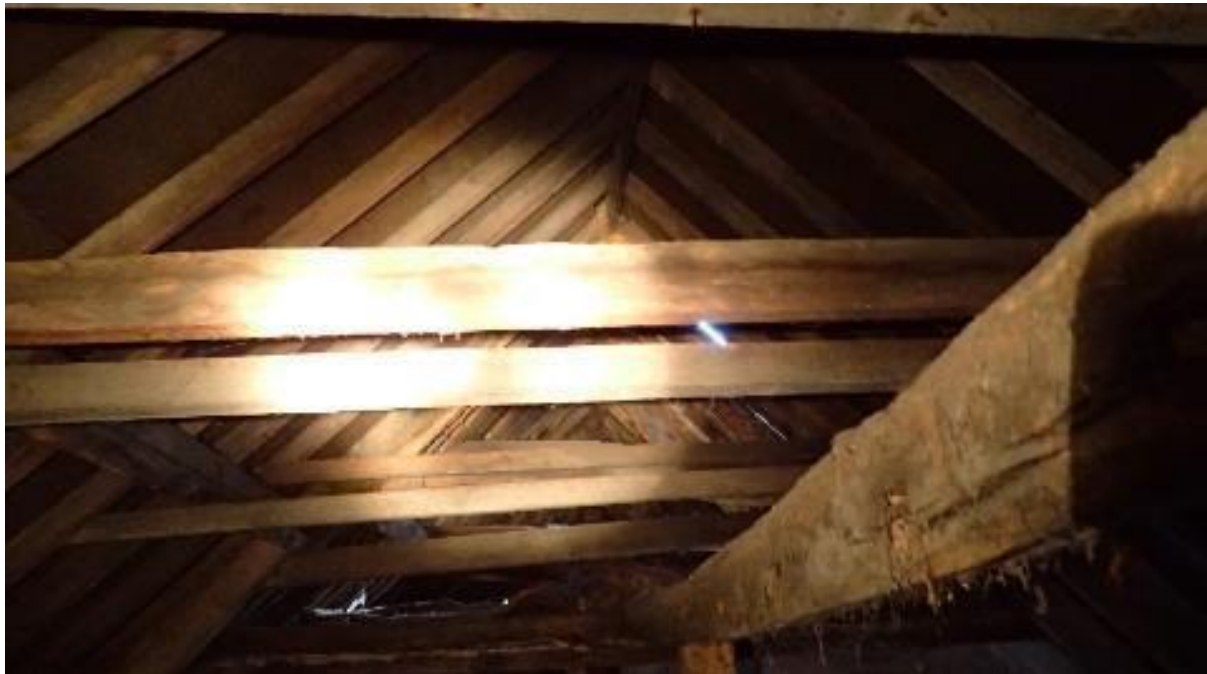
**Photograph 7: Interior of attic space of west section of outbuilding**

The interior of the outbuilding is divided into compartments. At the eastern end is a single full height room which still contains the original winch and hanging apparatus attached to the rafters. This room has timber ceiling panels several of which are missing exposing the attic space above.
