CCTV Inspection Report

**MILLFIELD HOUSE
LINLEY AVENUE
HAXBY
YORK
YO32 3NF**

20/04/2023

Job Number: 7663

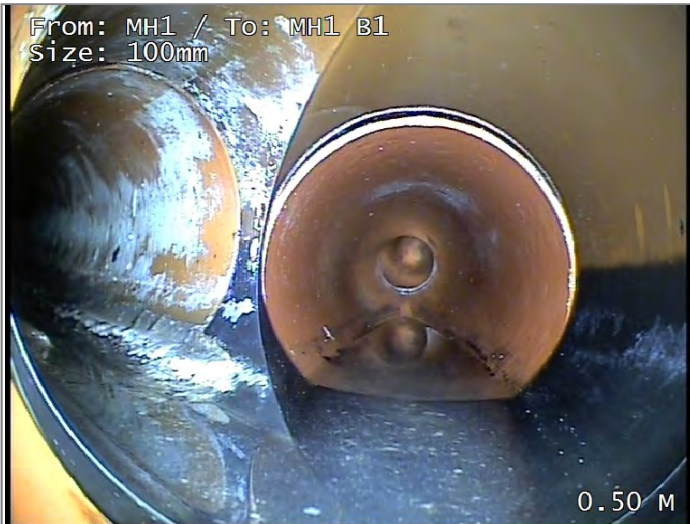
Junction at 9 o'clock, diameter 100mm - Remark: JUNCTION SERVES GULLY AT FRONT OF HOUSE.

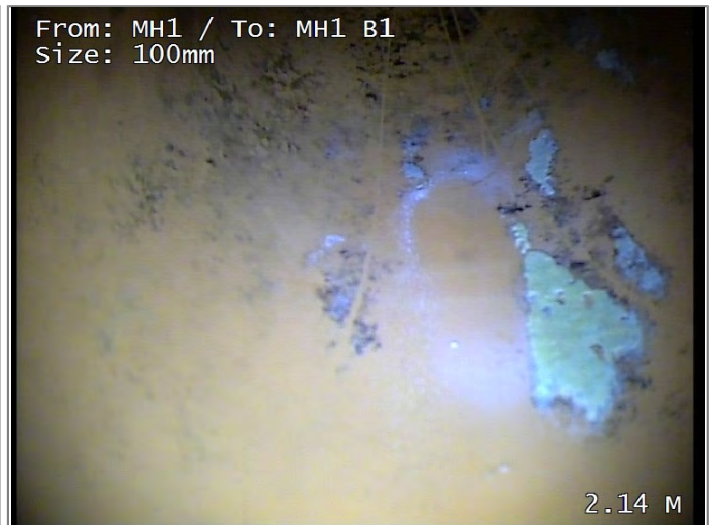
Line of drain/sewer deviates up

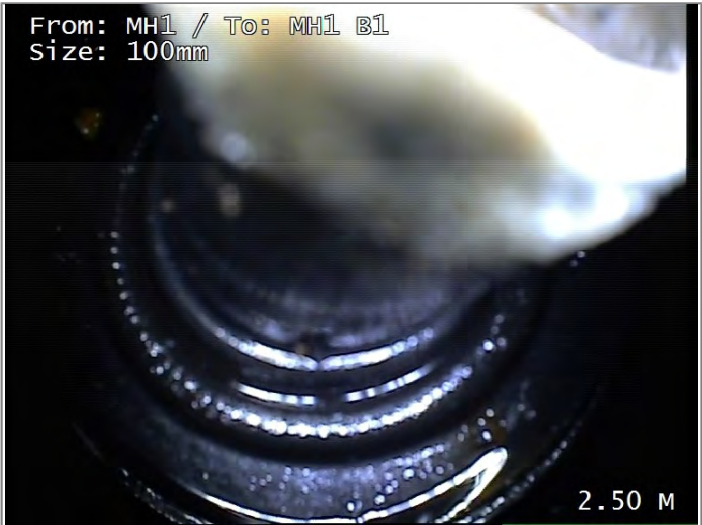
Finish node type, major connection without manhole, reference MH1 B1
REST BEND

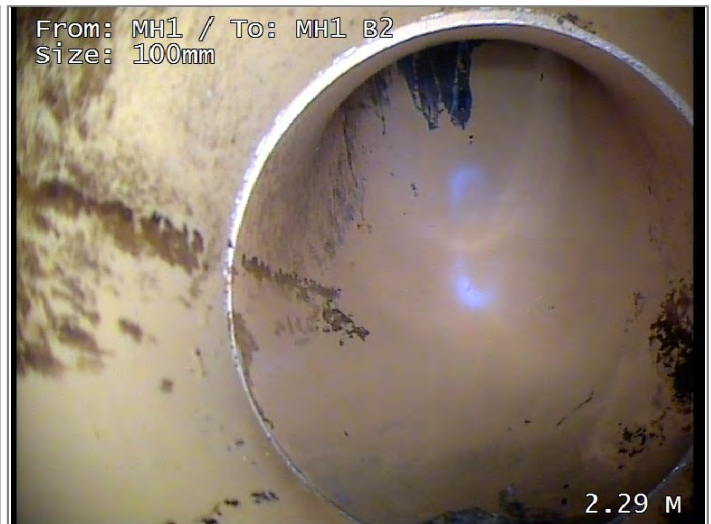
Line of drain/sewer deviates up

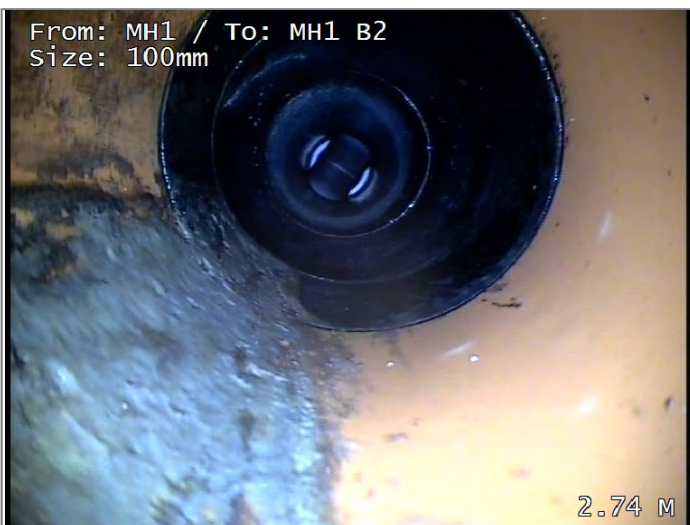
Finish node type, major connection without manhole, reference MH1 B2 REST BEND

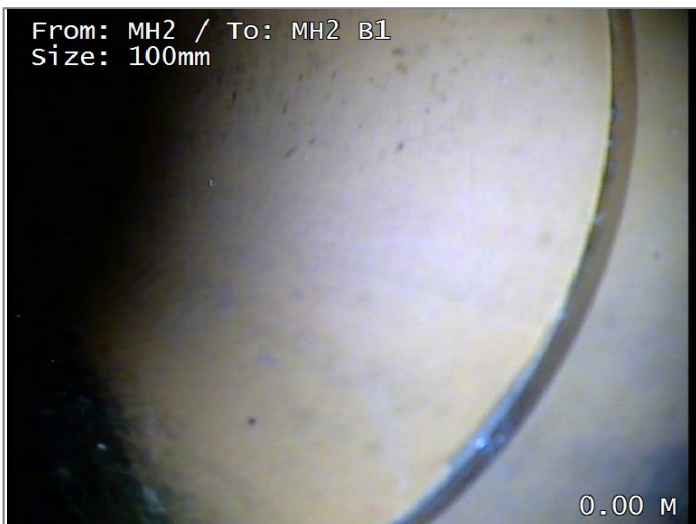
Line of drain/sewer deviates left

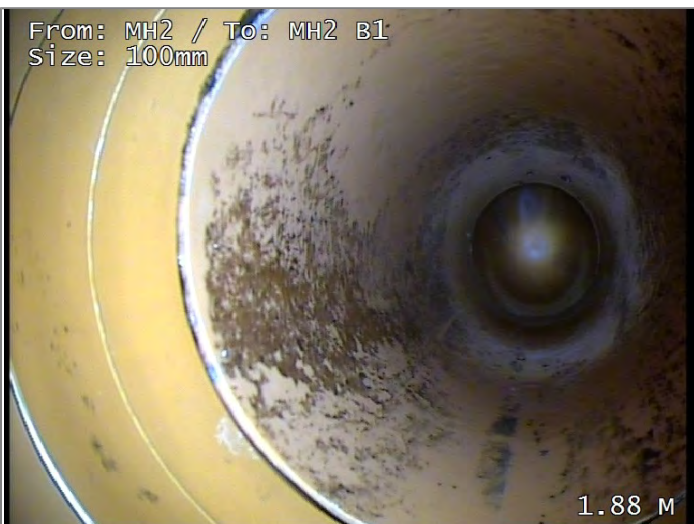
Line of drain/sewer deviates right

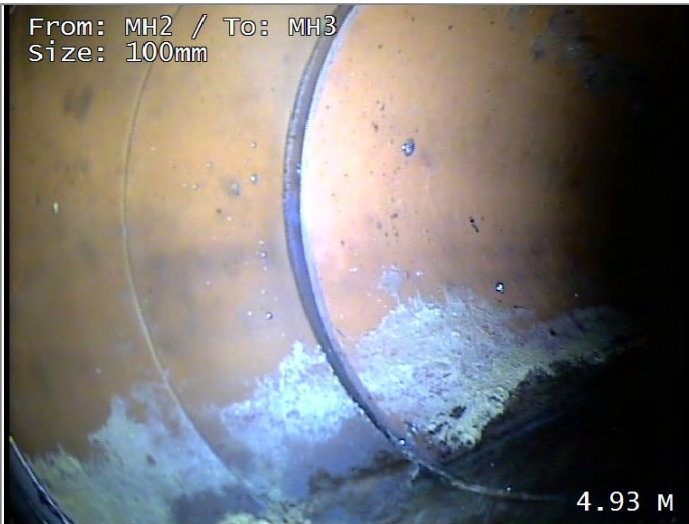
Line of drain/sewer deviates right

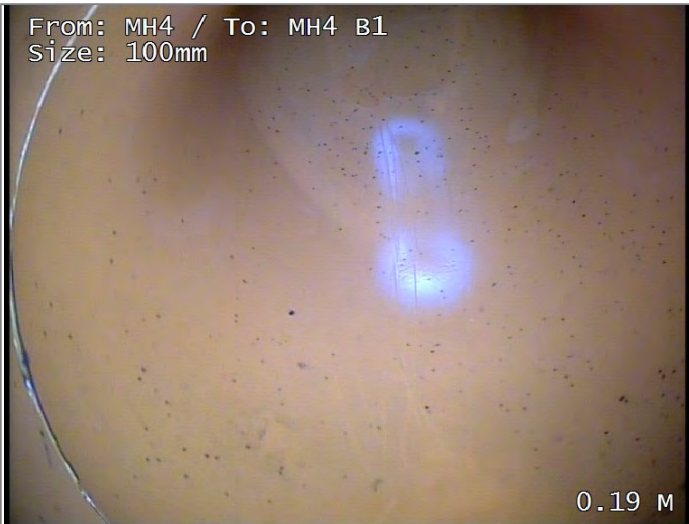
Line of drain/sewer deviates up

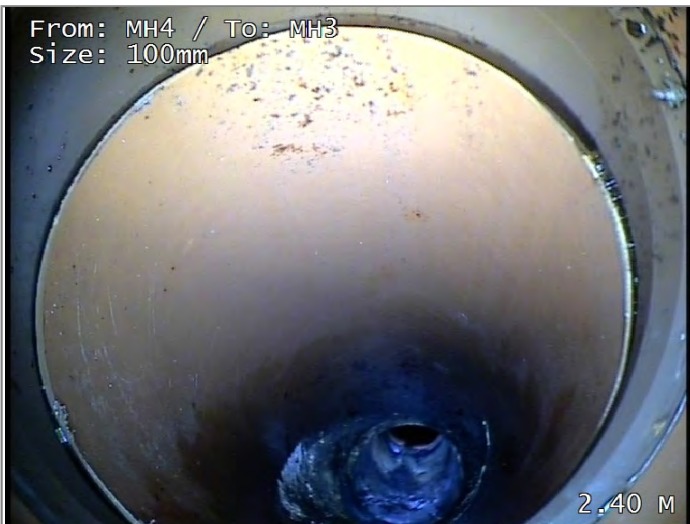
Line of drain/sewer deviates down

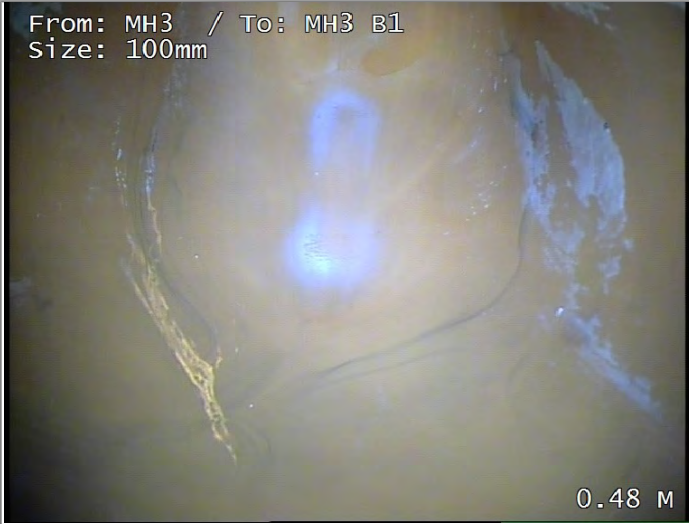
Line of drain/sewer deviates up

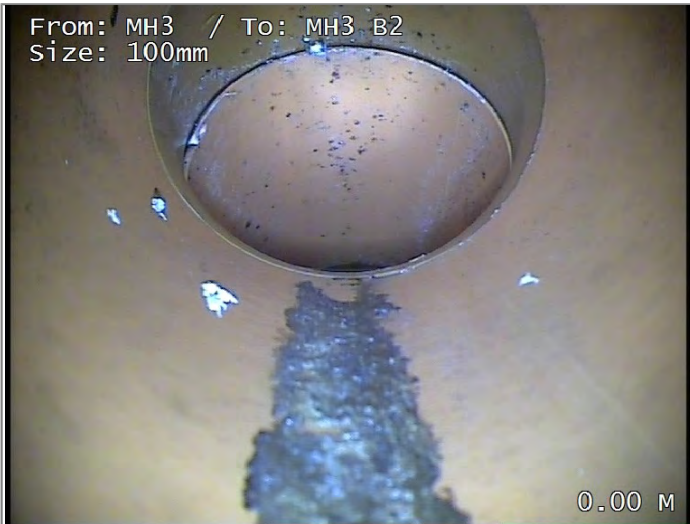
Line of drain/sewer deviates up

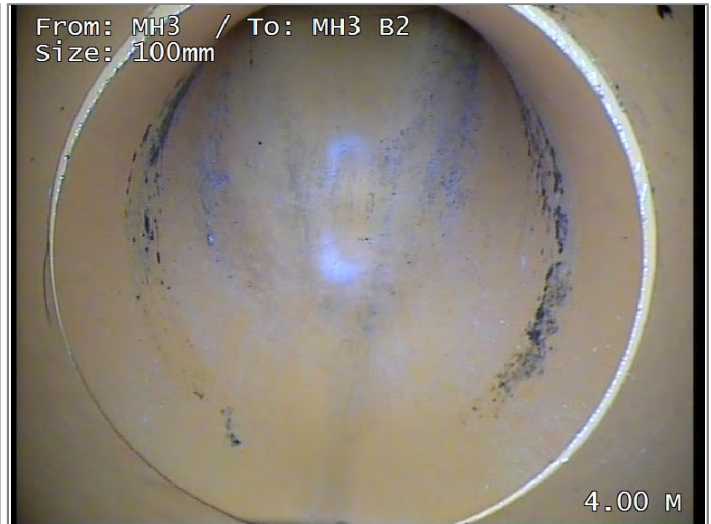
Line of drain/sewer deviates up

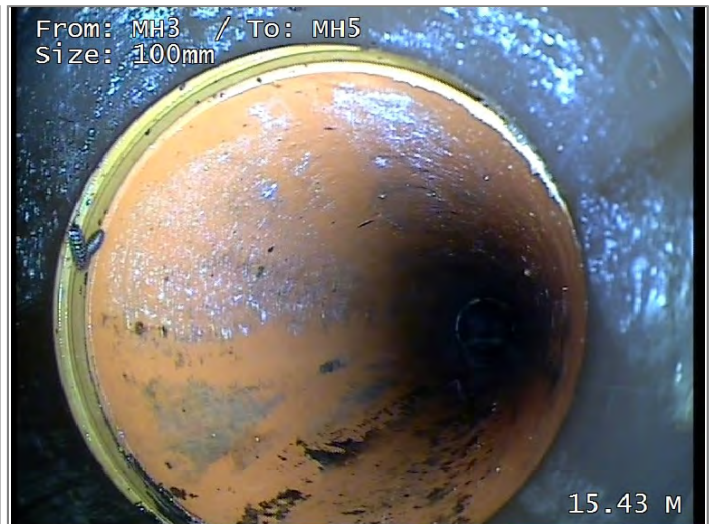
Line of drain/sewer deviates right

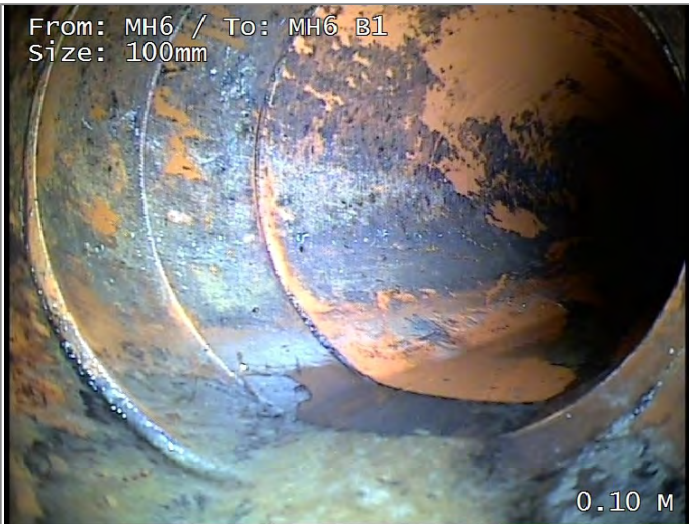
Line of drain/sewer deviates right

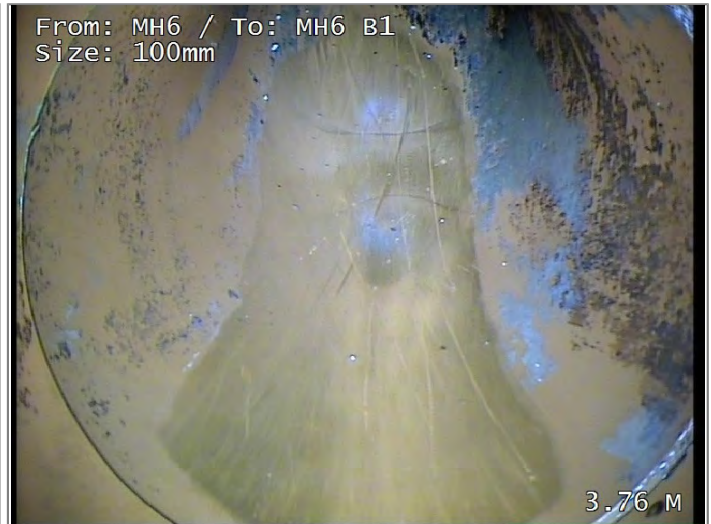
Line of drain/sewer deviates up

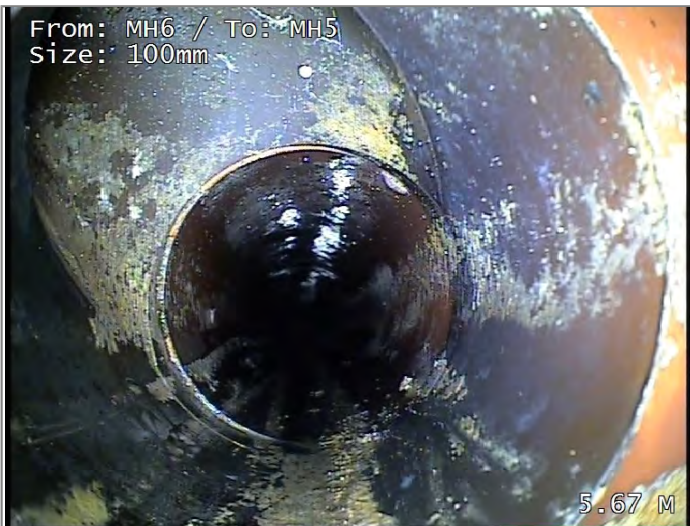
Junction at 11 o'clock, diameter 100mm

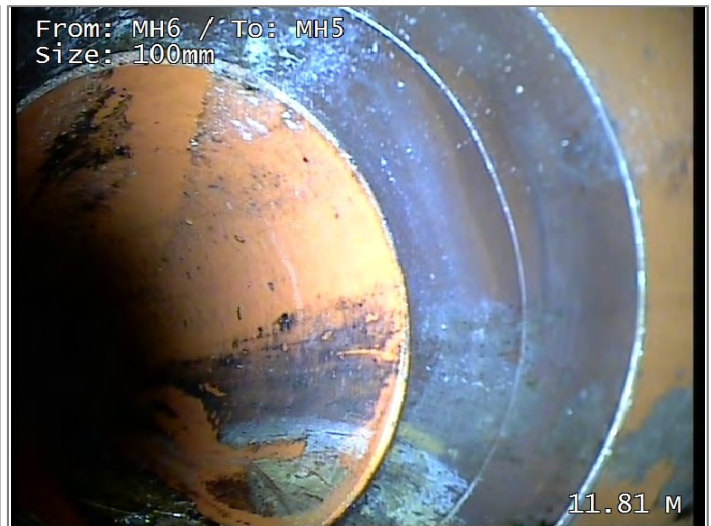
Line of drain/sewer deviates left

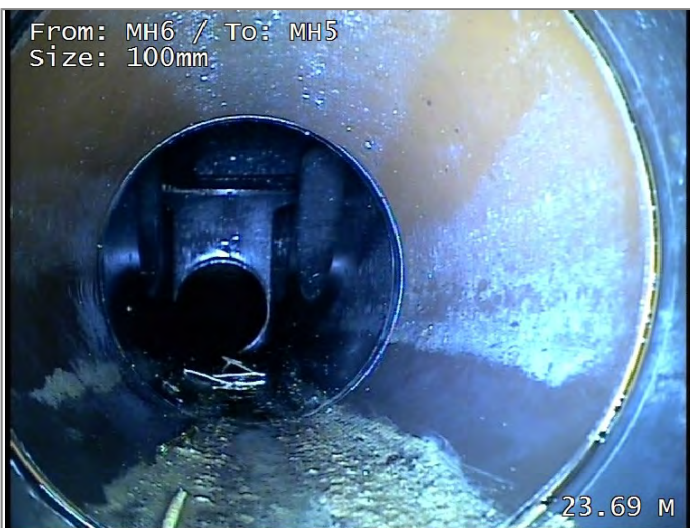
Line of drain/sewer deviates left

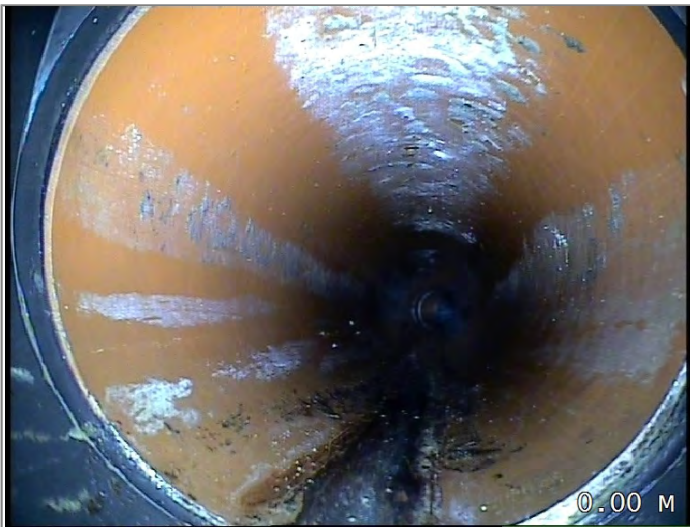
Start node type, inspection chamber, reference MH5

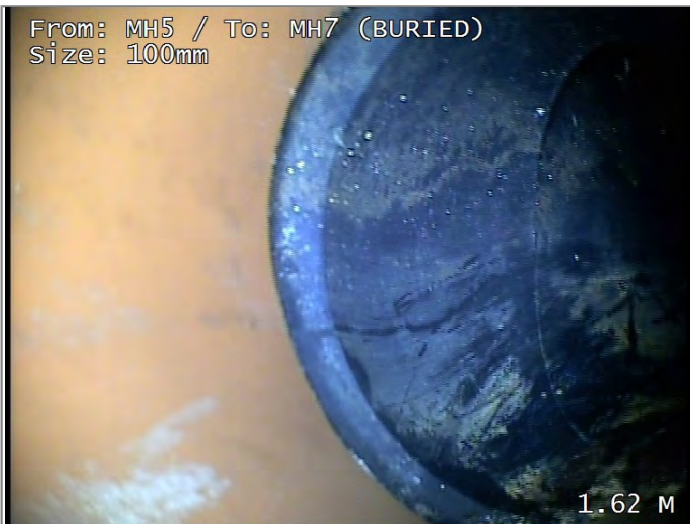
Line of drain/sewer deviates right

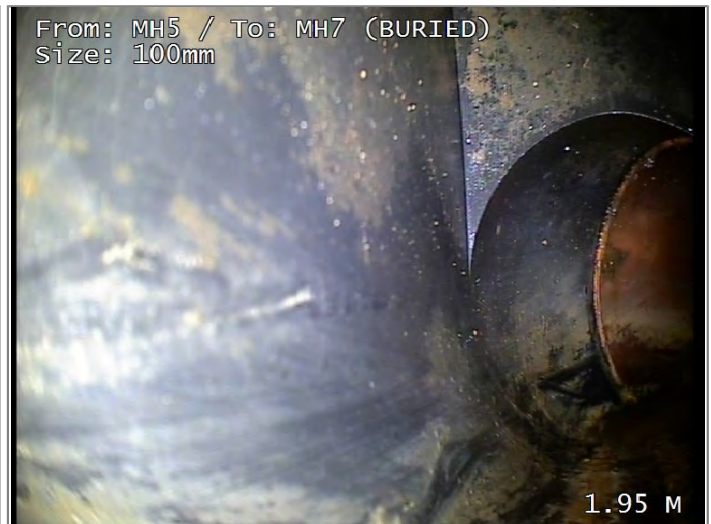
Finish node type, inspection chamber, reference MH7 (BURIED)

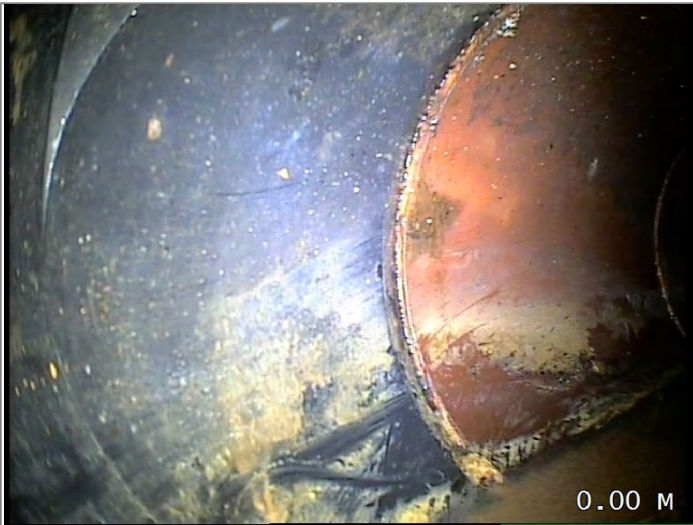
Start node type, inspection chamber, reference MH7 (BURIED)

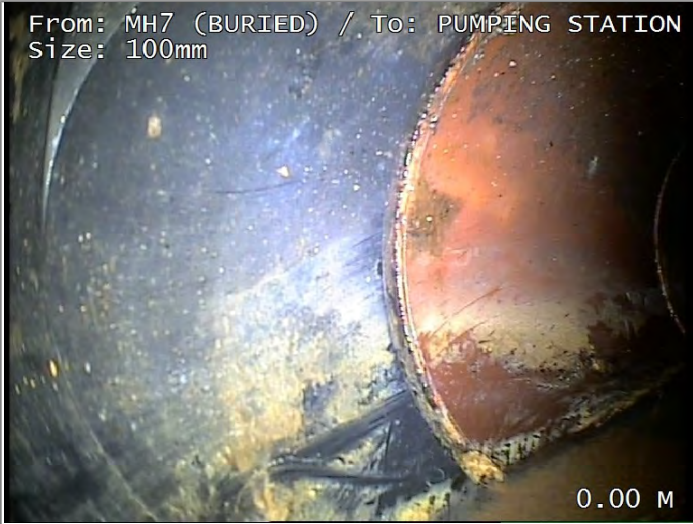
Line of drain/sewer deviates right

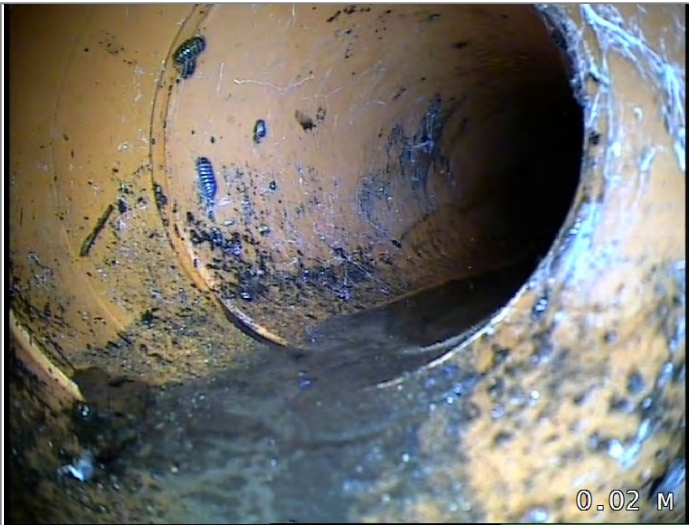
Start node type, manhole, reference MH8

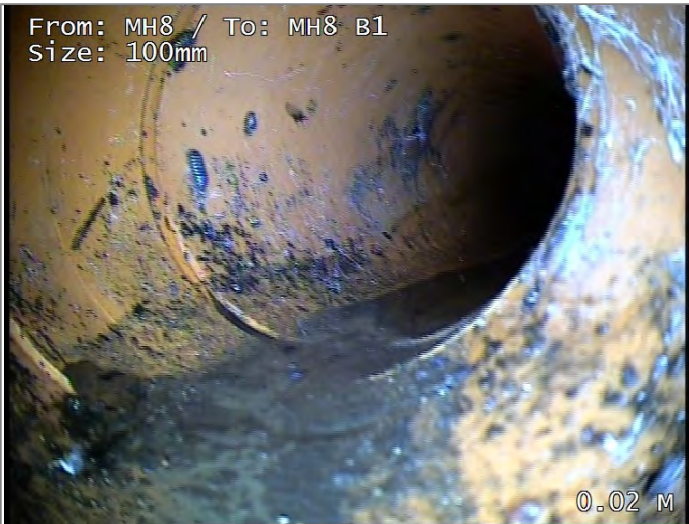
Line of drain/sewer deviates left

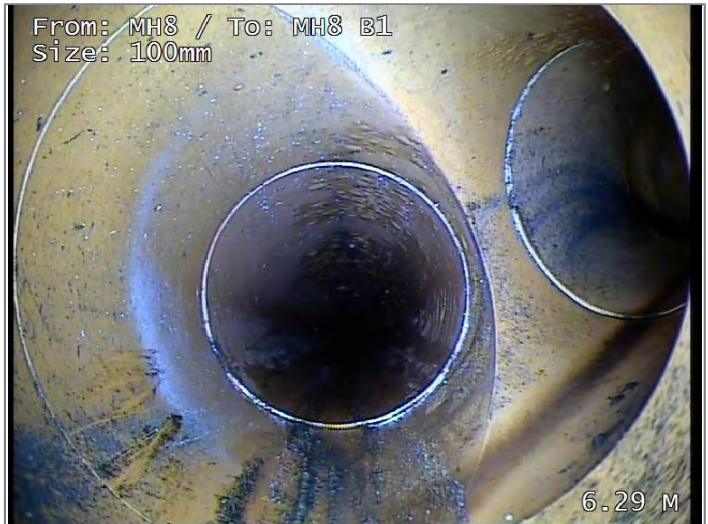
Junction at 2 o'clock, diameter 100mm

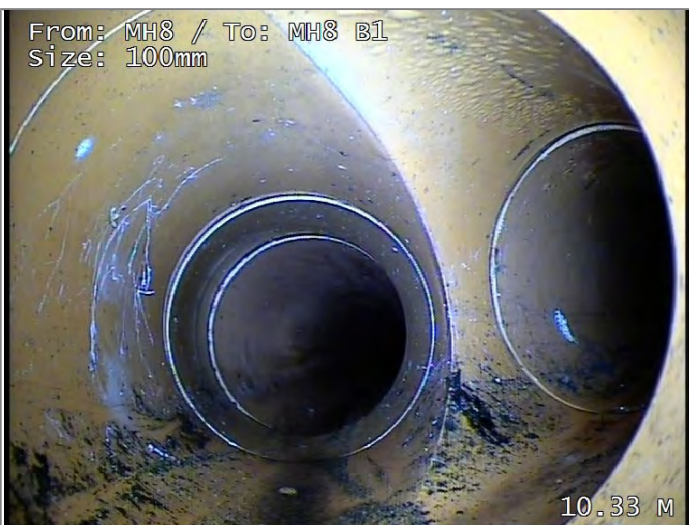
Junction at 3 o'clock, diameter 100mm

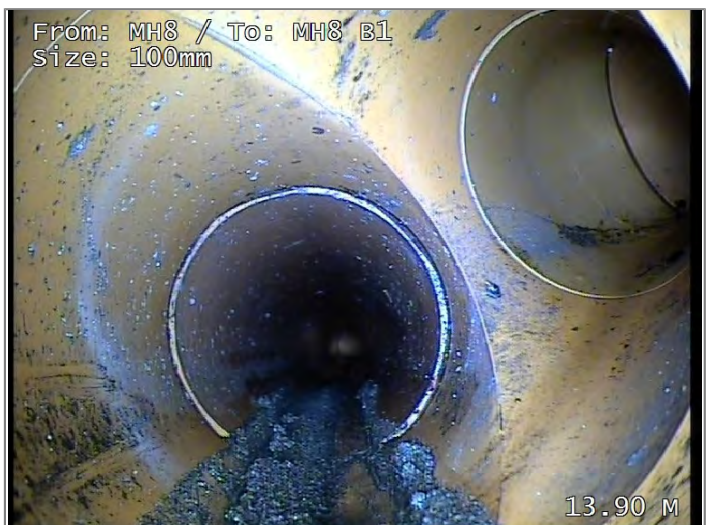
Junction at 2 o'clock, diameter 100mm

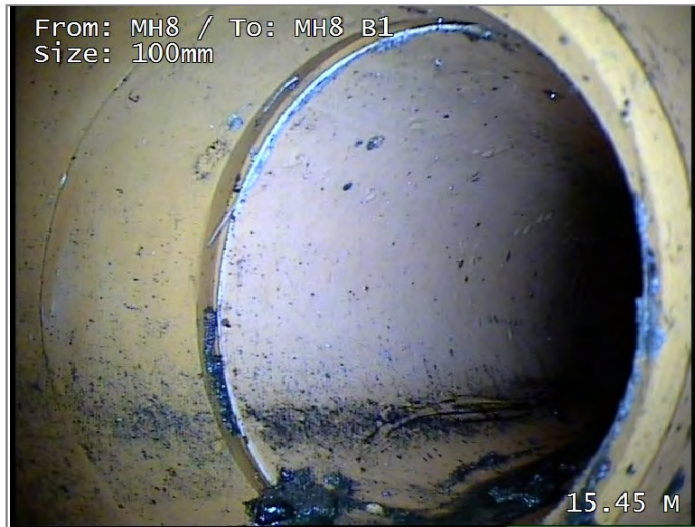
Line of drain/sewer deviates right

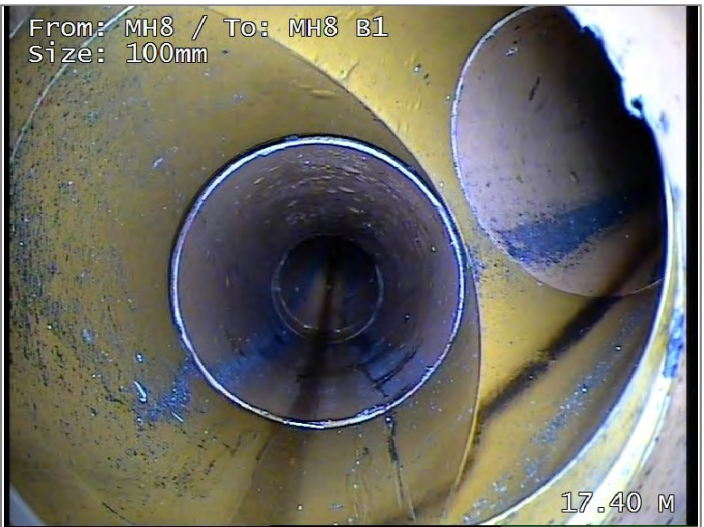
Junction at 2 o'clock, diameter 100mm

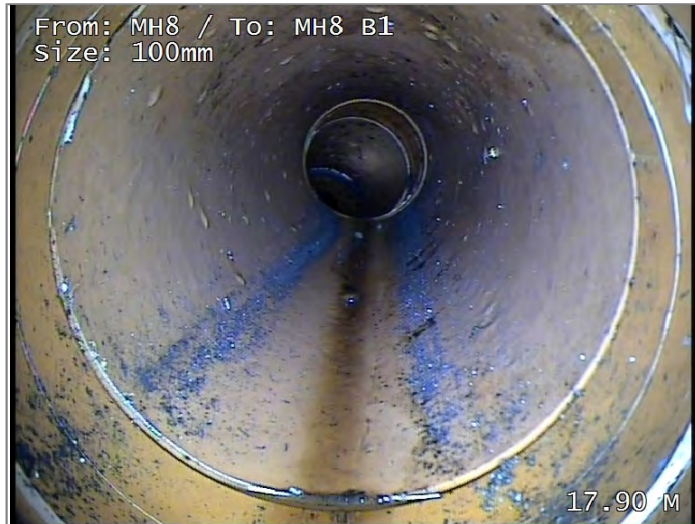
Line of drain/sewer deviates up

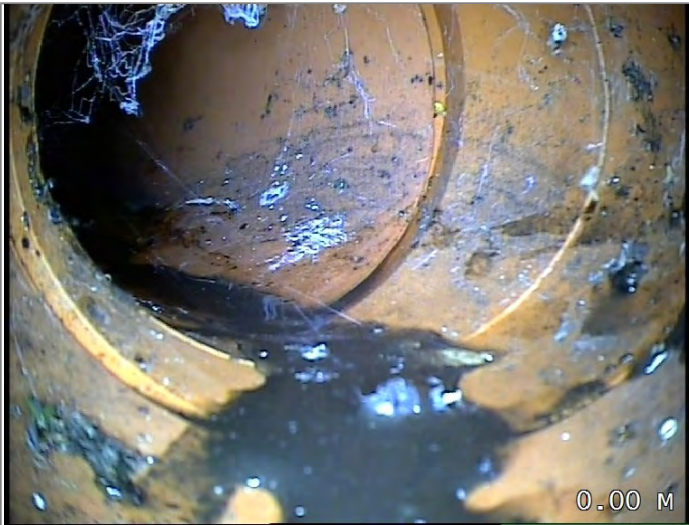
Start node type, inspection chamber, reference MH8

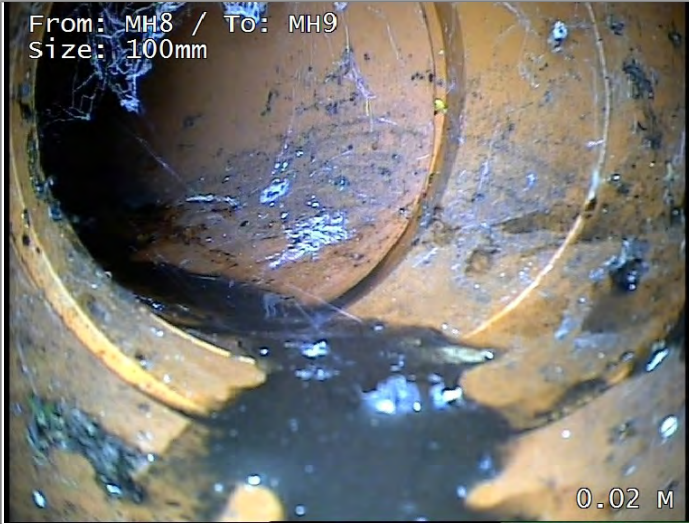
Line of drain/sewer deviates left

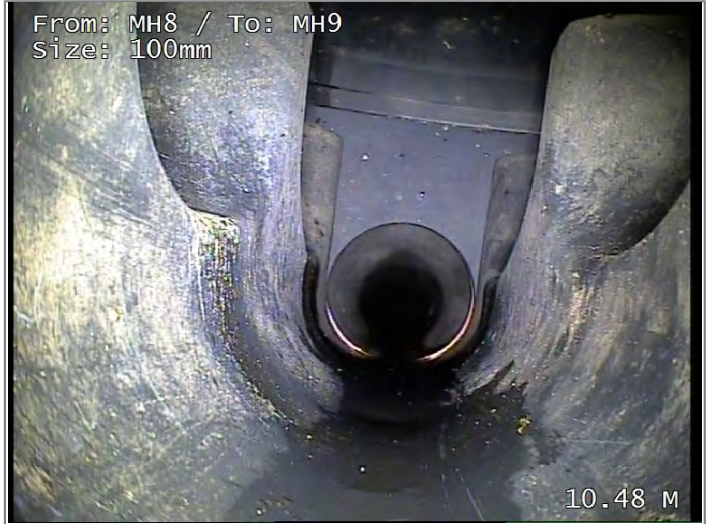
Finish node type, inspection chamber, reference MH9

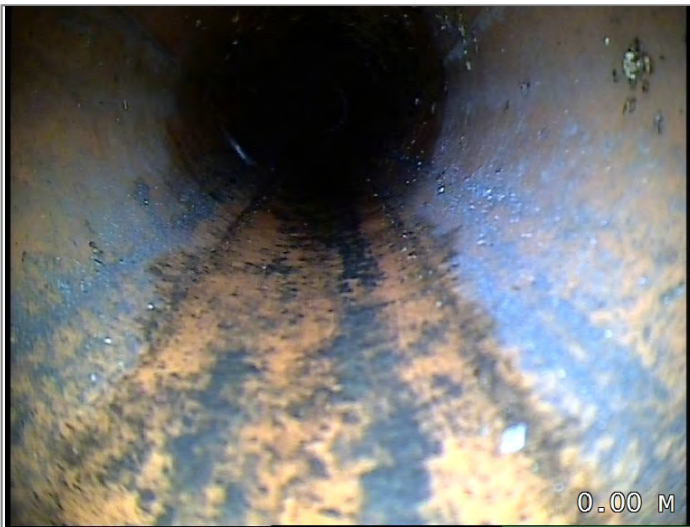
Start node type, inspection chamber, reference MH9

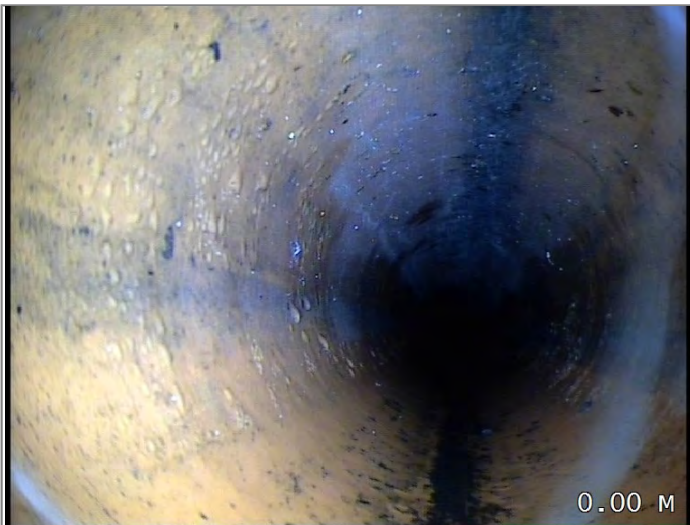
Start node type, inspection chamber, reference MH9

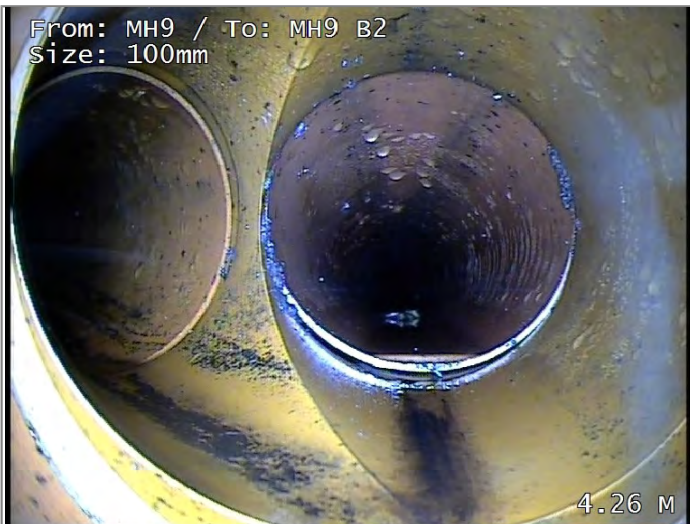
Junction at 9 o'clock, diameter 100mm

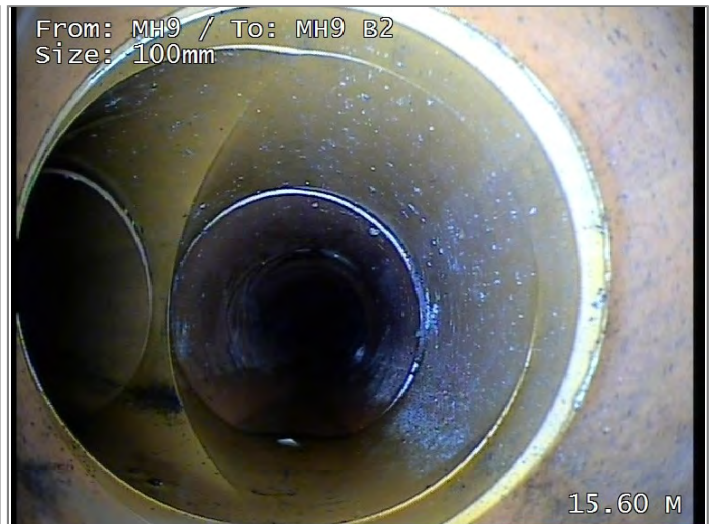
Junction at 9 o'clock, diameter 100mm

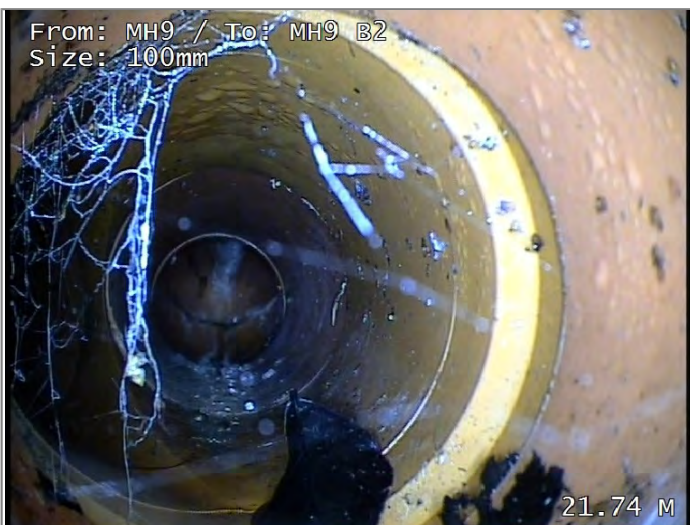
Junction at 9 o'clock, diameter 100mm

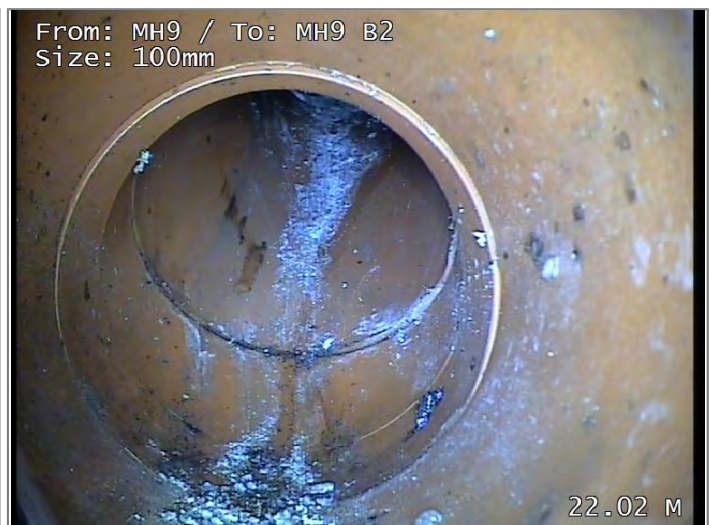
Line of drain/sewer deviates up

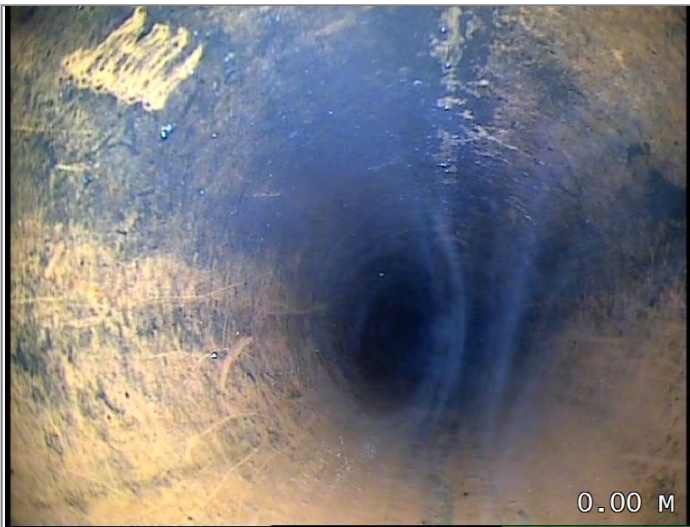
Start node type, inspection chamber, reference MH9
