**OVERVIEW SURVEY**

**ABERTILLERY & DISTRICT HOSPITAL  
ABERBEEG  
BLEANAU GWENT  
WALES  
NP13 2DA**

Elysium Healthcare Ltd  
2 Imperial Place  
Maxwell Rd  
Borehamwood  
WD6 1JN

April 2023

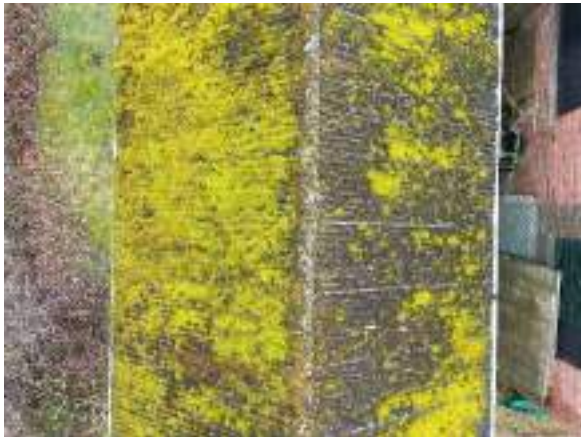
Photo 800.

1.01	800,80	Roof Coverings	Main roof	Corrugated pitched Asbestos sheet roof panels supported by timber rafter structure	Condition is okay. Renew when possible due this being a hazardous material.	Remove existing asbestos roof NOTE: INCLUDED IN ASBESTOS REMOVAL SEE SUMMARY. Re-roof with new lightweight metal roof sheeting system complete fixed to existing timber structure.	48m <sup>2</sup>	15,000

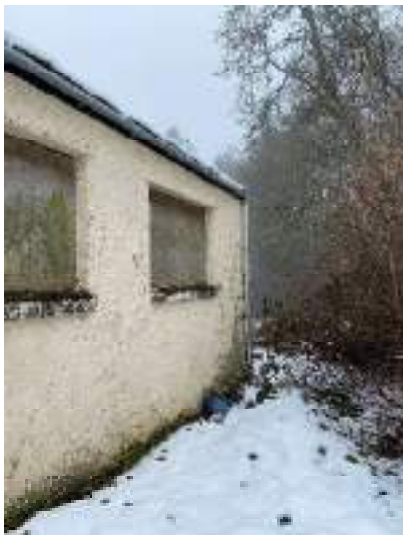
Photo 802.

1.02	802	Rain Water Goods	Main roof	Half round UPVC guttering and downpipes.	Poor condition. RWP's missing or broken and guttering brittle with poor connections.	Take down and replace with new UPVC RWP's and guttering with brackets.	271m	1,500

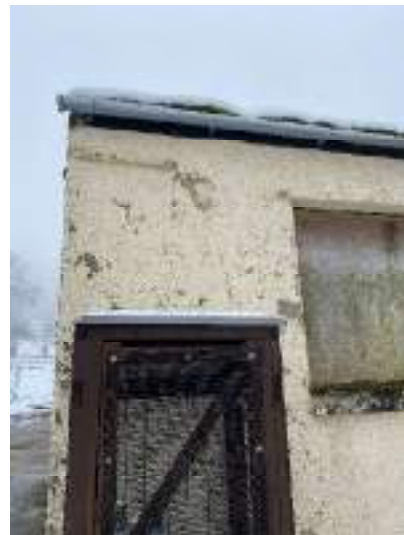
Photo 803.

1.03	803	Fascias/Soffits/Barge Boards	Main roof all around.	Painted timber fascias present only.	Very poor condition. Timber decay and damaged sections.	Replace timbers, fascias complete with new no maintenance pre-finished fascias.	201m	1,000	17,500
<b>2.00</b>		<b>Walls</b>

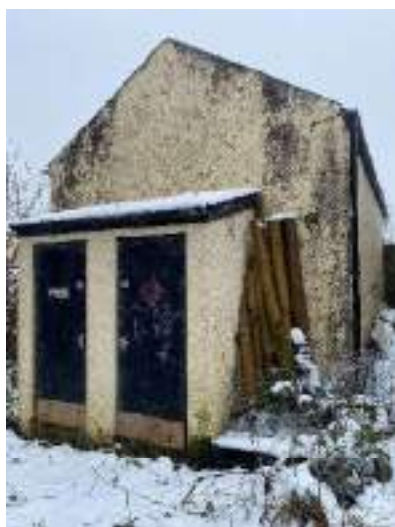
Photo 804.

2.02	804			Pebbledash concrete render.	Render in contact with ground on all elevations is in contact with ground and has hairline cracking and sections of blown render.	Hack off bottom of render 150mm above finished ground level and defective areas & make good. Re-render defective areas to match existing. Decorate low level blockwork with waterproof black paint. Repair around cracking and repair cracks with new render/concrete repairs.	14m <sup>2</sup>	2,000

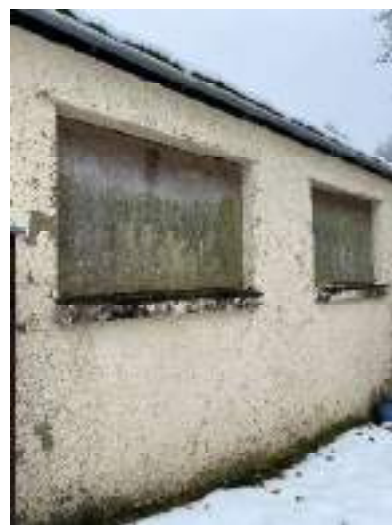
Photo 805.

2.03	805, 80	Windows	2no windows on side elevations (2no per side)	Boarded up timber windows with stone/concrete cills under.	Windows in very poor condition. Cills in need of redecoration.	Remove dis-used windows and block up windows with matching and apply matching external concrete render externally to match adjacent finish.	8m <sup>2</sup>	1,500

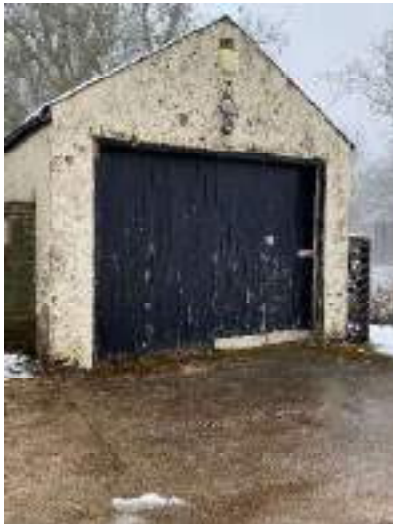
Photo 806.

2.04	806, 80	Doors	Main Doors Front Elevation	Vehicular timber folding doors to garage.	Bare timber doors in very poor condition. Very old damaged with signs of numerous historic patch repairs.	Replace doors with new folding timber doors and ironmongery including framework.	3.5m x 2.5m	7,500	
2	804		Rear elevation	2no single timber doors	Poor condition peeling decorations and bottom of doors boarded over repairs where door has become rotten.	Renew doorset including framework with new prefinished timber composite doors and ironmongery.	2no doors	1,500

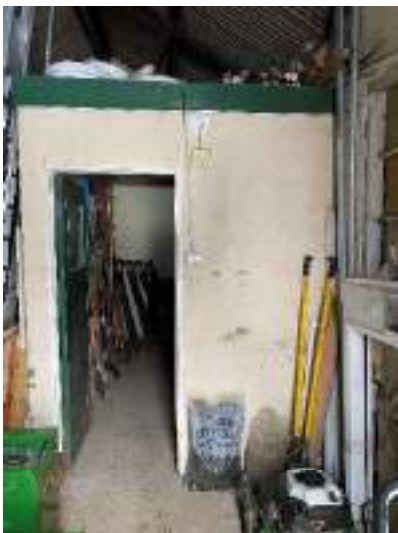
Photo 808.

3.02	808	Walls	Internal walls	Timber studwork walls finished with plasterboard.	Walls in average condition for building use.	N/A			
3.03		Floors	Throughout building	Solid concrete ground bearing floor slab.	Average condition with an area of damage where floor slab is breaking up with undulating surface.	Concrete repairs to floor slab as necessary.	10m <sup>2</sup>	1,500
