REPORT ON THE TREES LOCATED AT 16 HOPE TERRACE, EDINBURGH

18 December 2023

Prepared at the request of Elpis Property Ltd

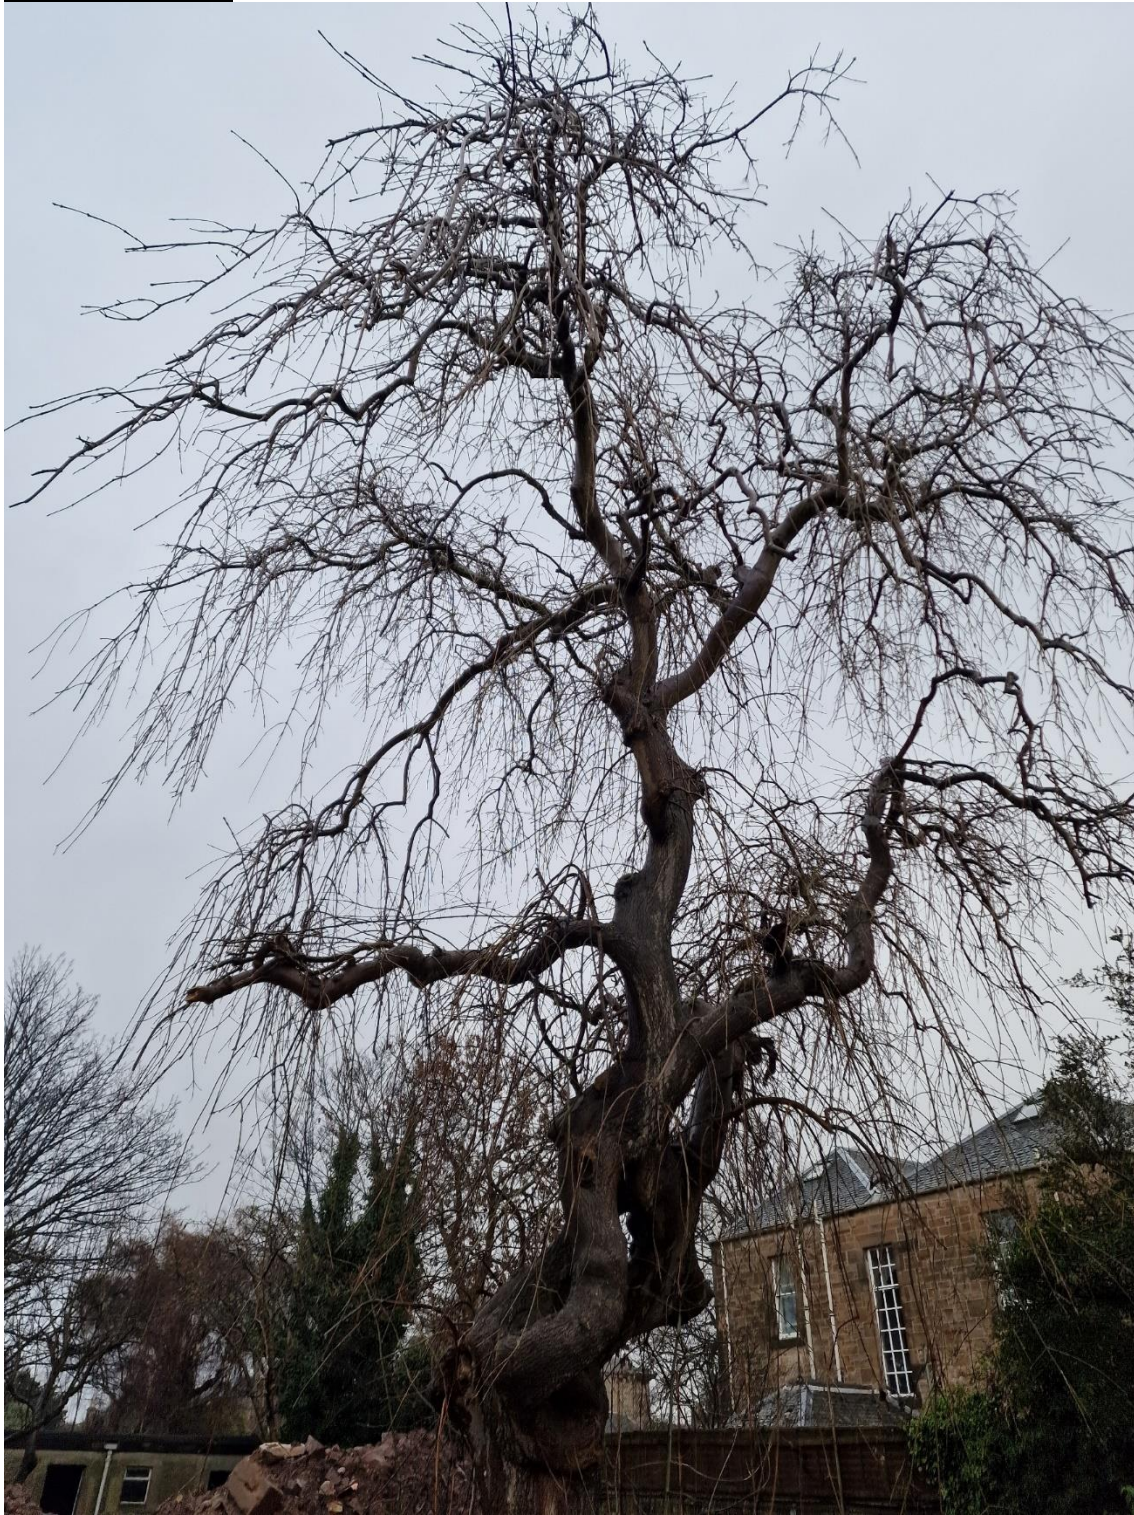
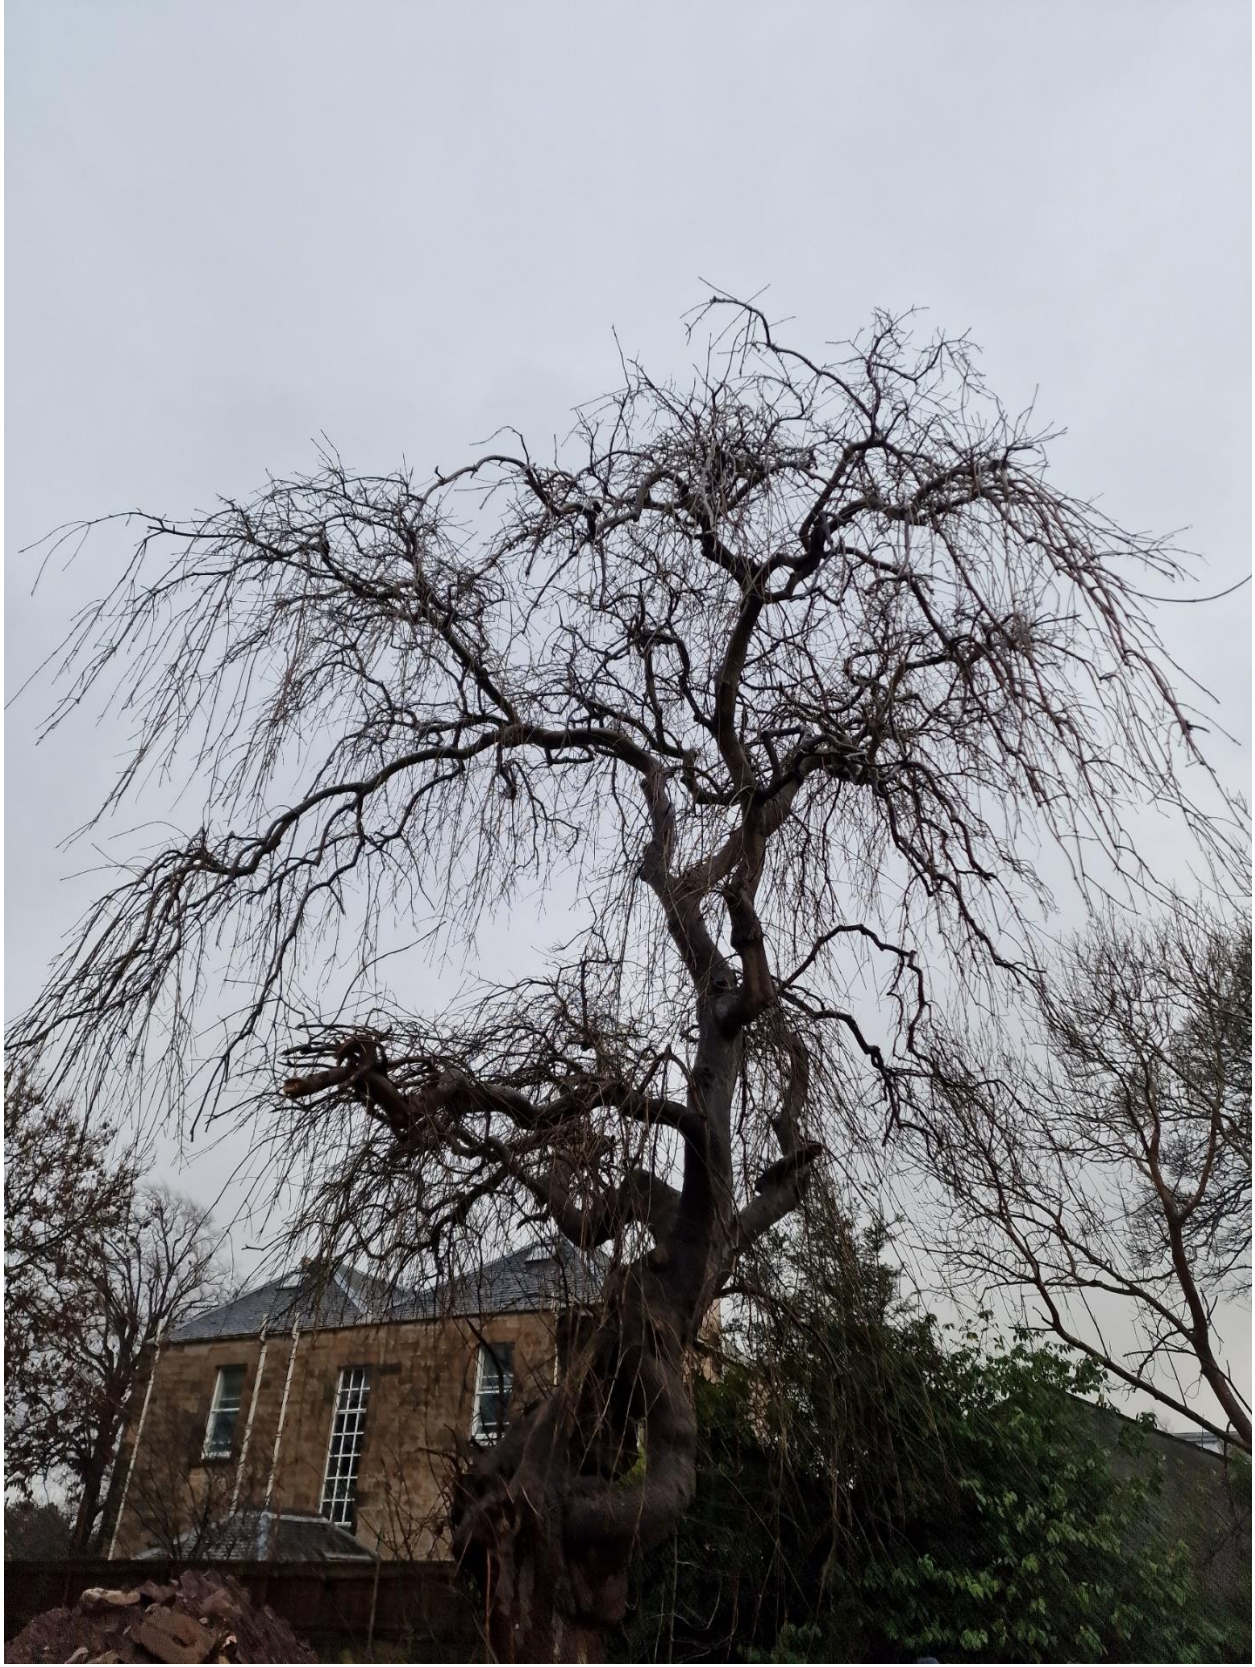
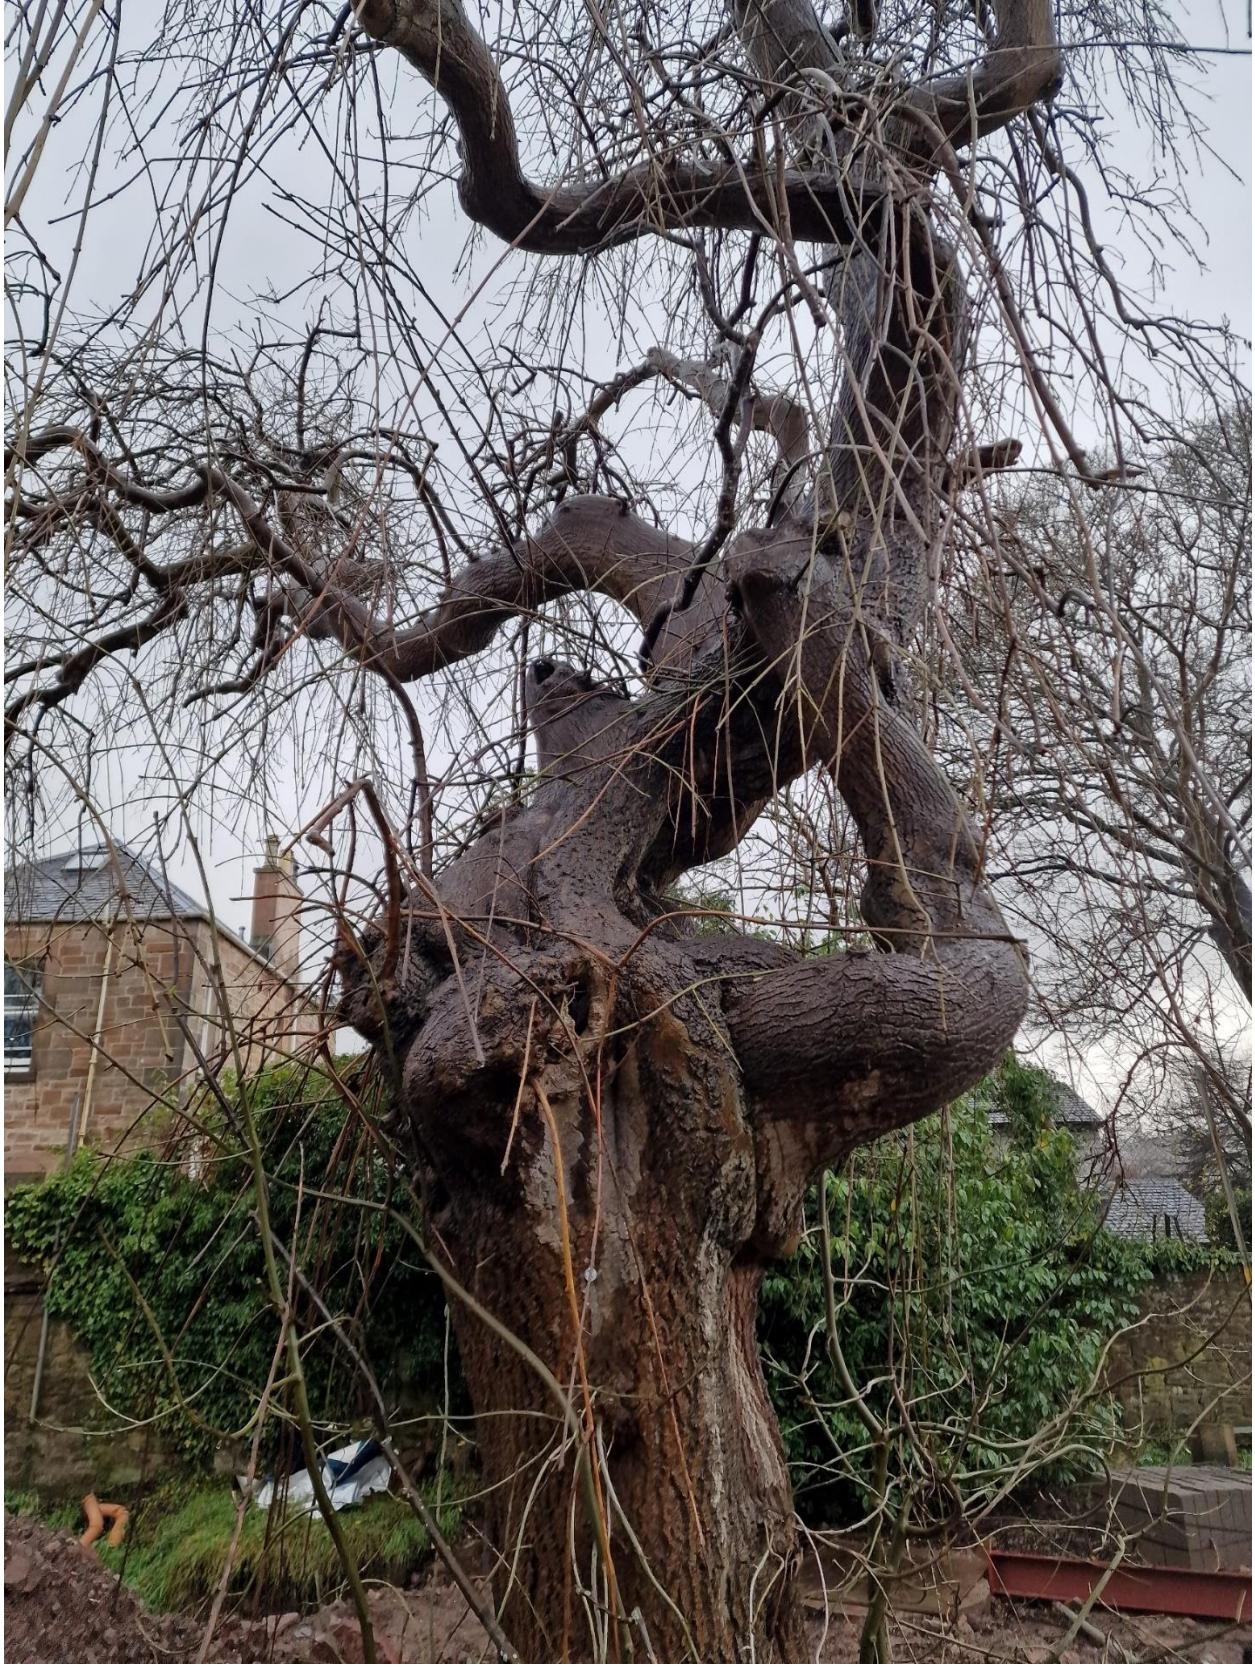
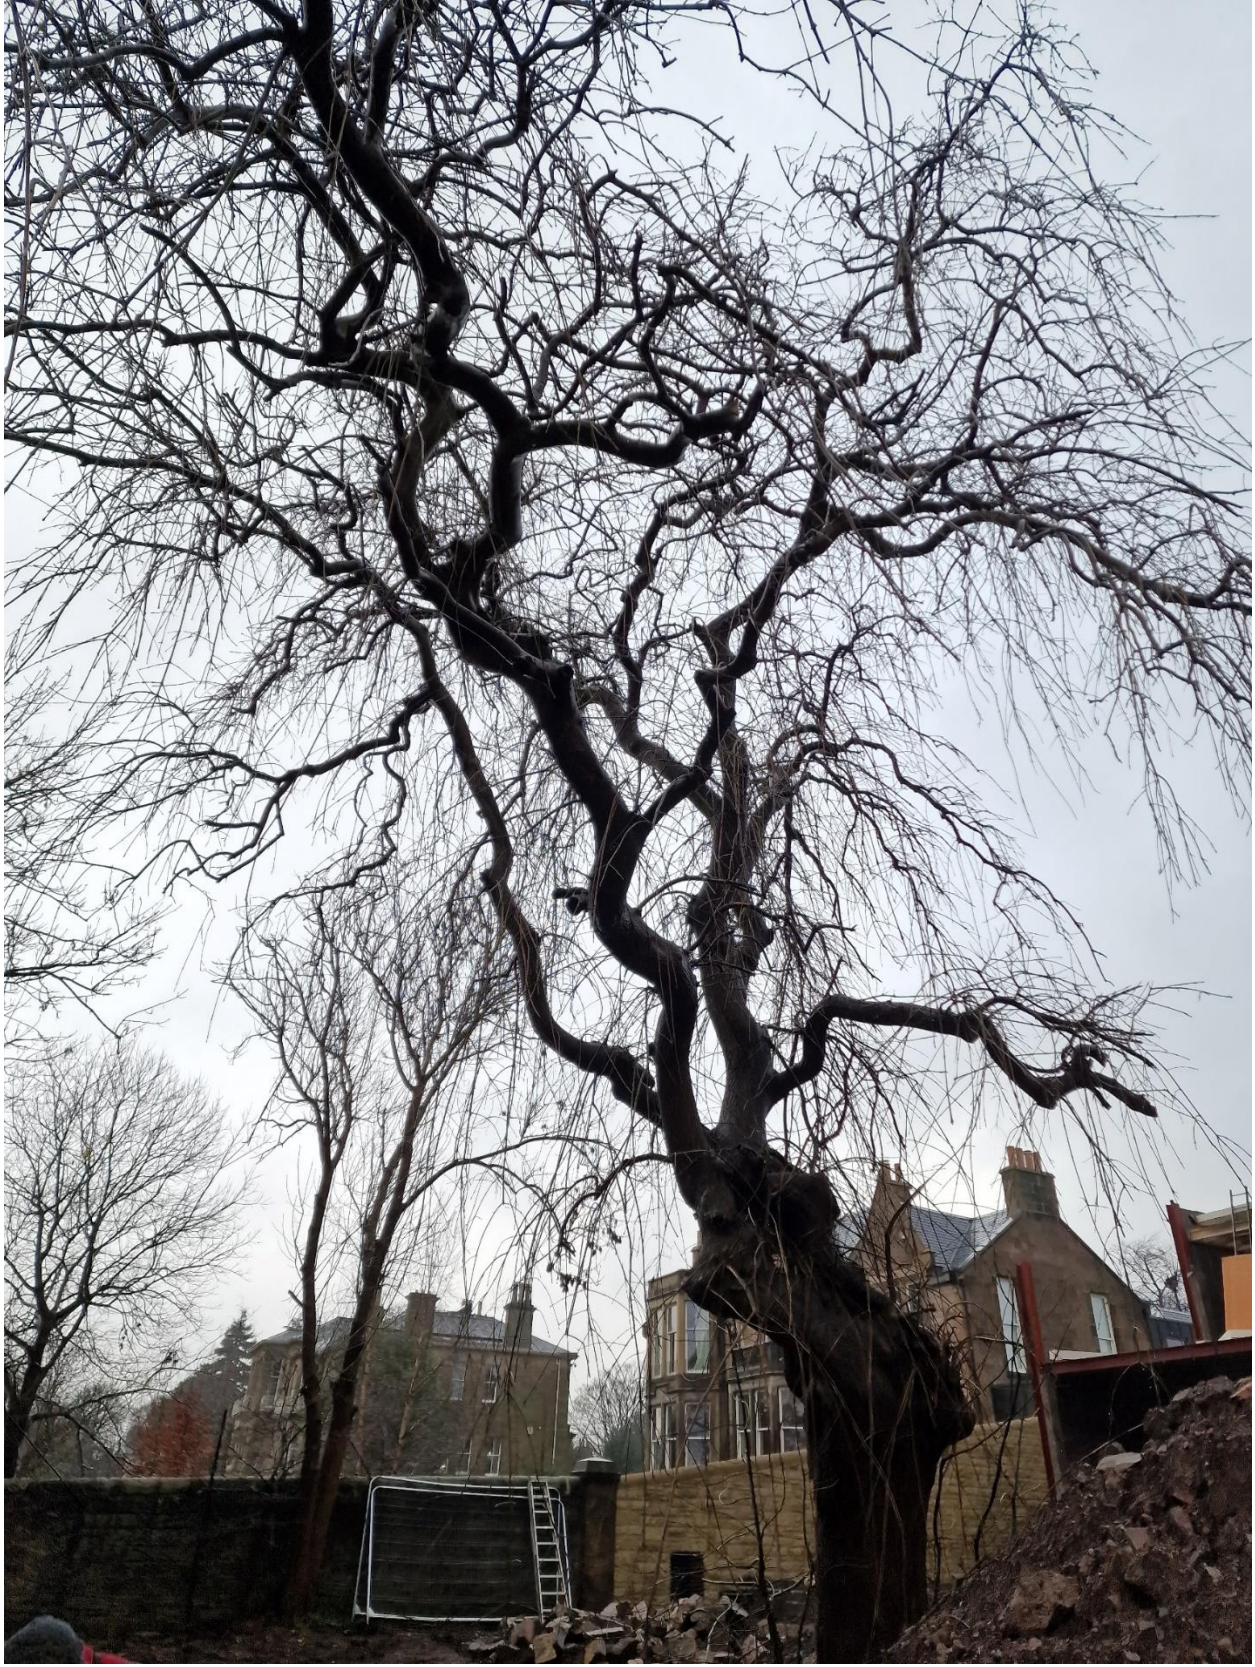
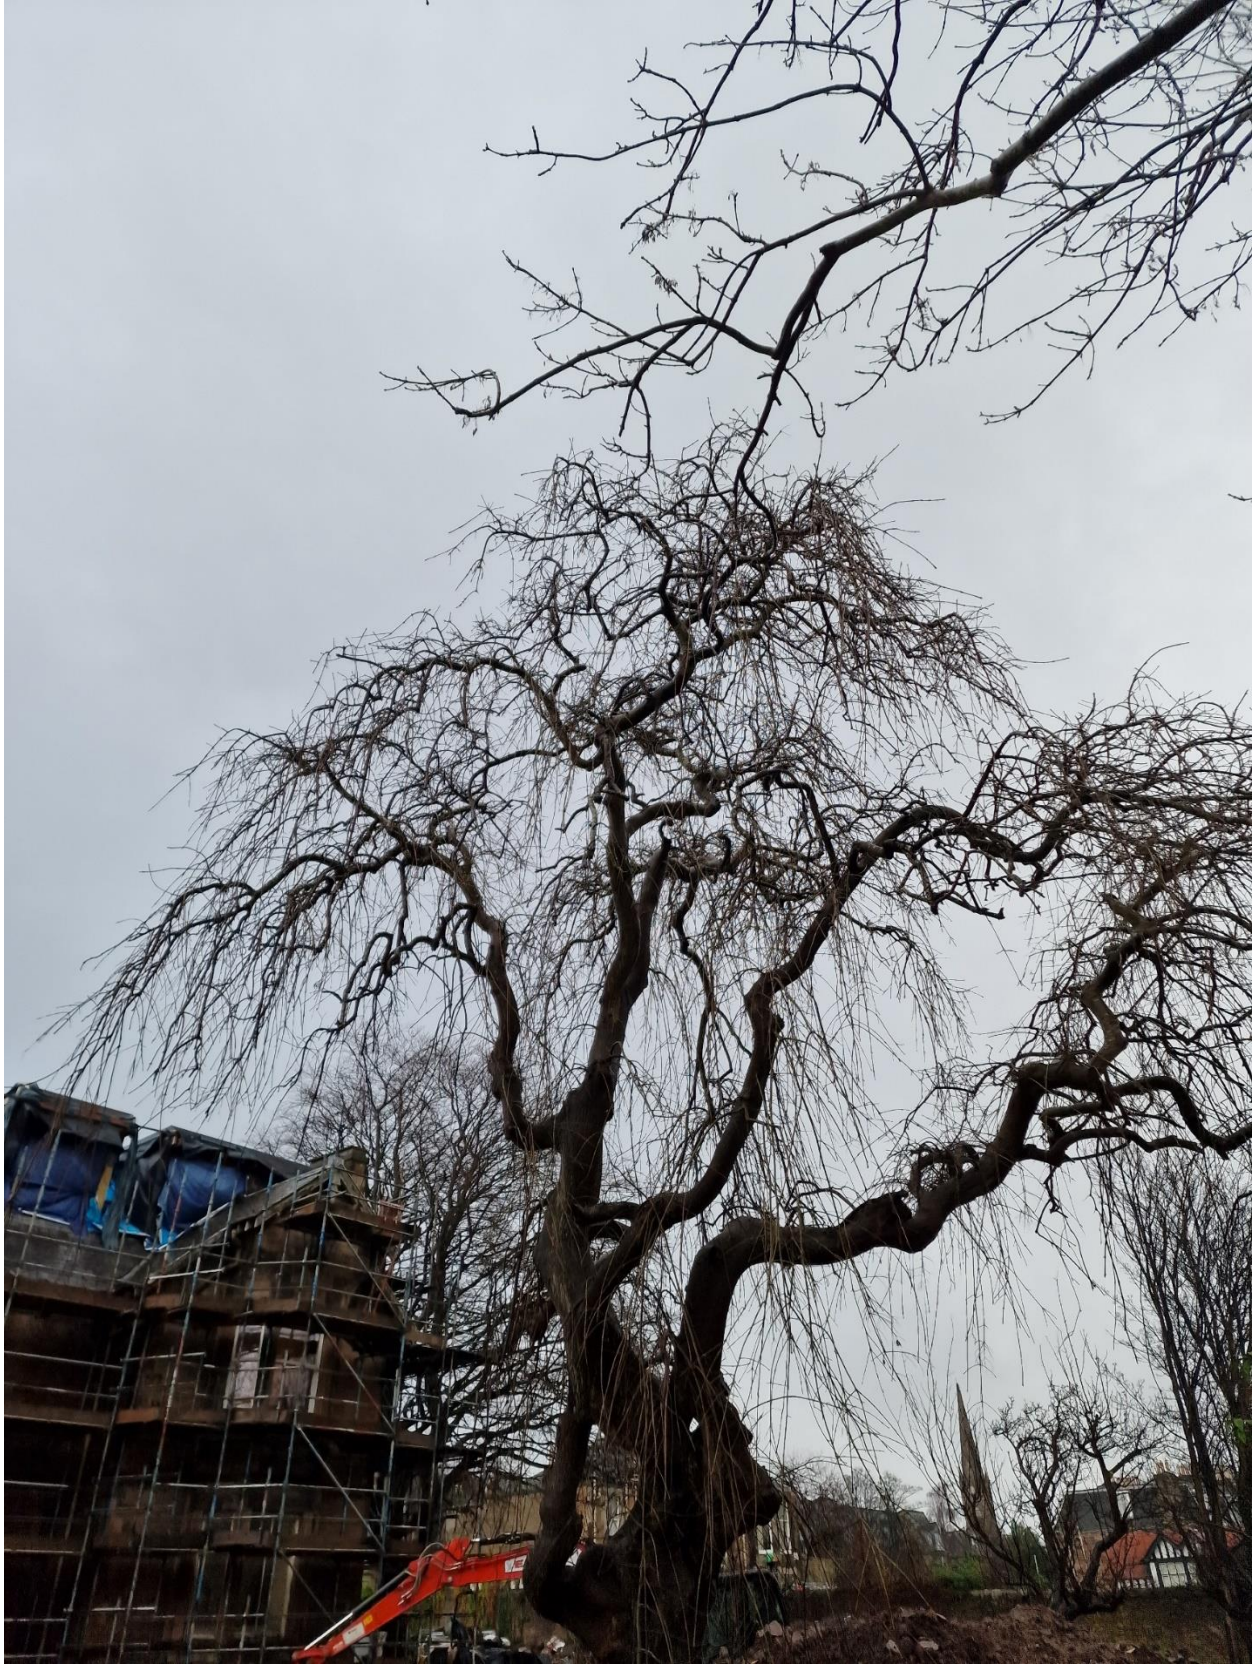
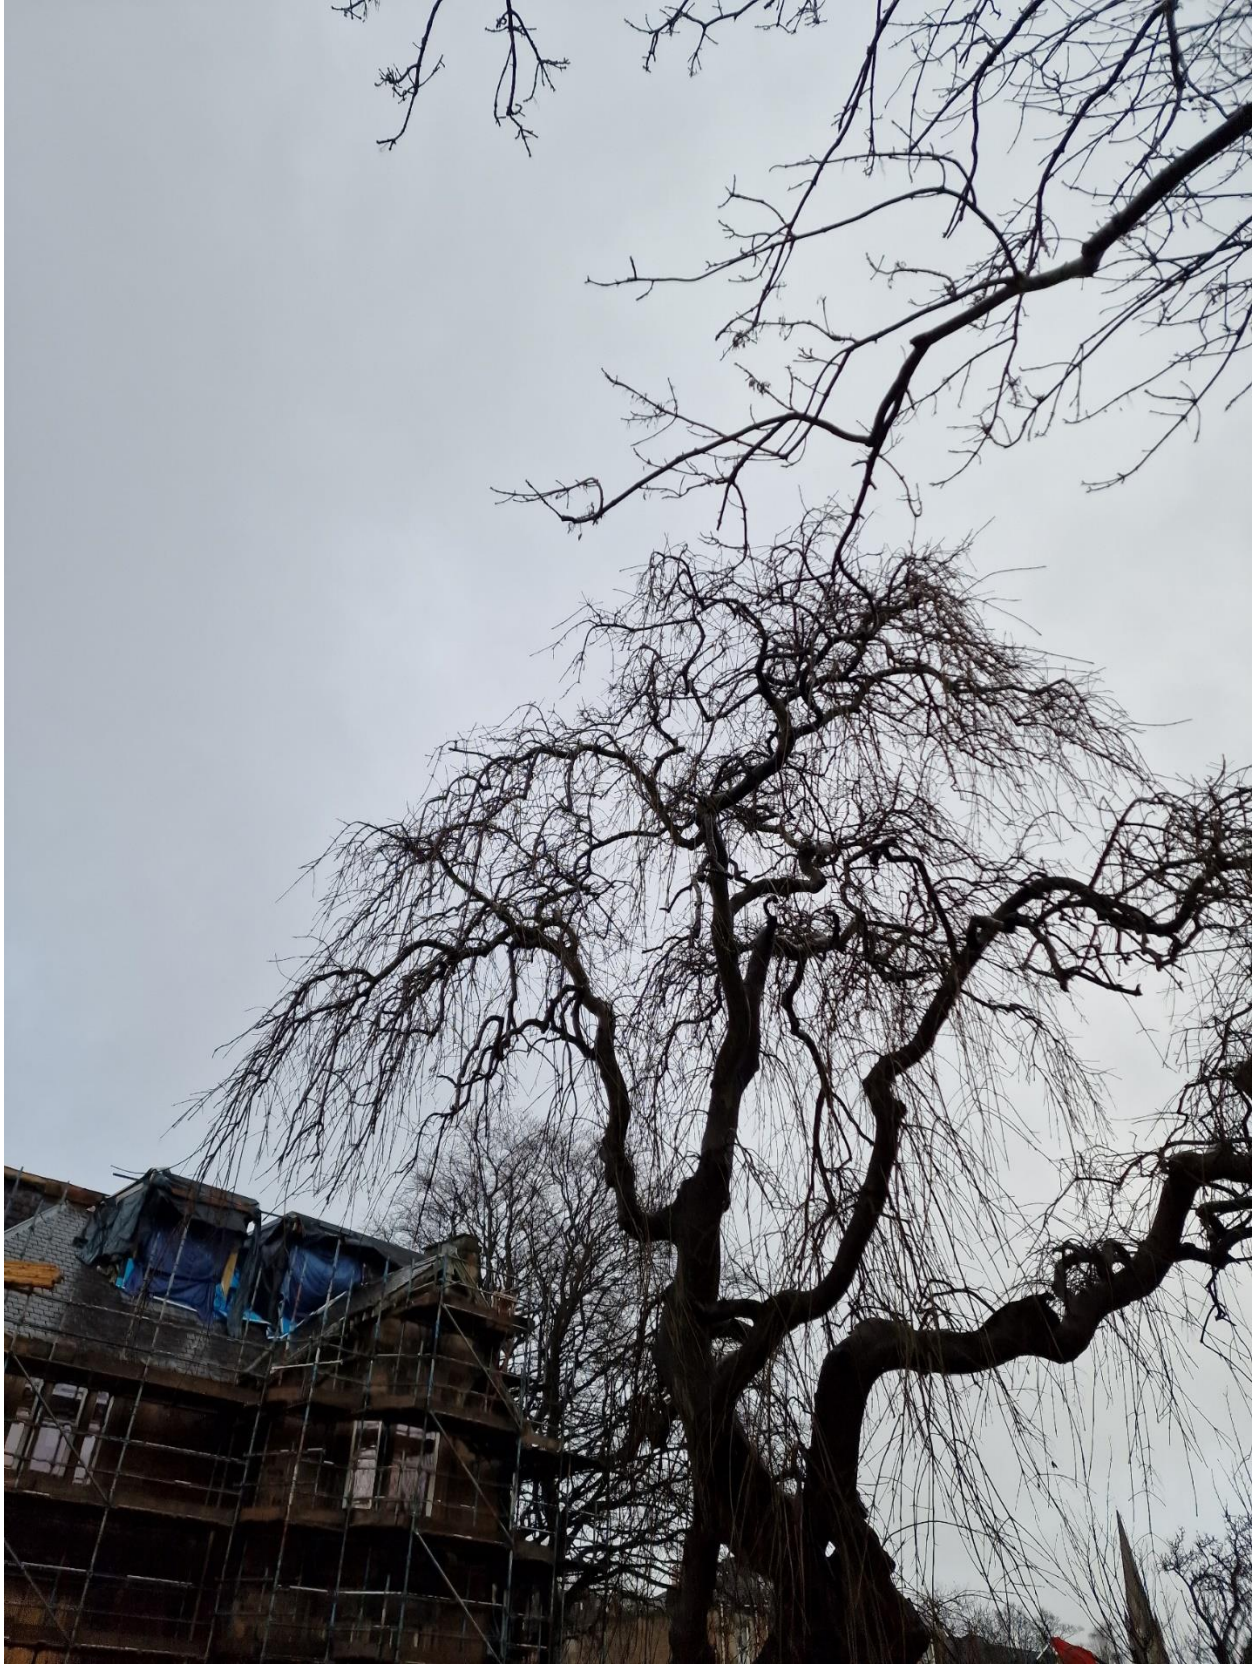
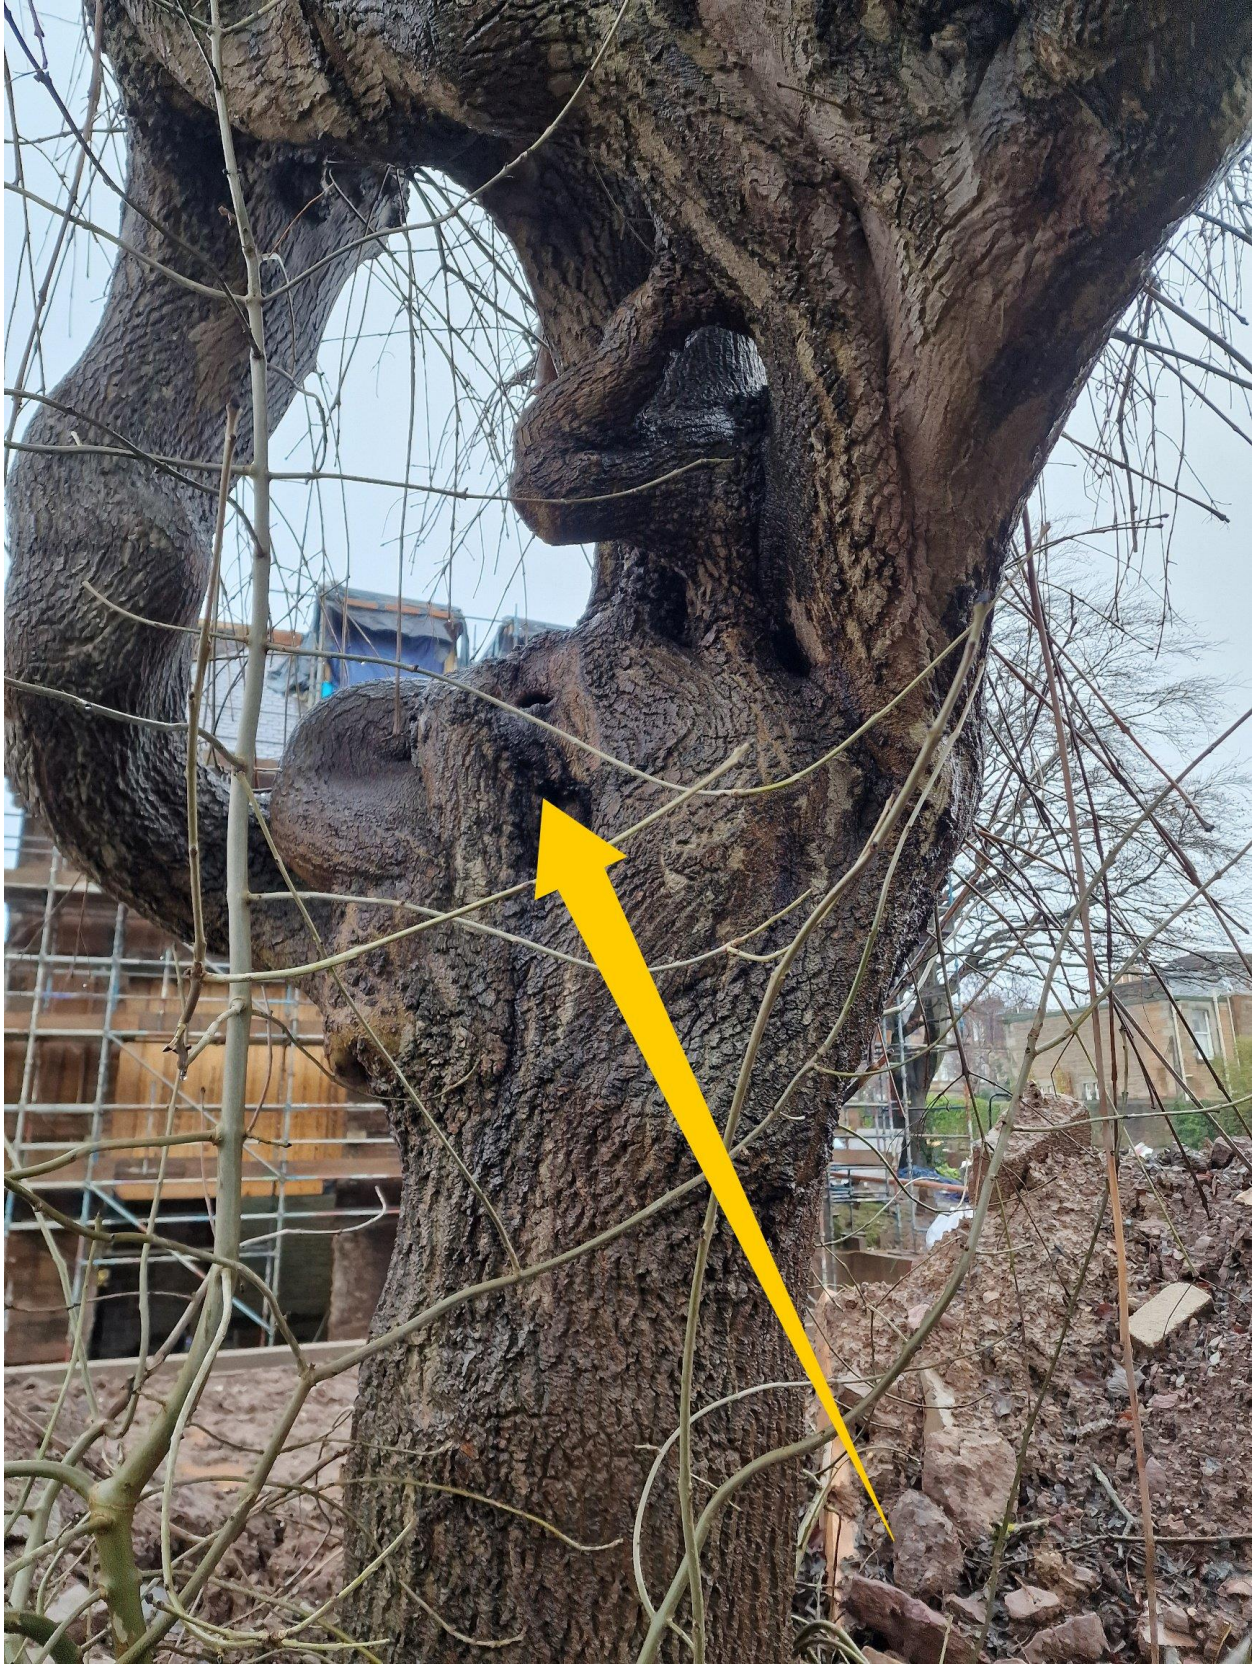
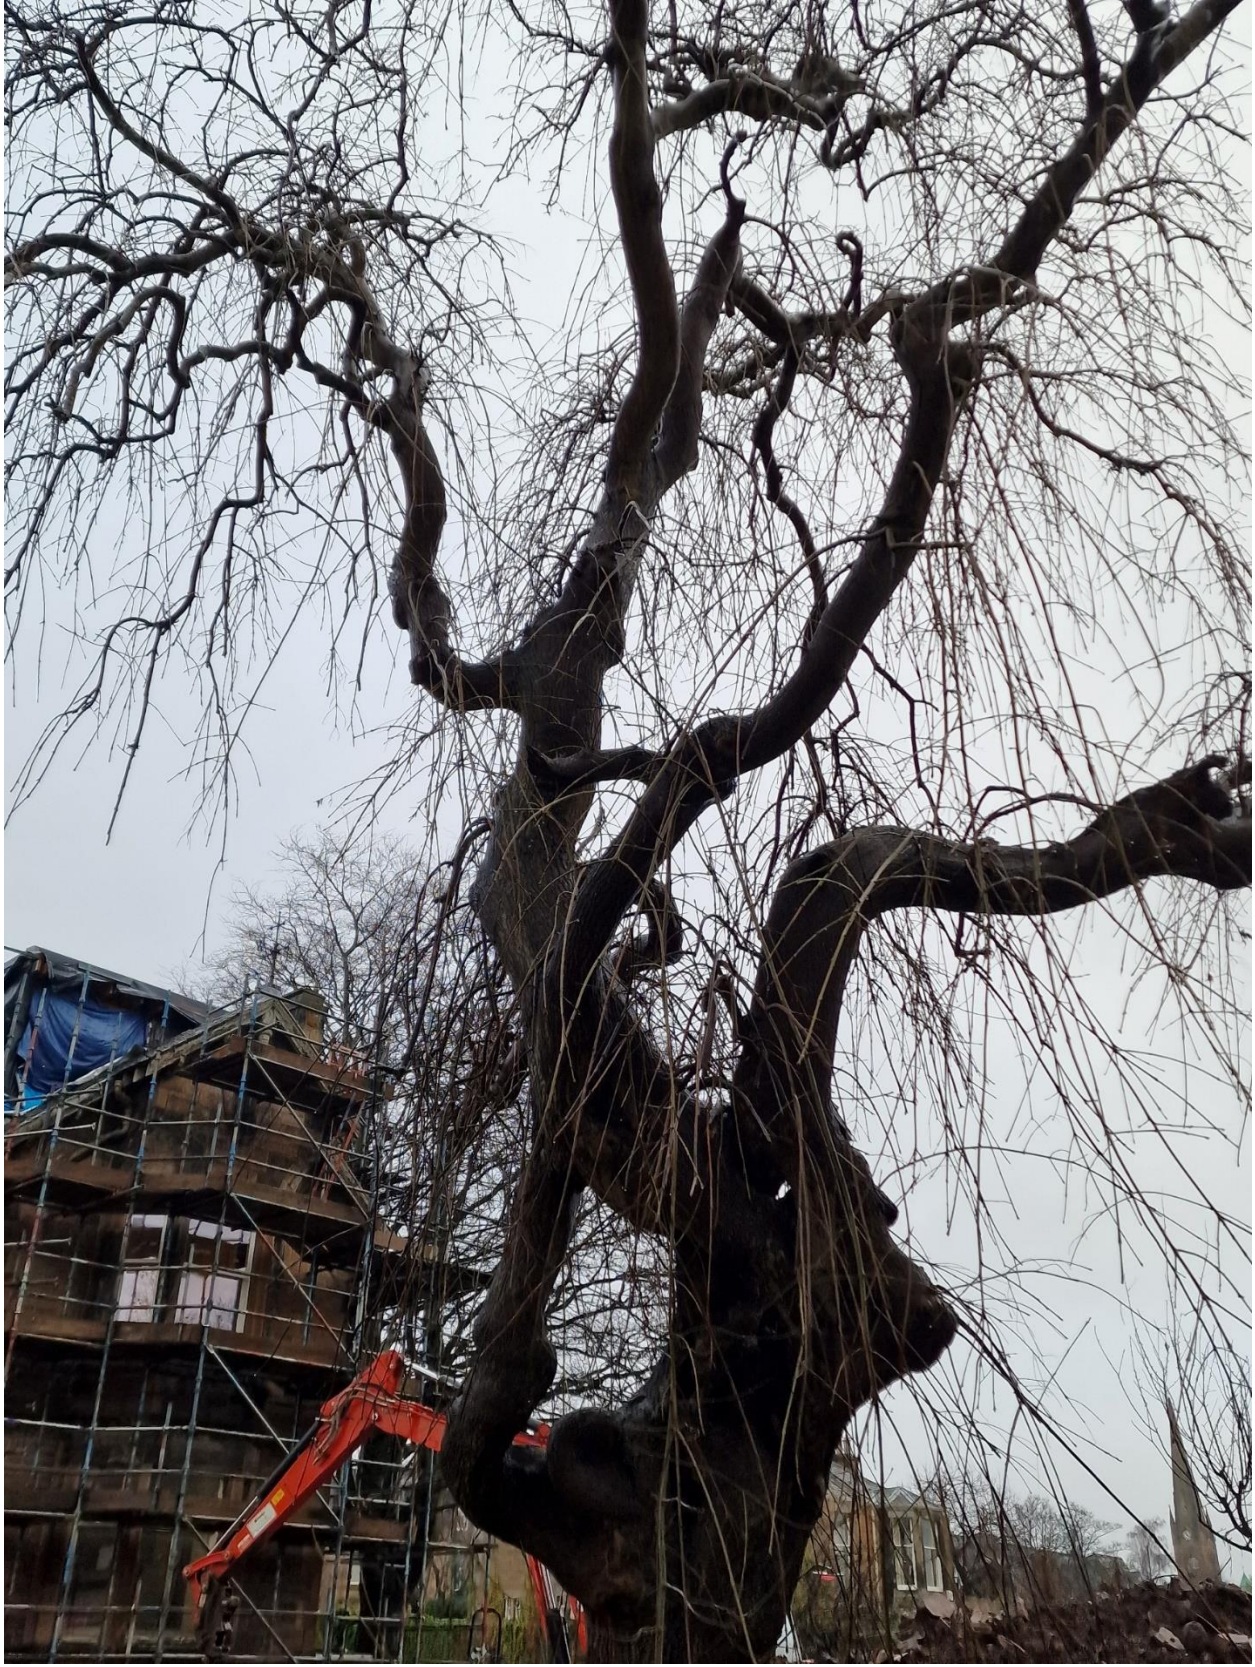
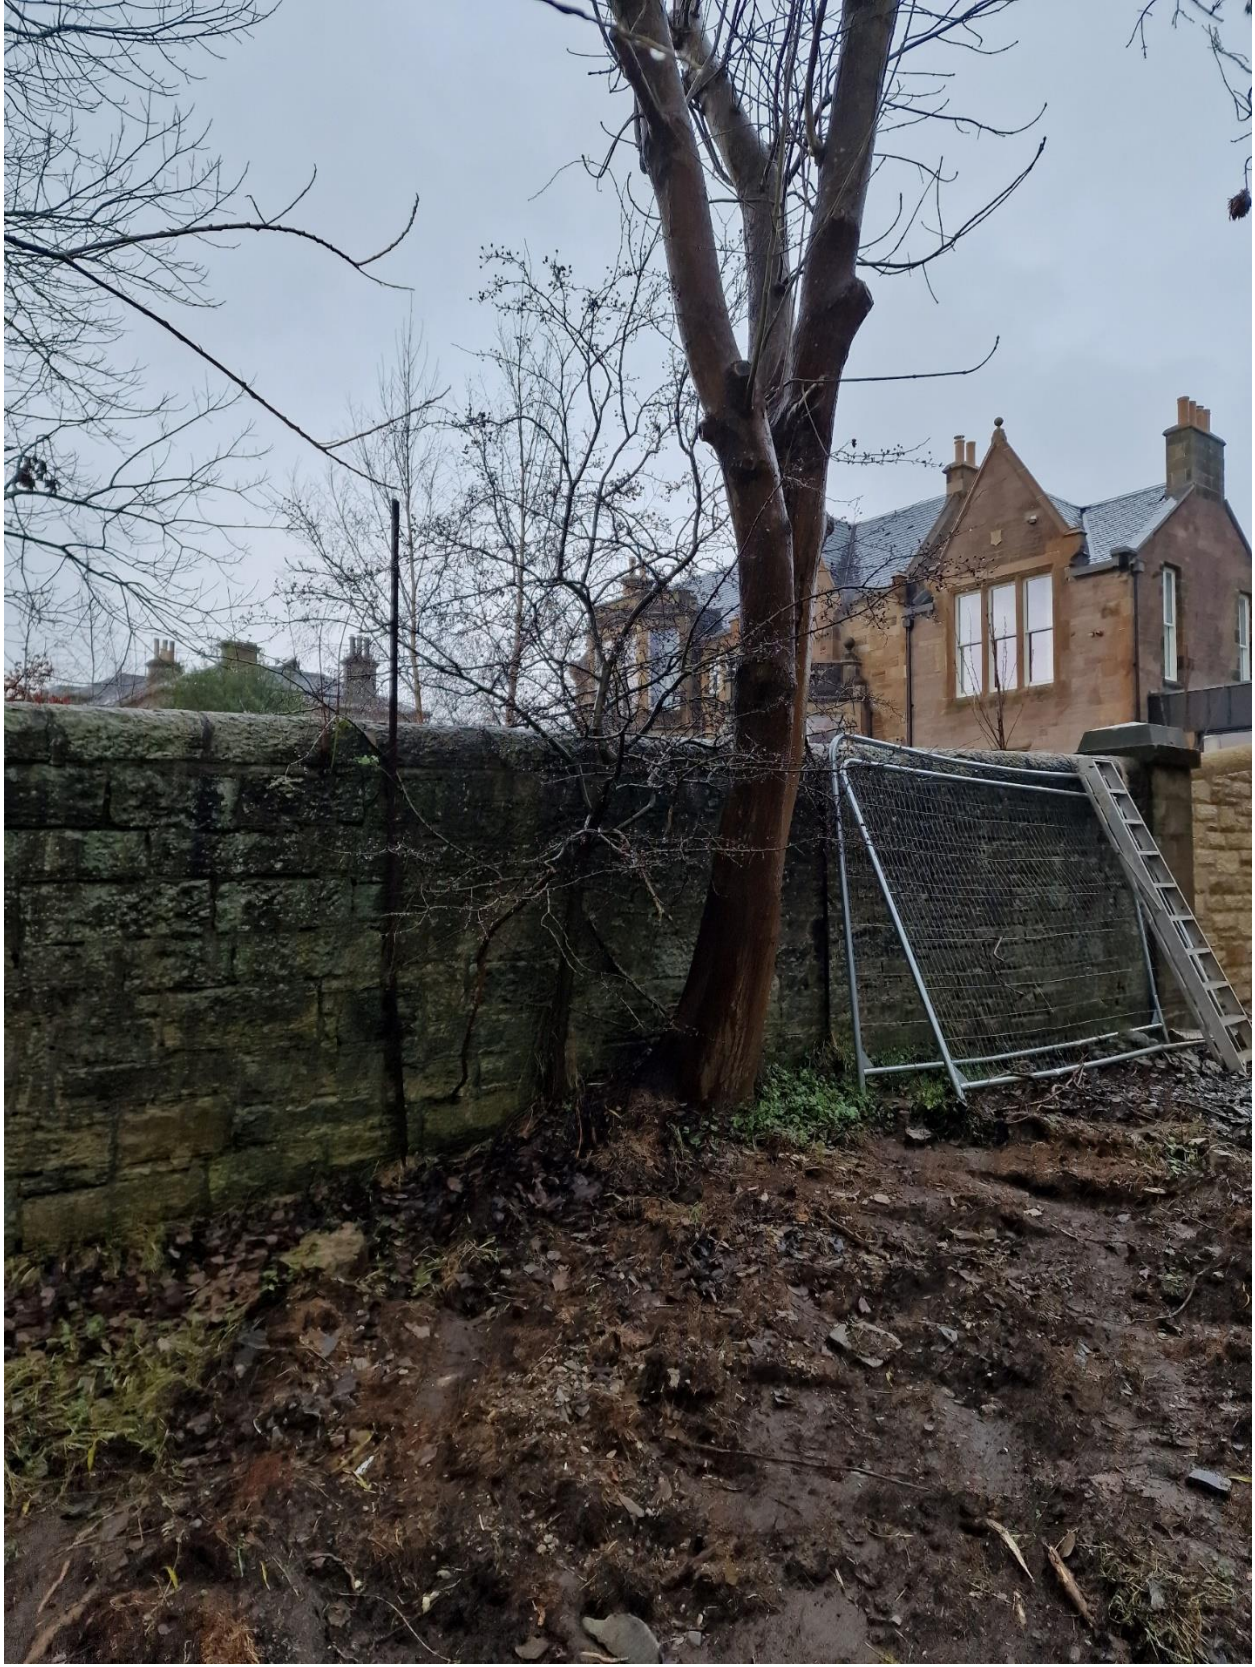
PHOTOGRAPHS

- 3.3 It is seen from the inspection of Ash Tree T0952 that the fungal body *I. hispidus* is growing from the trunk of the tree. It should be noted David Lonsdale's "Principles of Tree Hazard Assessment and Management" Forestry Commission: Research for amenity N0.7 says, "Since *I. hispidus* weakens the wood of *F. excelsior* at an early stage of decay, its presence on this species, often indicates that breakage of the affected branch or trunk could be imminent." Whilst this specimen is Weeping Ash, (*Fraxinus excelsior* "pendula") this would still be relevant and more so as its general weeping form has an inherent structural weakness. It is often seen in collapse of ash stems and branches caused by *I. hispidus* undermining the structural integrity of the tree's heartwood. The reason it does this is that this is a heart rot fungi that feeds on both the lignin and cellulose in the heartwood, weakening the trees structural integrity by undermining the trees flexibility and rigidity at the same time. David Lonsdale also points out in the same publication that Ash has a low resistance to decay this is because "*The relatively low moisture content of Fraxinus wood makes it rather susceptible to decay. Also the heartwood does not appear to be rich in preformed defensive substances*" What this means is the trees level of toxins that are used by trees to fight decay and fungal – bacterial infection are low in this species and as such fungi like *I. hispidus* can cause high levels of damage here whereas in a plane tree it may be lower. It is for this reason the fungi is commonly found on Ash trees.

- 3.4 Further, tree T0952 has significant dieback throughout the canopy with large amounts of dead wood present. This tree has symptoms consistent with Ash Dieback and removal is recommended within the next 6 months
