THE BARN  
CANAGLAZE  
ALTARNUN  
CORNWALL

Heritage Assessment

South West Archaeology Ltd. report no. 230516

South West Archaeology Ltd. was commissioned to undertake a heritage assessment for the Barn at Canaglaze, Altarnun, Cornwall to inform plans to consolidate and convert the barn to a dwelling. This work was carried out in consultation with HEP(Arch) and in accordance with the relevant guidance.

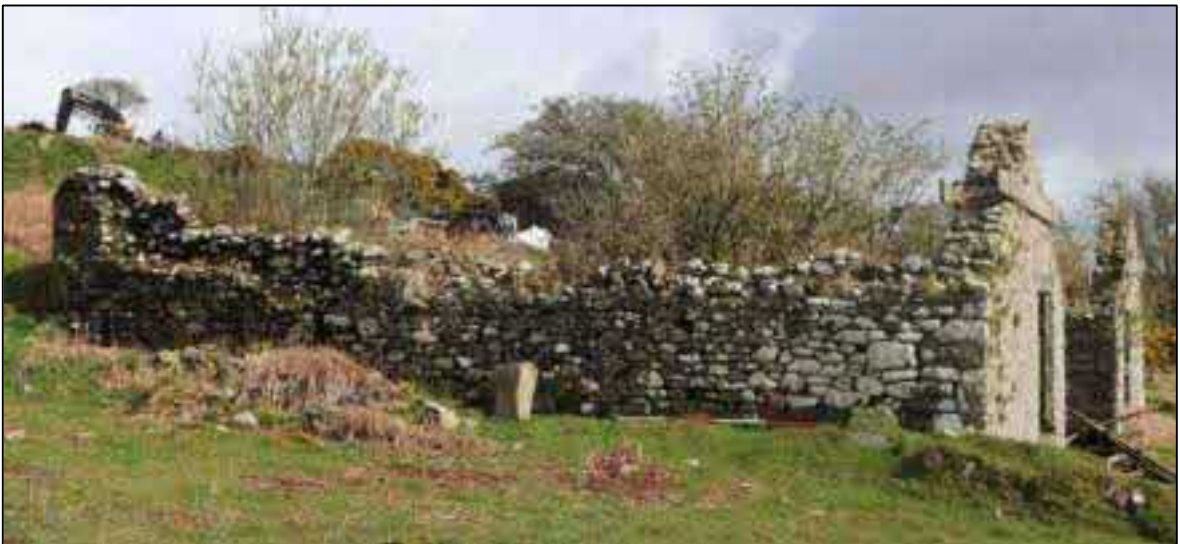
The south-west elevation is blind save for two ground-floor slit vents in the gable end of B1a, although most of the gable has fallen down and it is possible other openings were once present. A slate levelling course was noted to the eaves.

FIGURE 21: THE SOUTH-WEST ELEVATION; VIEWED FROM THE SOUTH (SCALE 2M).

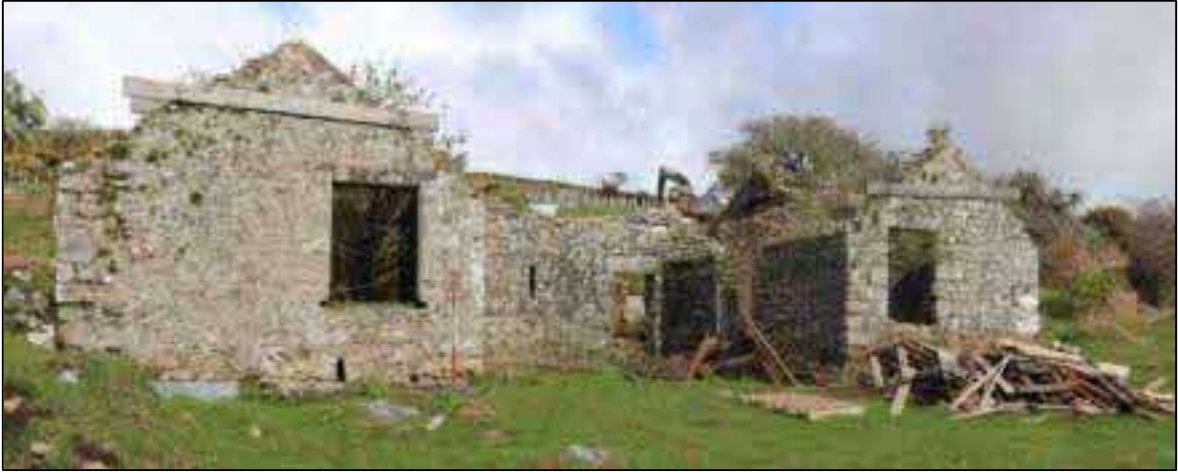
The south-east elevation faces across the valley. The gable end of each wing features a large and symmetrical splayed window opening (W3, W5). They have heavy granite lintels, but no timber components survive. The gable above is braced in each instance by modern timbers. The south-east elevation of B1a has a doorway to each side (D2, D3) with a central slit vent. Both doors were single width with granite thresholds and lintels. Both openings had quoin dressings to jambs, and each had one quoin that extended into the opening with a carved lip that would have prevented the doors opening outwards. Both had heavy iron pintles opposing the granite lip.

FIGURE 22: THE SOUTH-EAST ELEVATION; VIEWED FROM THE SOUTH-EAST (SCALE 2M).

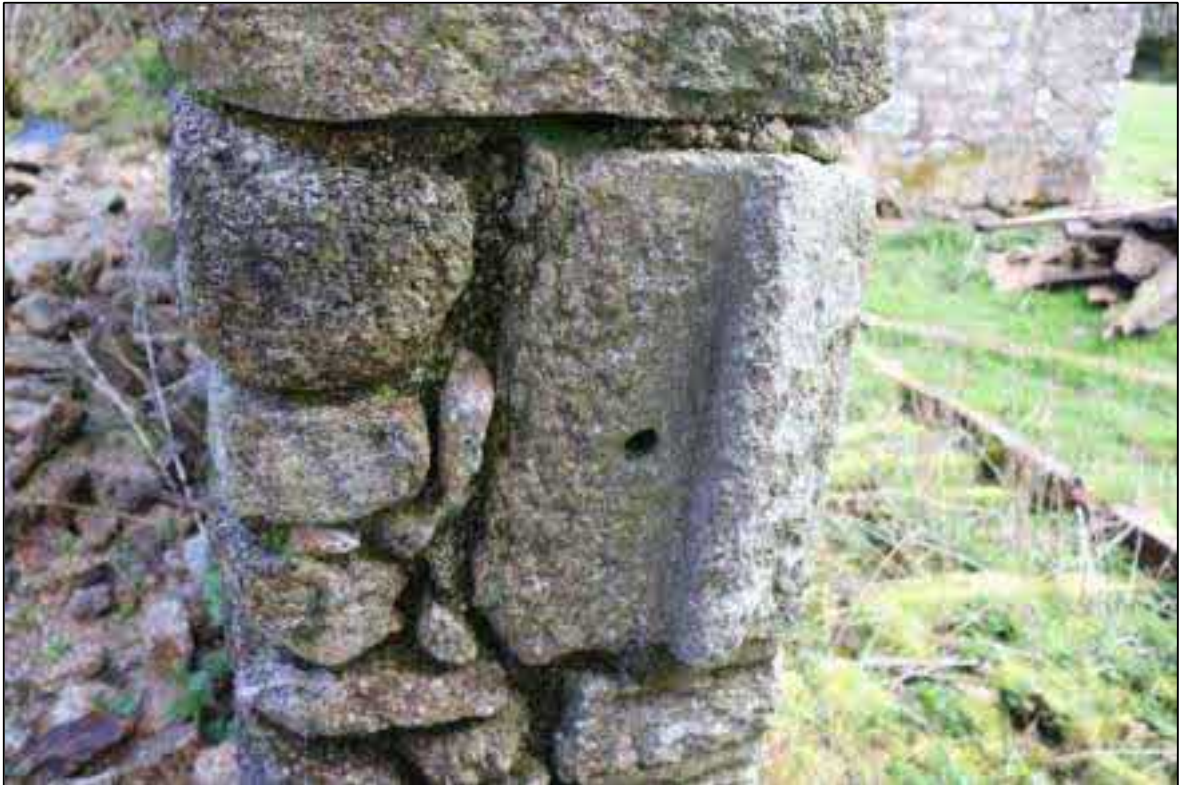
The two wings formed a small yard in front of B1a; the opposing walls appear to abut B1a, and each contain a single doorway (D4, D5); D4 is wider than D5. D5 has a granite lintel but it has fallen; D4 appears to have had a timber lintel. As for D2 and D3, these doorways have iron pintles and a single quoin with a projecting lip, indicating they opened inwards.

FIGURE 24: THE QUOIN WITH PROJECTING LIP AND SOCKET HOLE TO D3; VIEWED FROM THE SOUTH-WEST.

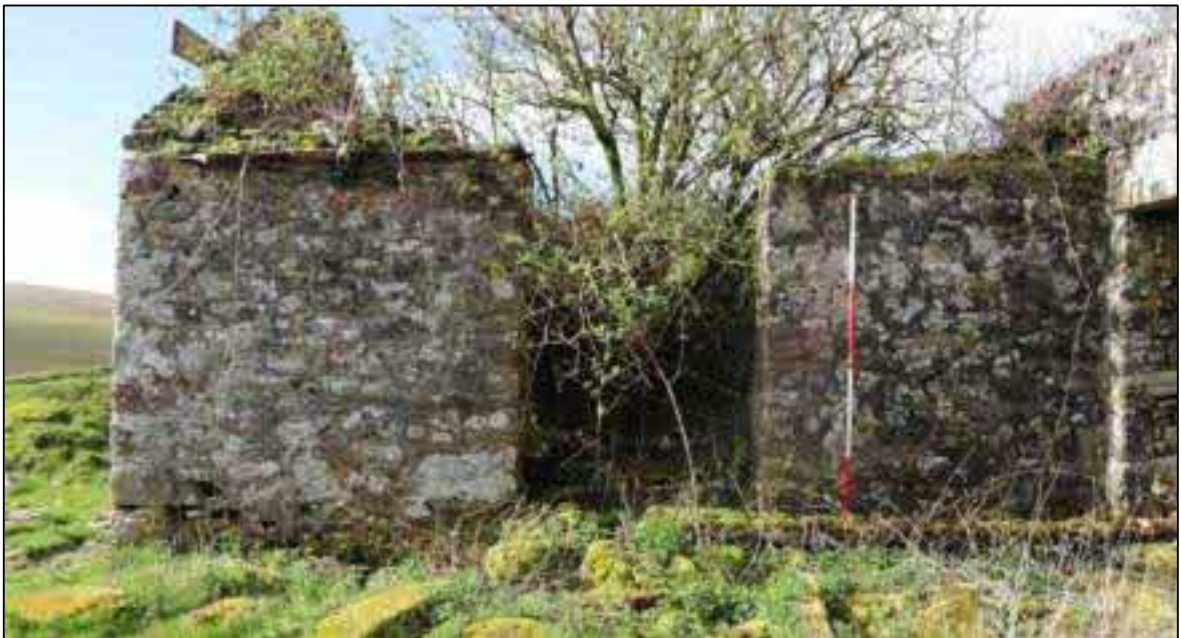
FIGURE 25: D4 INTO B1B; VIEWED NORTH-EAST (SCALE 2M).

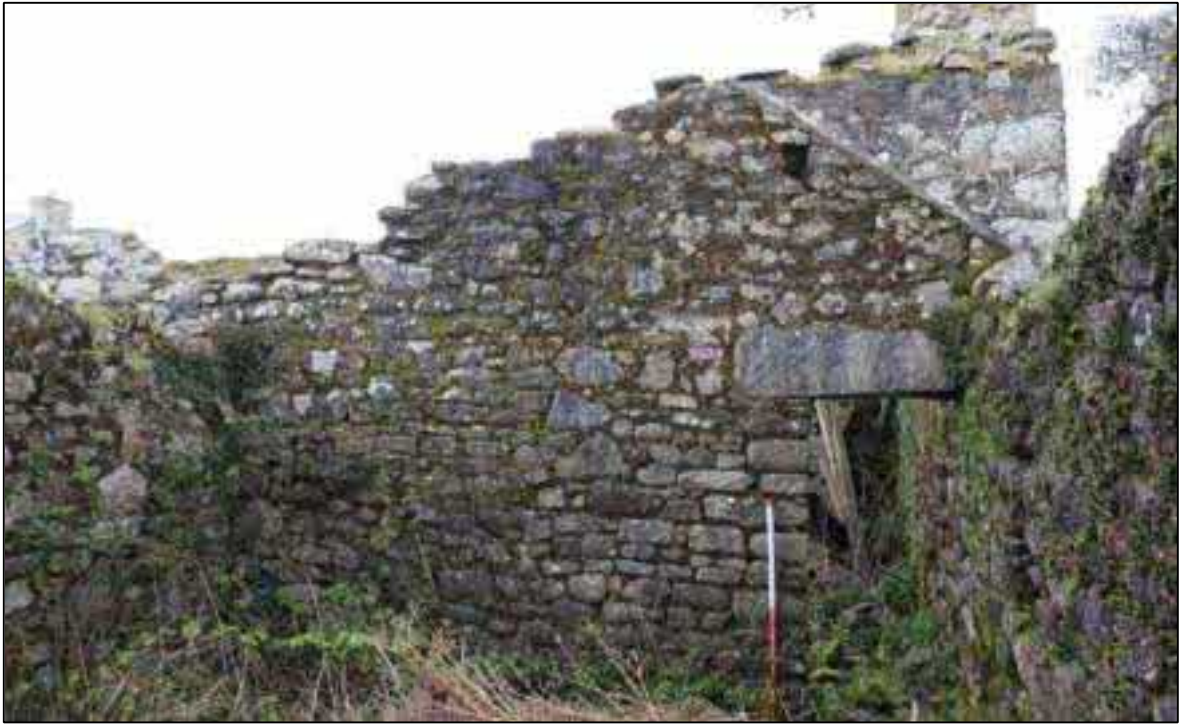
The interior of B1b was very overgrown and could not be entered safely. No fittings appear to survive apart from a fallen pegged timber door frame. There was no access into B1a, or any signs of a blocked opening between the two. The interior of B1c was more open and featured a feed passage along the north-east wall with the remains of a brick feed trough along one side. There is a doorway (D1) into B1a from that feed passage. The floor of the room is concrete.

FIGURE 26: THE INTERIOR OF B1C; VIEWED FROM THE EAST (SCALE 1M).

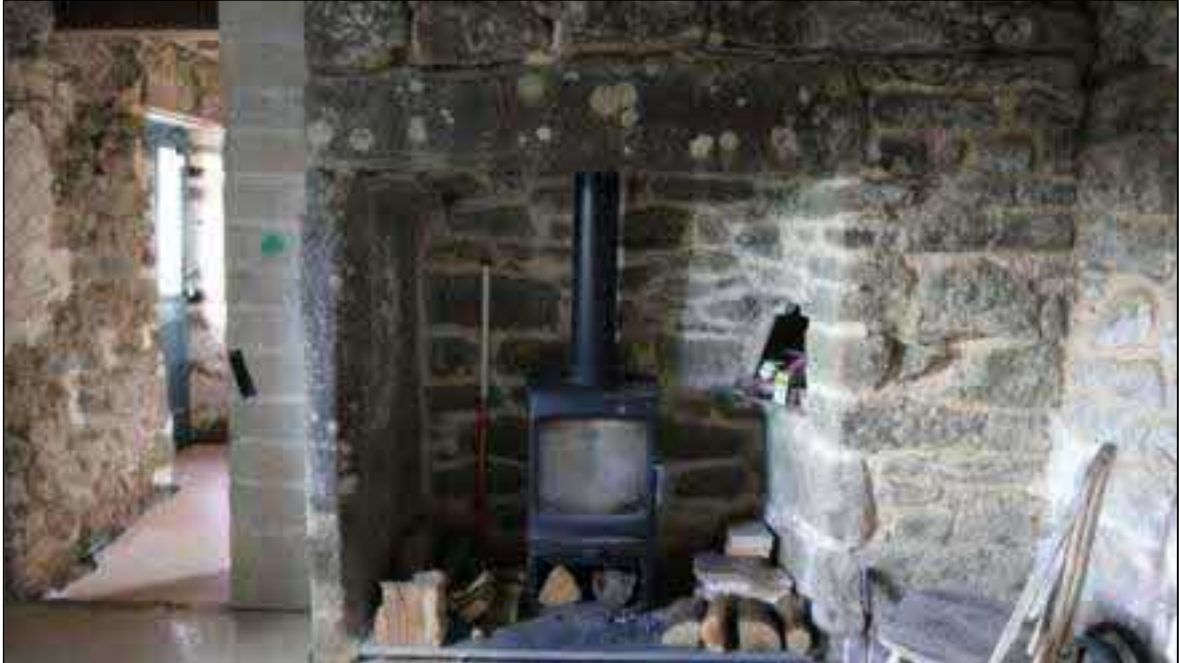
south end of the block is a deep fireplace with chamfered granite bressumer and jamb, with a cloam oven to one side. The fireplace has been shortened to accommodate a forced doorway. To the north end is a second fireplace in an inserted shallow stack. The floors of this space were of earth with some flagstones. There is a later external buttress to the south-west corner of this block. This would appear to have been a two-room cross-passage house, the character of the main fireplace indicating a 17<sup>th</sup> century date.

FIGURE 27: CHAMFERED FIRE SURROUND SEEN TO CENTRAL BAY OF HOUSE; VIEWED FROM THE NORTH (SCALE 1M).

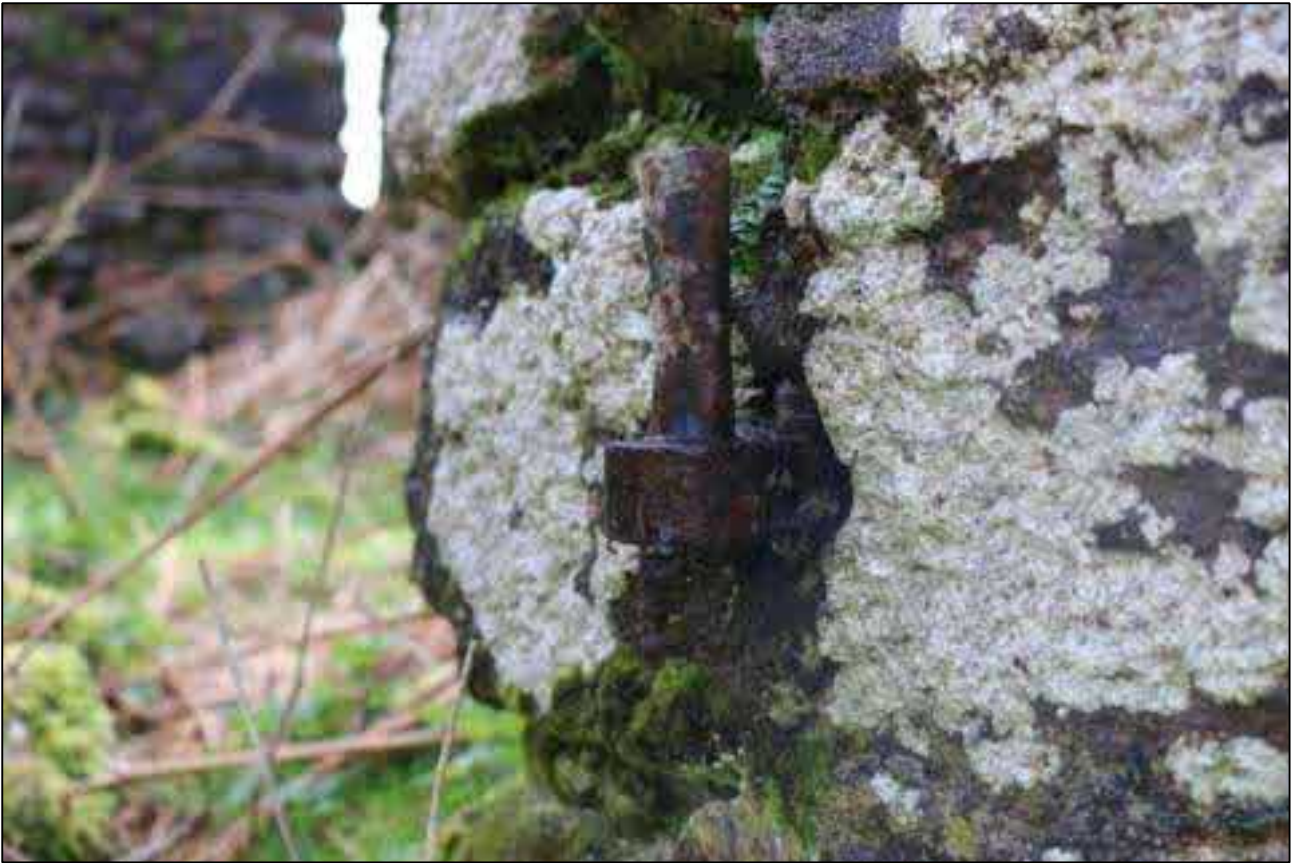
7. HEAVY PINTLE SURVIVING TO NORTH SIDE OF D3.

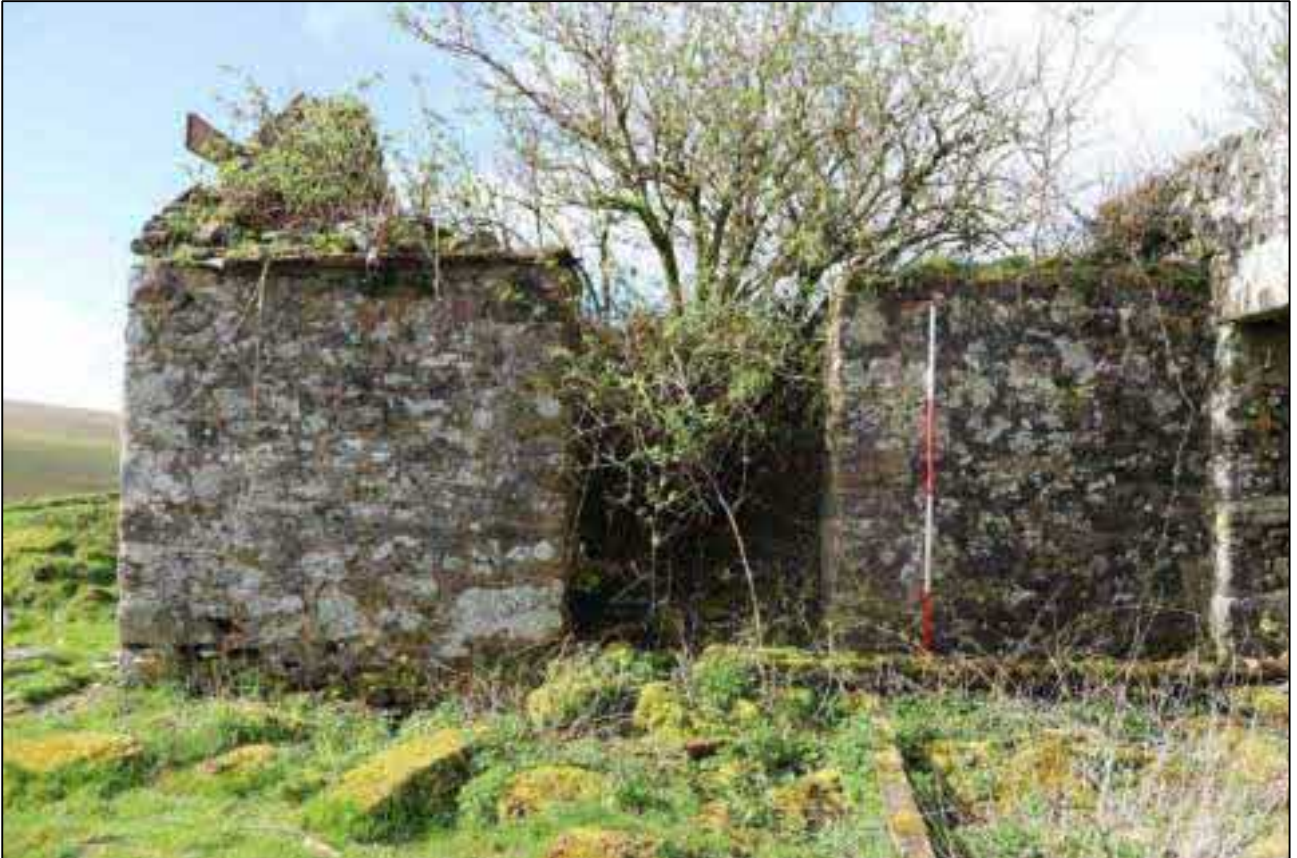
8. D4 LEADING TO B1B; VIEWED FROM THE NORTH (SCALE 2M).

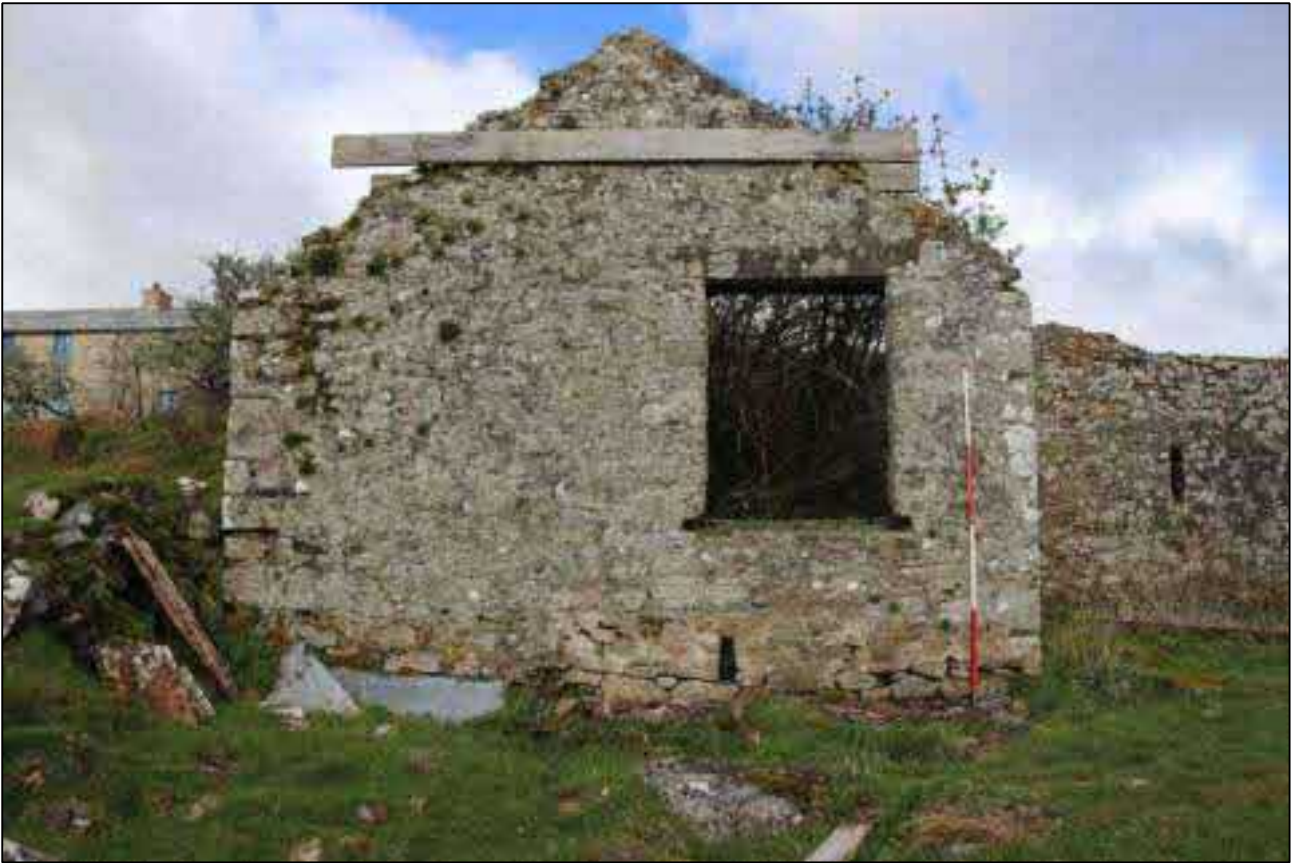
9. THE EAST FACING ELEVATION OF B1B WITH LARGE RECTANGULAR WINDOW; VIEWED FROM THE NORTH-EAST (SCALE 2M).

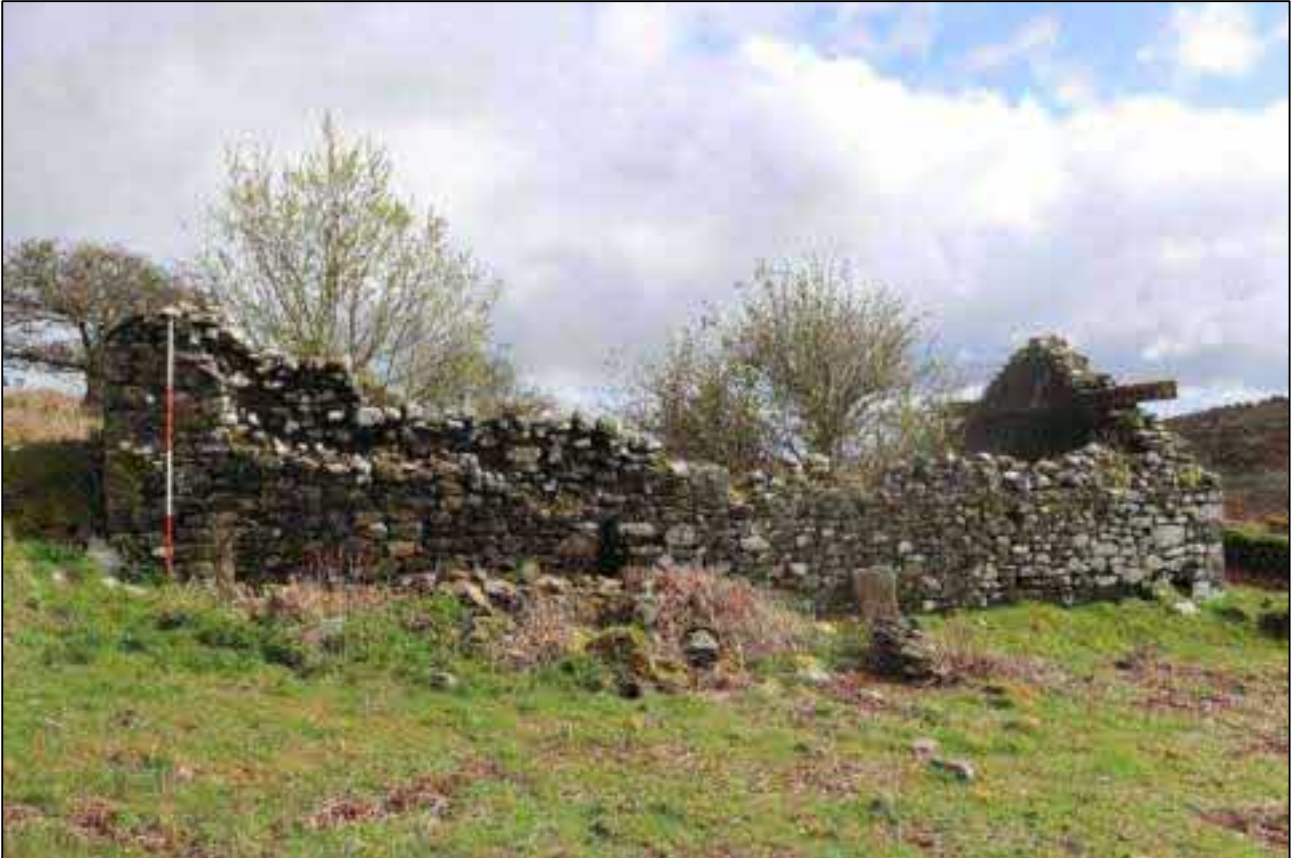
10. THE SOUTH-WEST ELEVATION SHOWING NO DISTINCT JOIN BETWEEN B1A AND B1B; VIEWED FROM THE SOUTH (SCALE 2M).

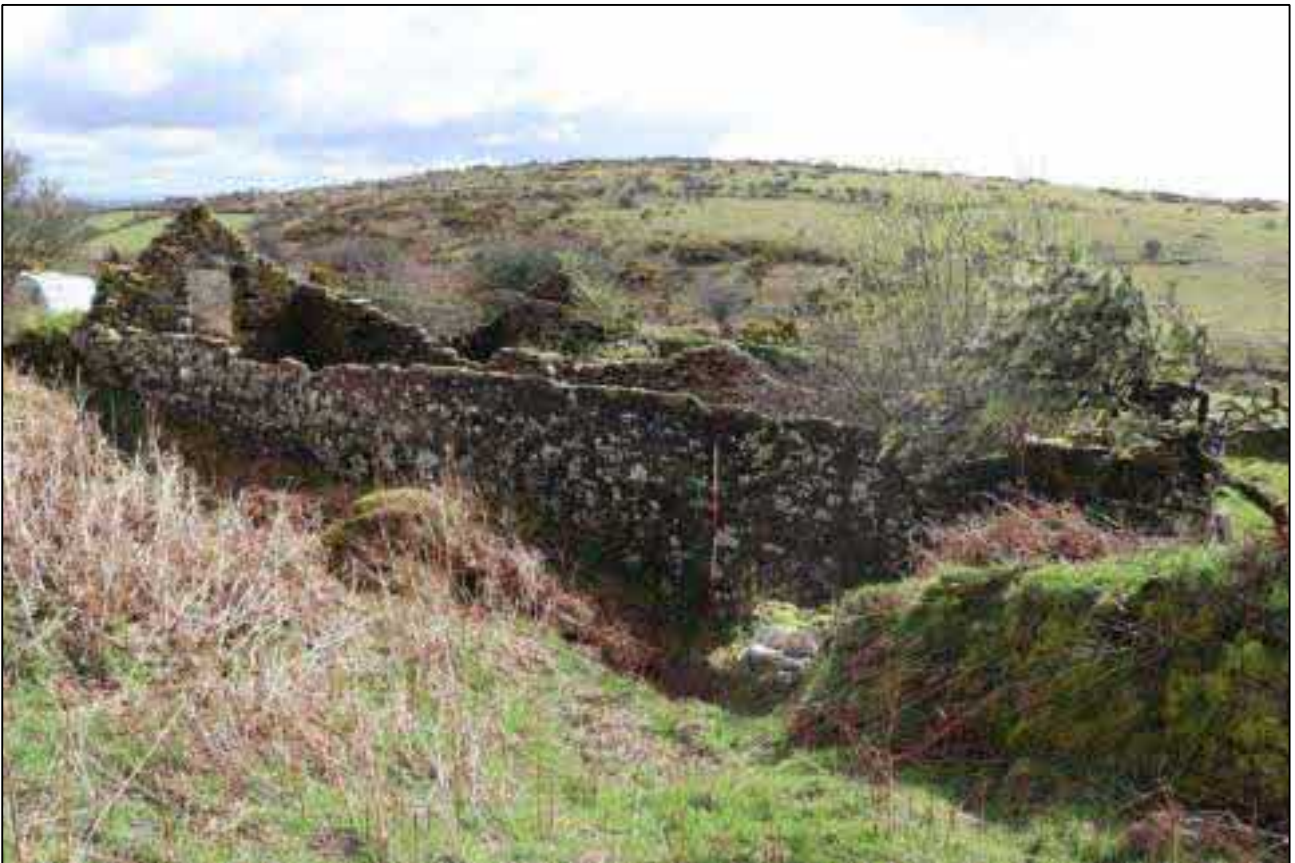
12. THE WEST ELEVATION OF THE BARN; VIEWED FROM THE SOUTH-WEST (SCALE 2M).

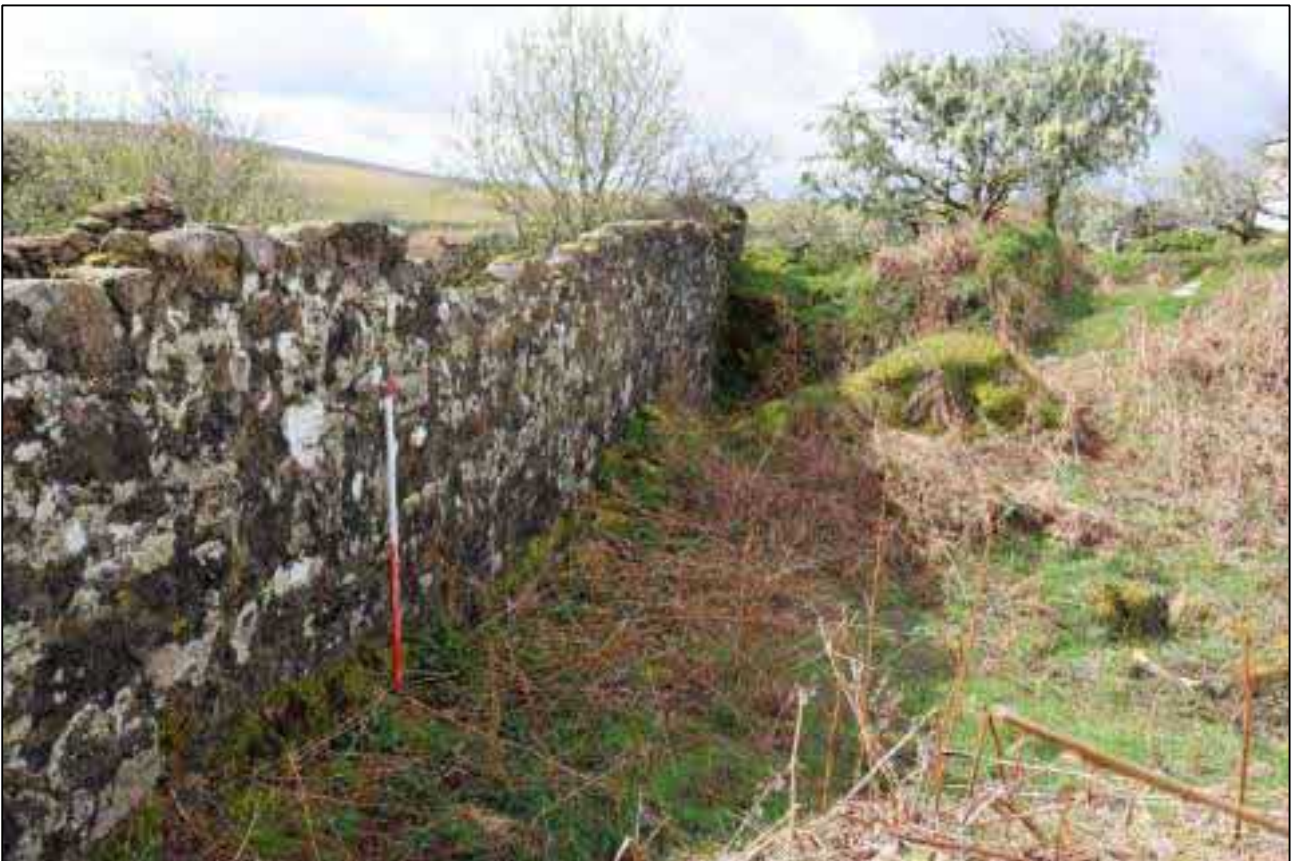
14. THE WEST ELEVATION SHOWS NO SIGNS OF AN OPENING LINKING IT TO THE HORSE WHIM; VIEWED FROM THE NORTH-EAST (SCALE 1M).

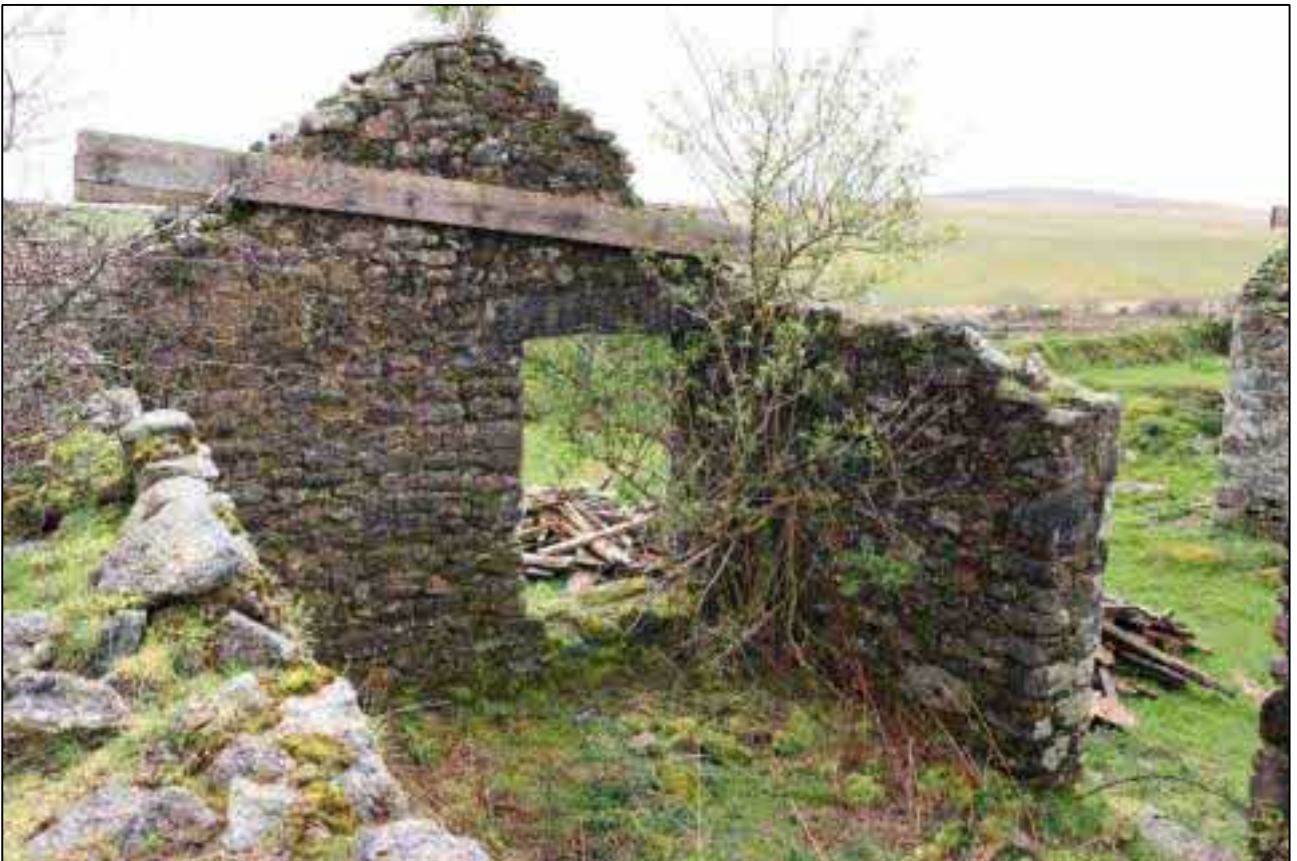
25. THE EAST INTERNAL ELEVATION OF B1C; VIEWED FROM THE WEST (SCALE 1M).

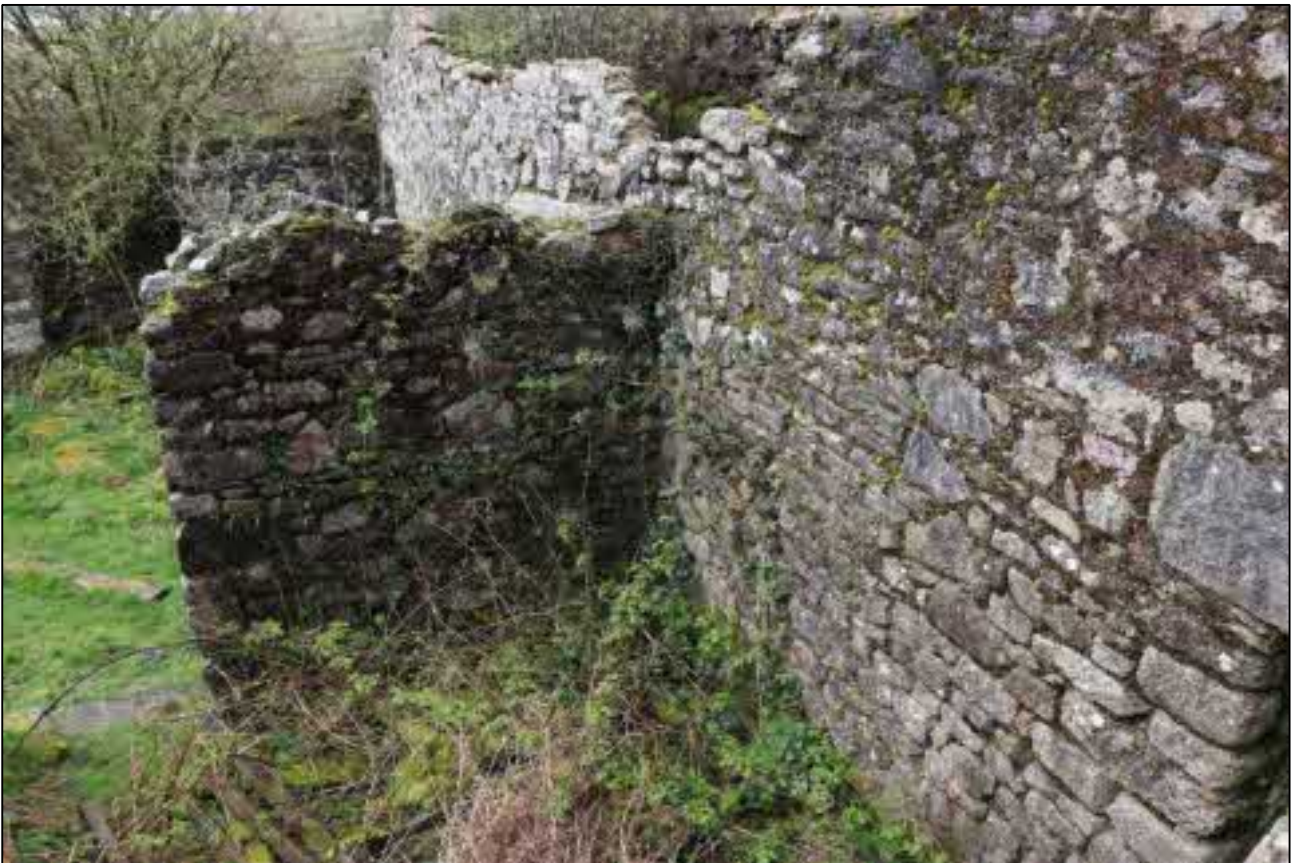
27. D5 LOOKING THROUGH TO THE SMALL YARD AND B1B; VIEWED FROM THE NORTH (SCALE 1M).

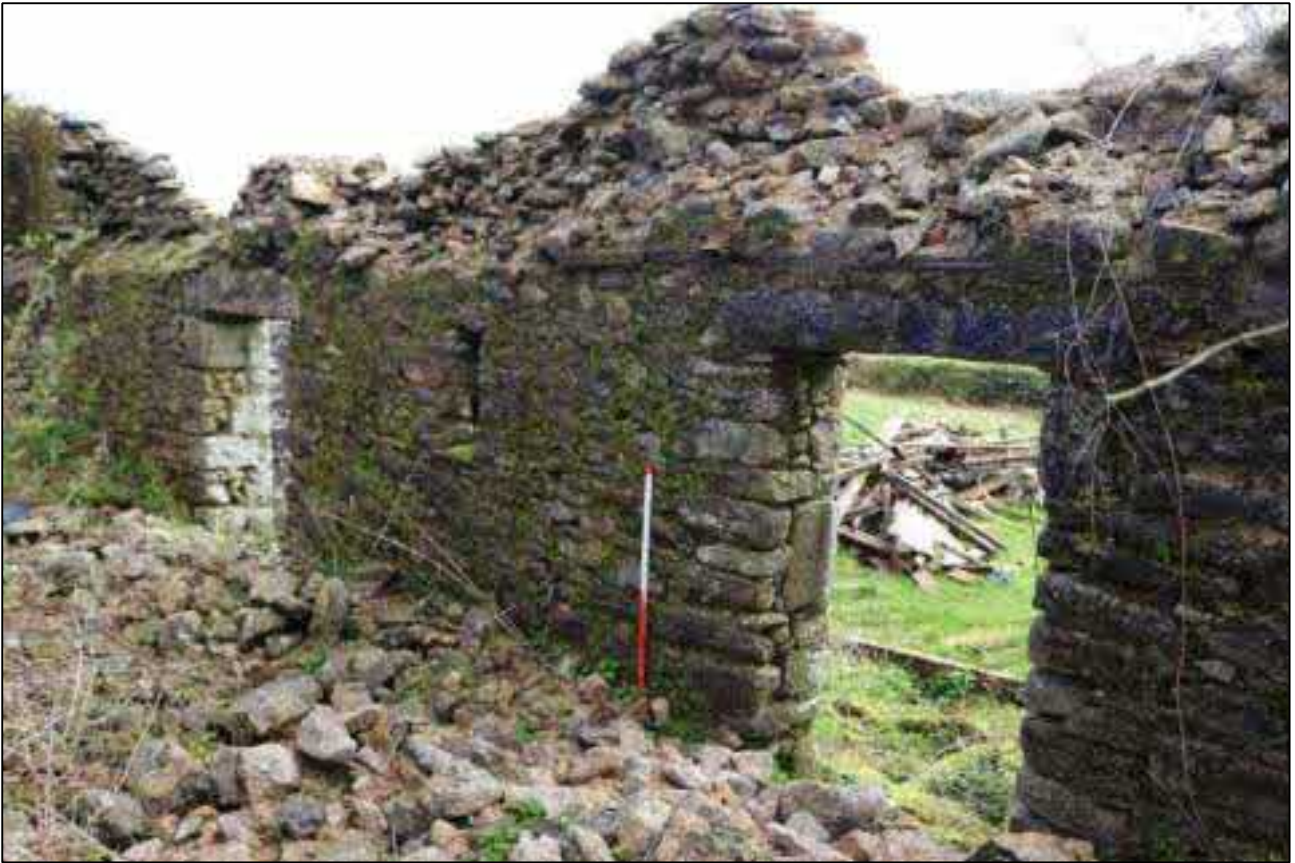
29. THE INTERNAL EAST ELEVATION OF B1A; VIEWED FROM THE SOUTH-WEST (SCALE 1M).

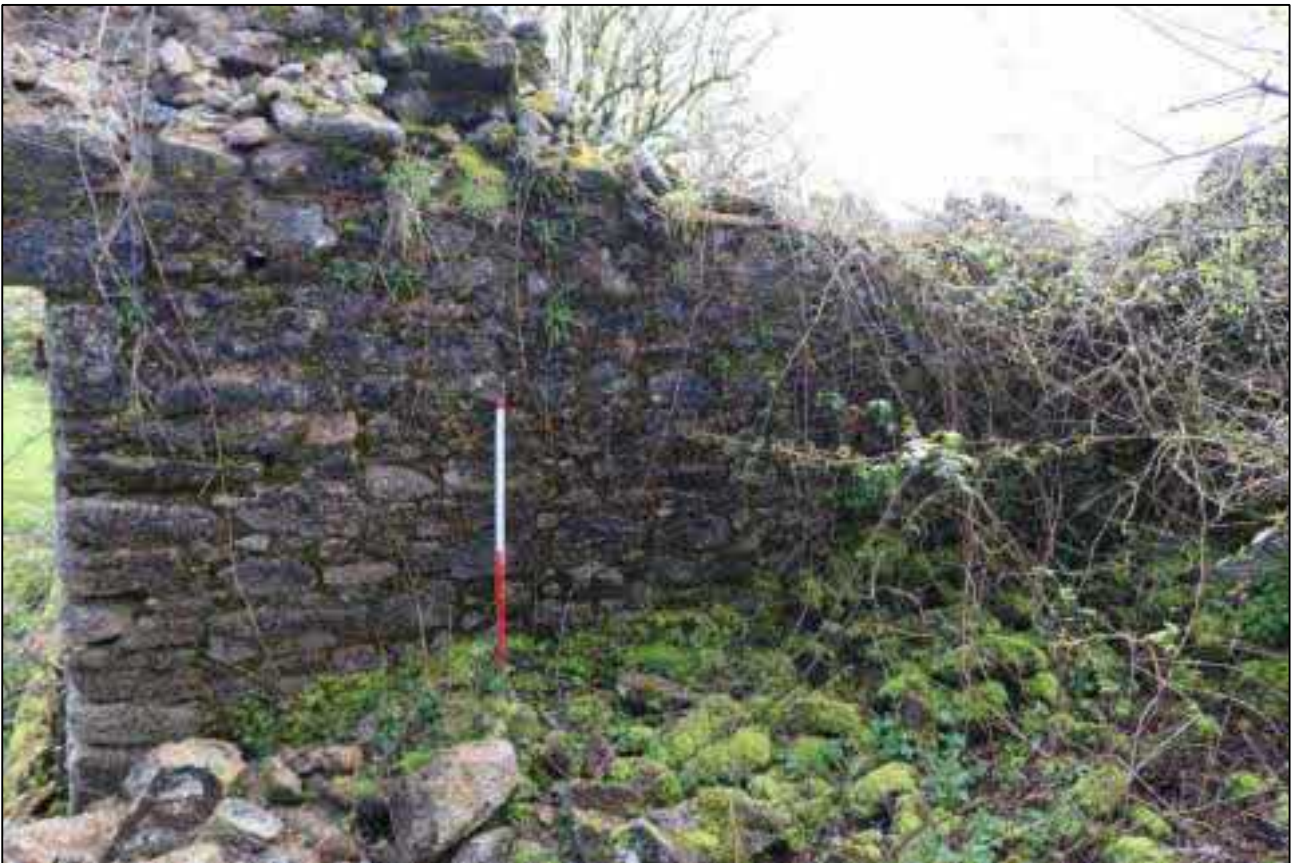
30. THE SOUTH-EAST CORNER OF B1A, NO EVIDENCE OF AN OPENING IT TO B1B; VIEWED FROM THE WEST (SCALE 1M).

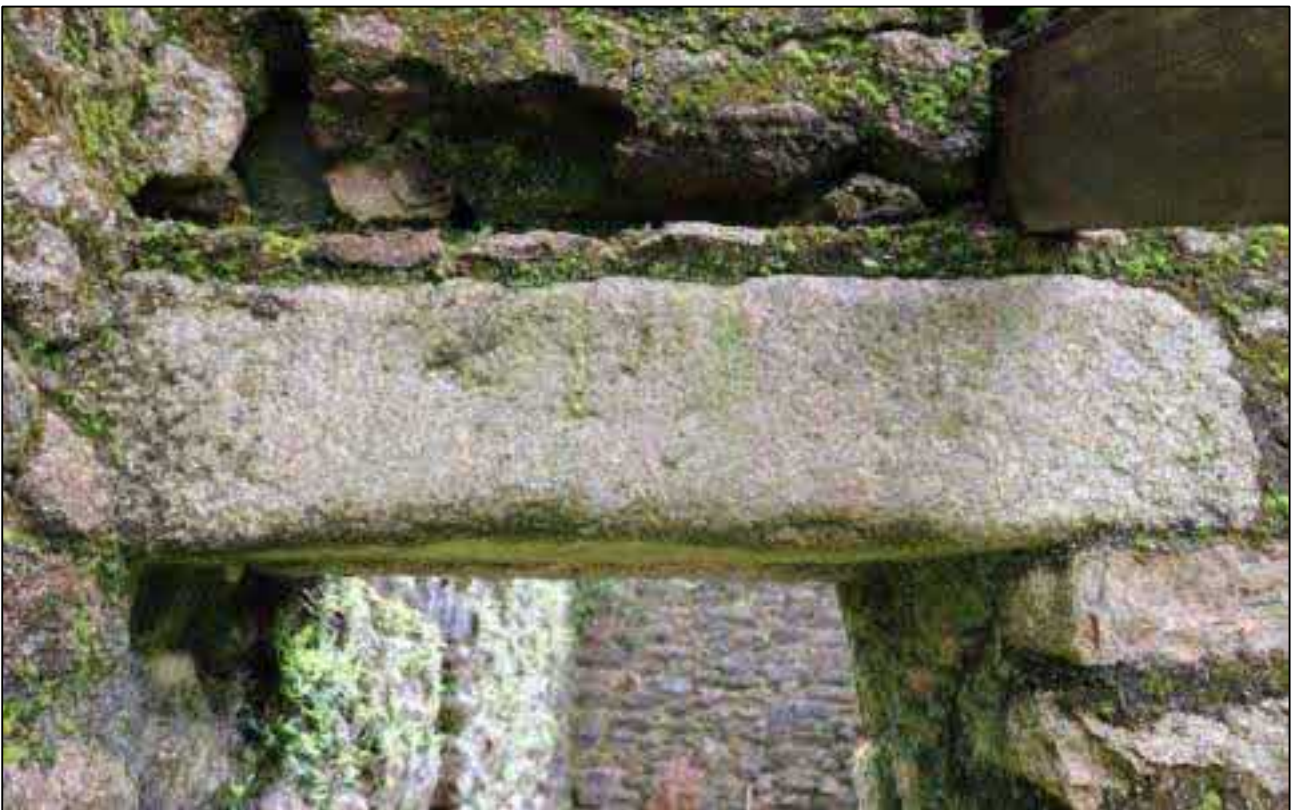
34. THE GRANITE LINTEL TO D1, LEADING FROM B1A TO B1C; VIEWED FROM THE WEST.

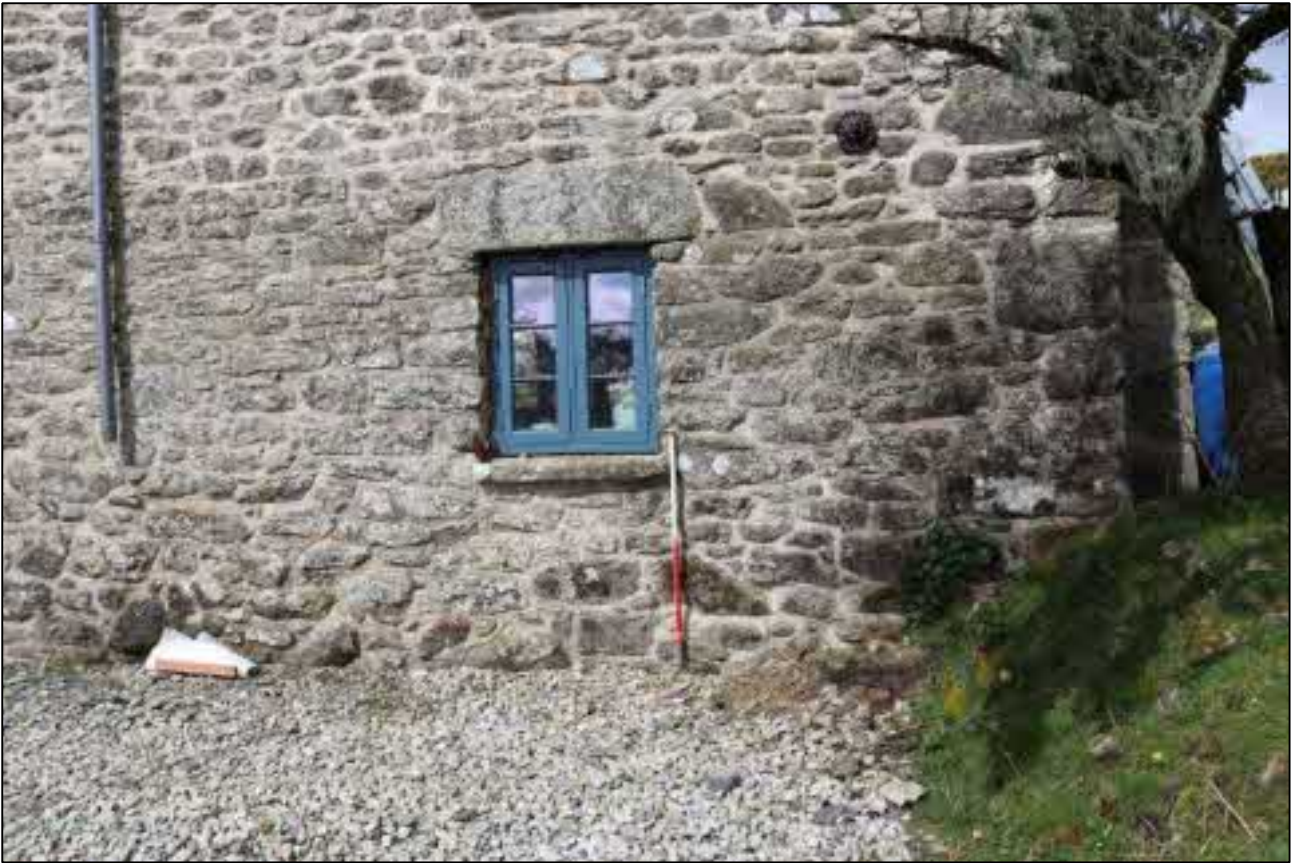
41. THE NORTH END OF EAST ELEVATION, THIS WINDOW OPENING IN A BLOCKED DOORWAY; VIEWED FROM THE EAST (SCALE 1M).

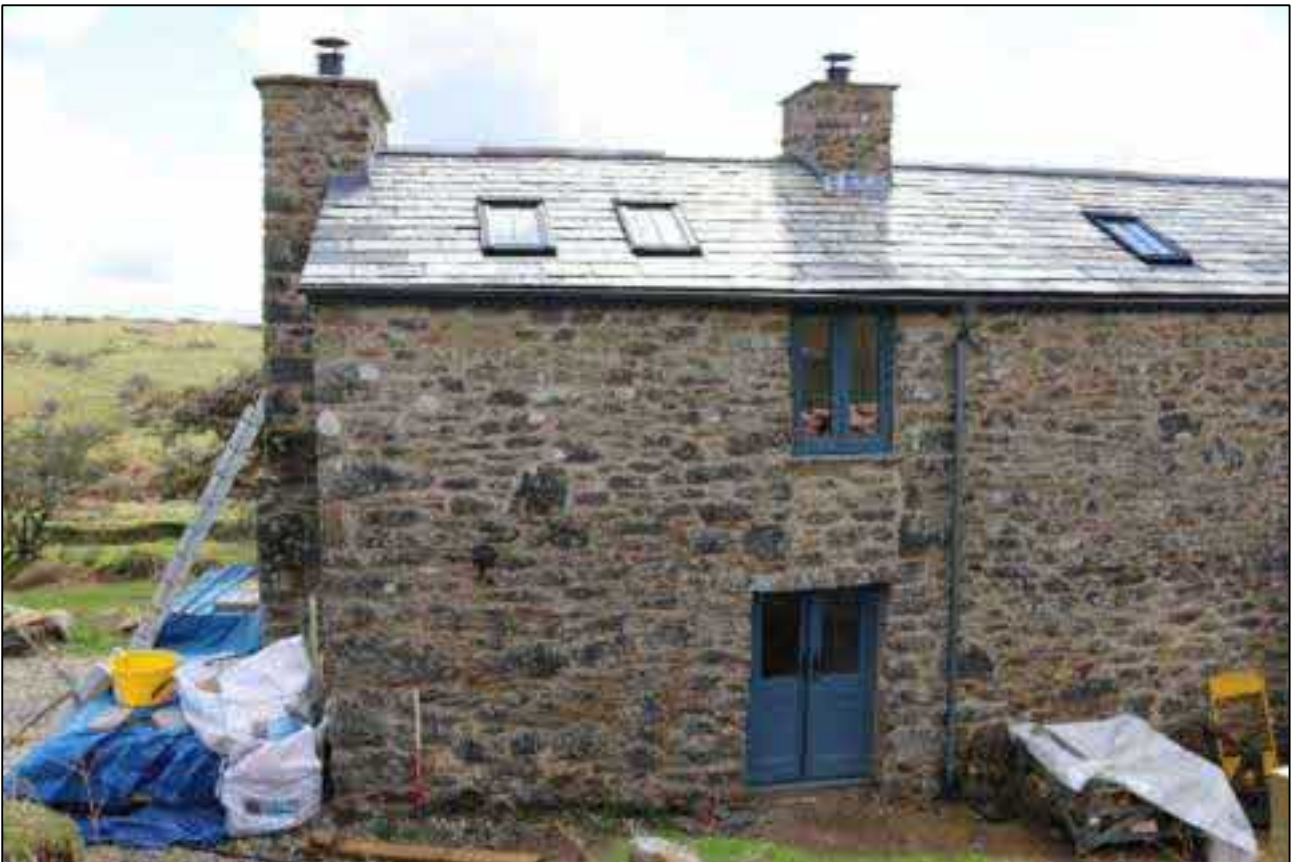
44. THE NORTH END OF WEST ELEVATION, SHOWING THE ALTERED OPENINGS; VIEWED FROM THE WEST (SCALE 1M).

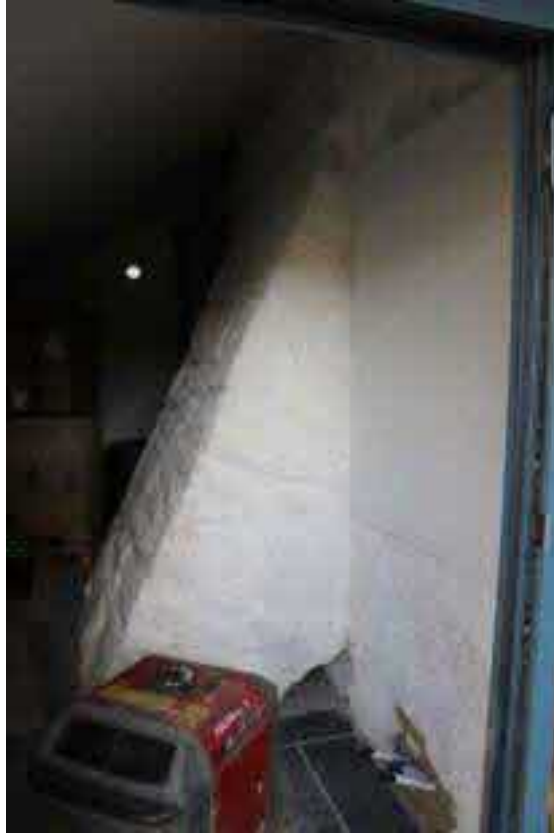
47. THE GRANITE BUTTRESS TO THE SOUTH END OF THE WEST ELEVATION, NOW WITH A MODERN PLANT ROOM; VIEWED FROM THE SOUTH.

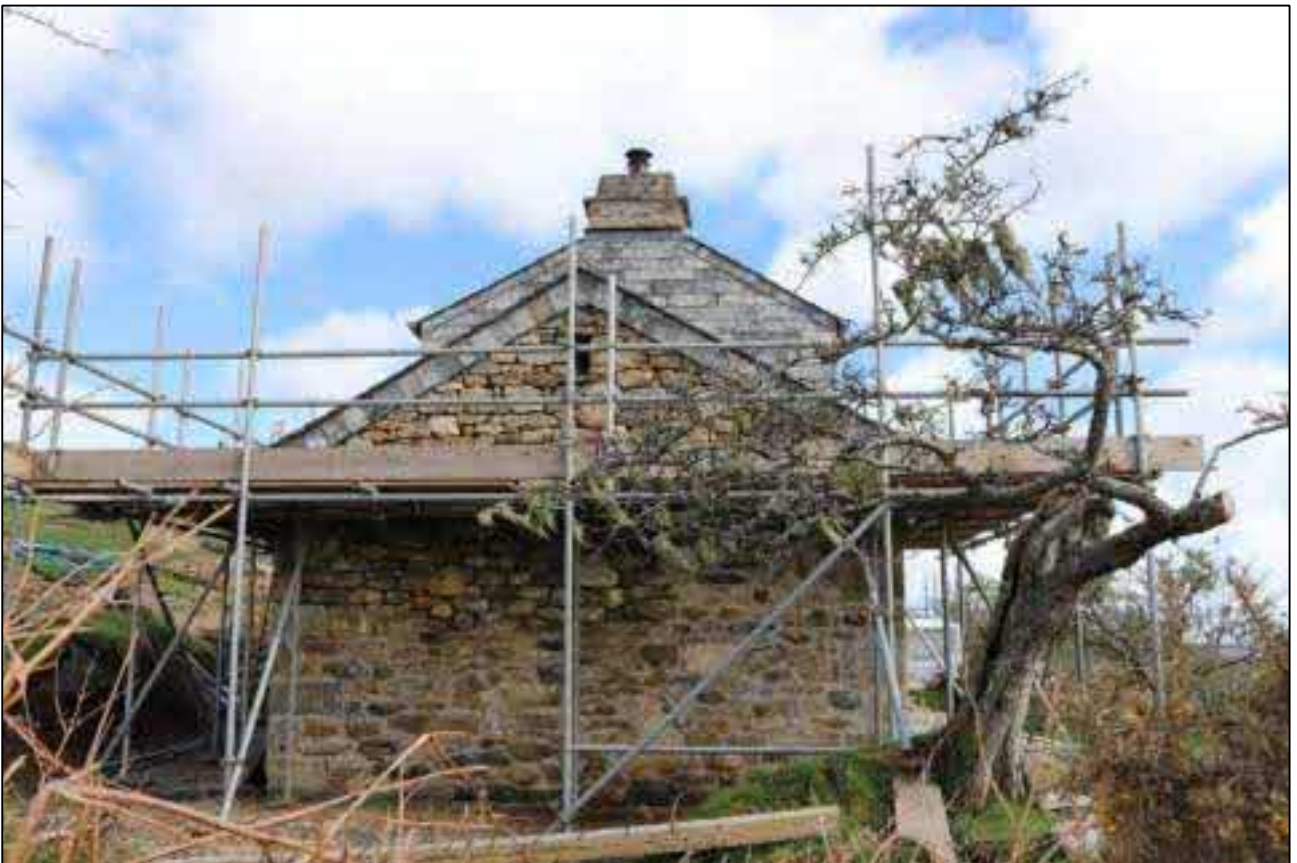
48. THE SOUTH EXTENSION, AND SLATE HANGING (MODERN) TO SOUTH WALL; VIEWED FROM THE SOUTH.

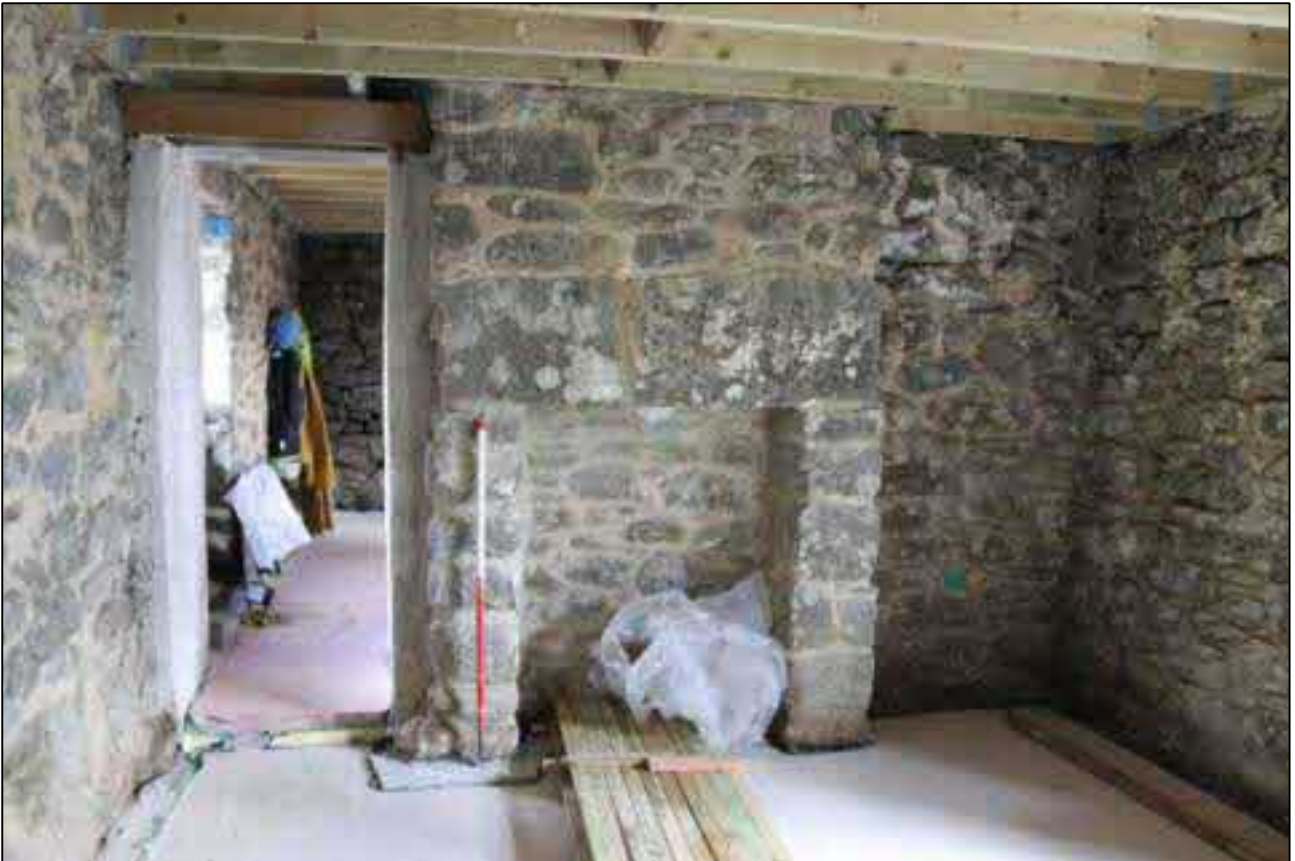
51. THE SHALLOW FIREPLACE AT THE NORTH END OF THE CENTRAL BAY; VIEWED FROM THE SOUTH (SCALE 1M).
