THE BARN  
CANAGLAZE  
ALTARNUN  
CORNWALL

Heritage Assessment

South West Archaeology Ltd. report no. 230516

South West Archaeology Ltd. was commissioned to undertake a heritage assessment for the Barn at Canaglaze, Altarnun, Cornwall to inform plans to consolidate and convert the barn to a dwelling. This work was carried out in consultation with HEP(Arch) and in accordance with the relevant guidance.

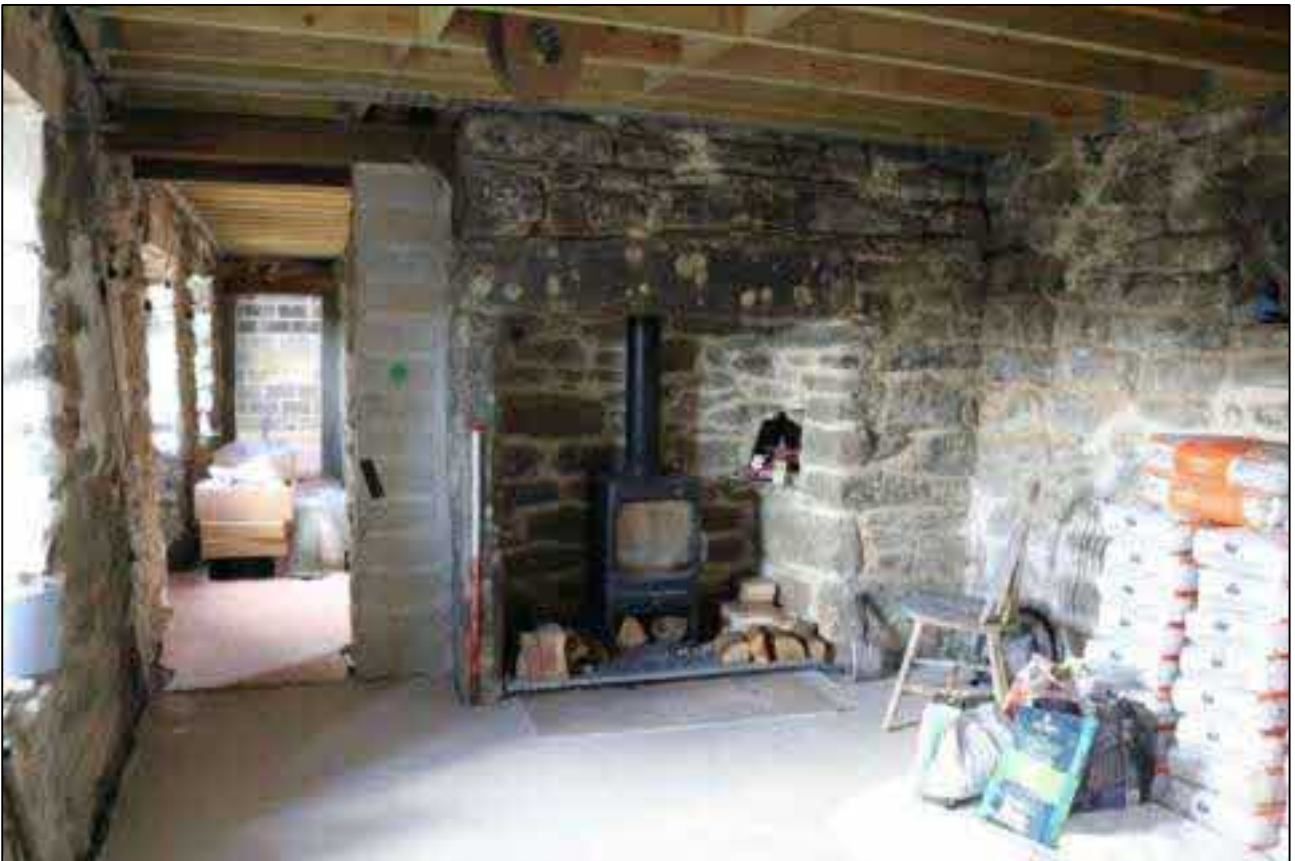
52. THE LARGE STACK TO THE SOUTH END OF THE CENTRAL BAY, CLOAM OVEN TO RIGHT; VIEWED FROM THE NORTH (SCALE 1M).

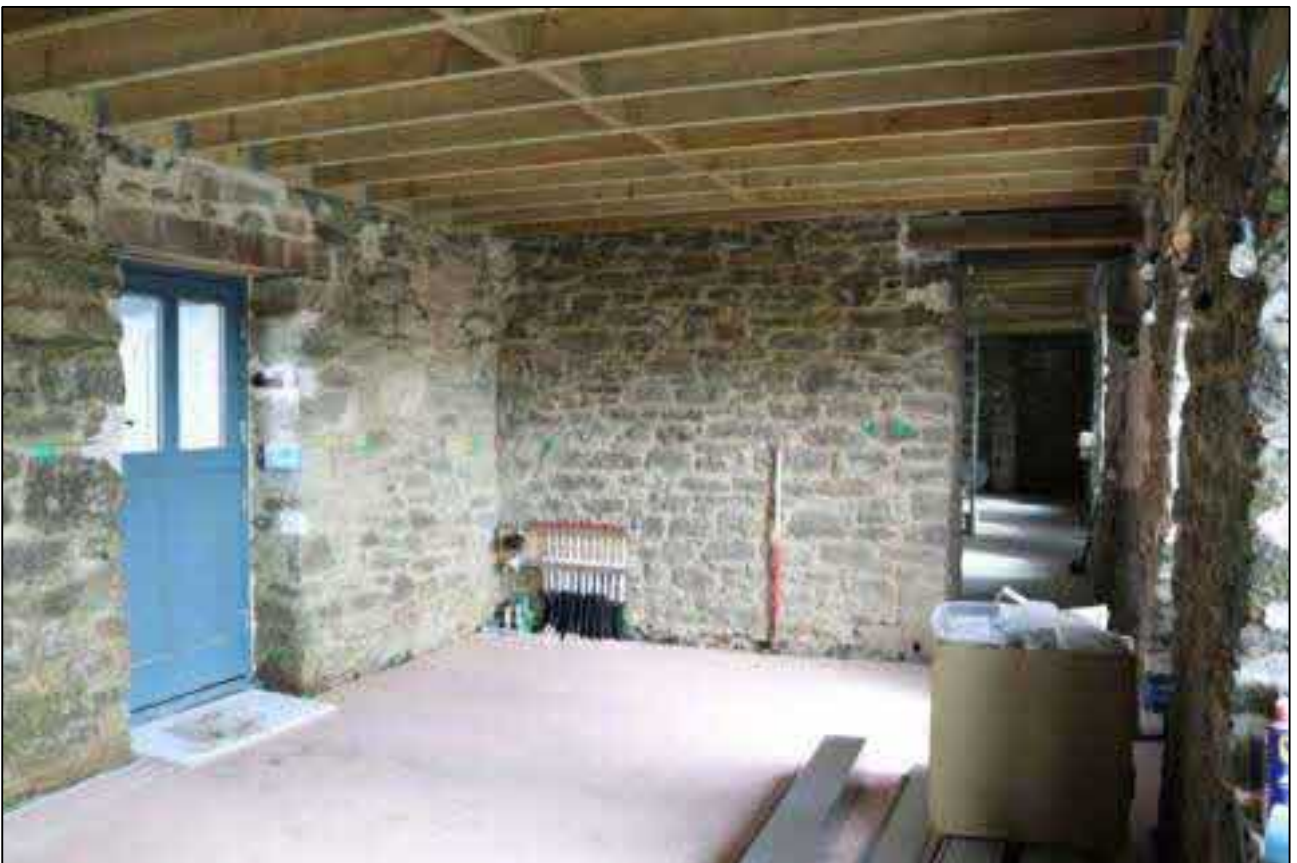
54. THE NORTH AND WEST PARTS OF SOUTHERN BAY; VIEWED FROM THE SOUTH-EAST (SCALE 1M).

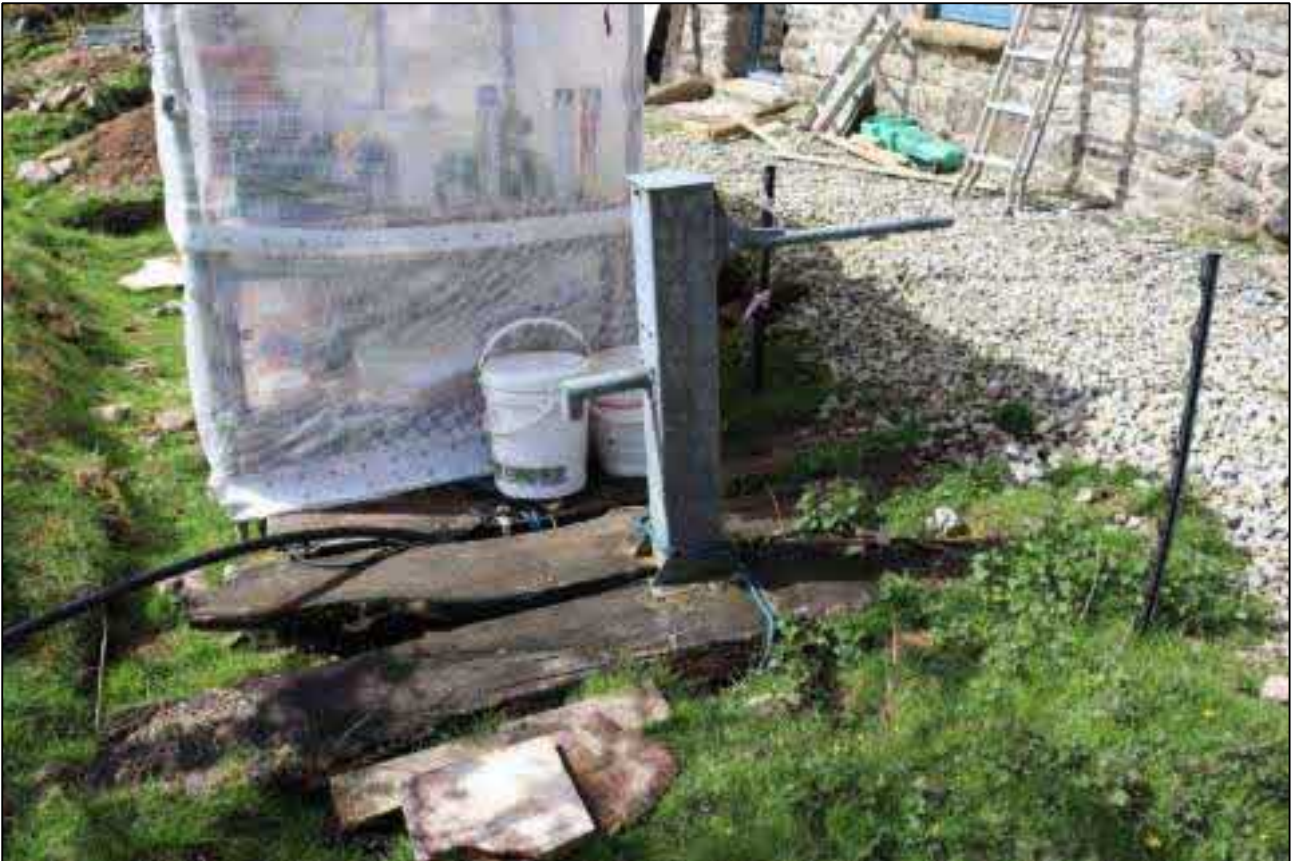
57. A DEEP WELL COVERED, LOCATED TO THE NORTH OF THE HOUSE AGAINST EAST ELEVATION; VIEWED FROM THE NORTH.

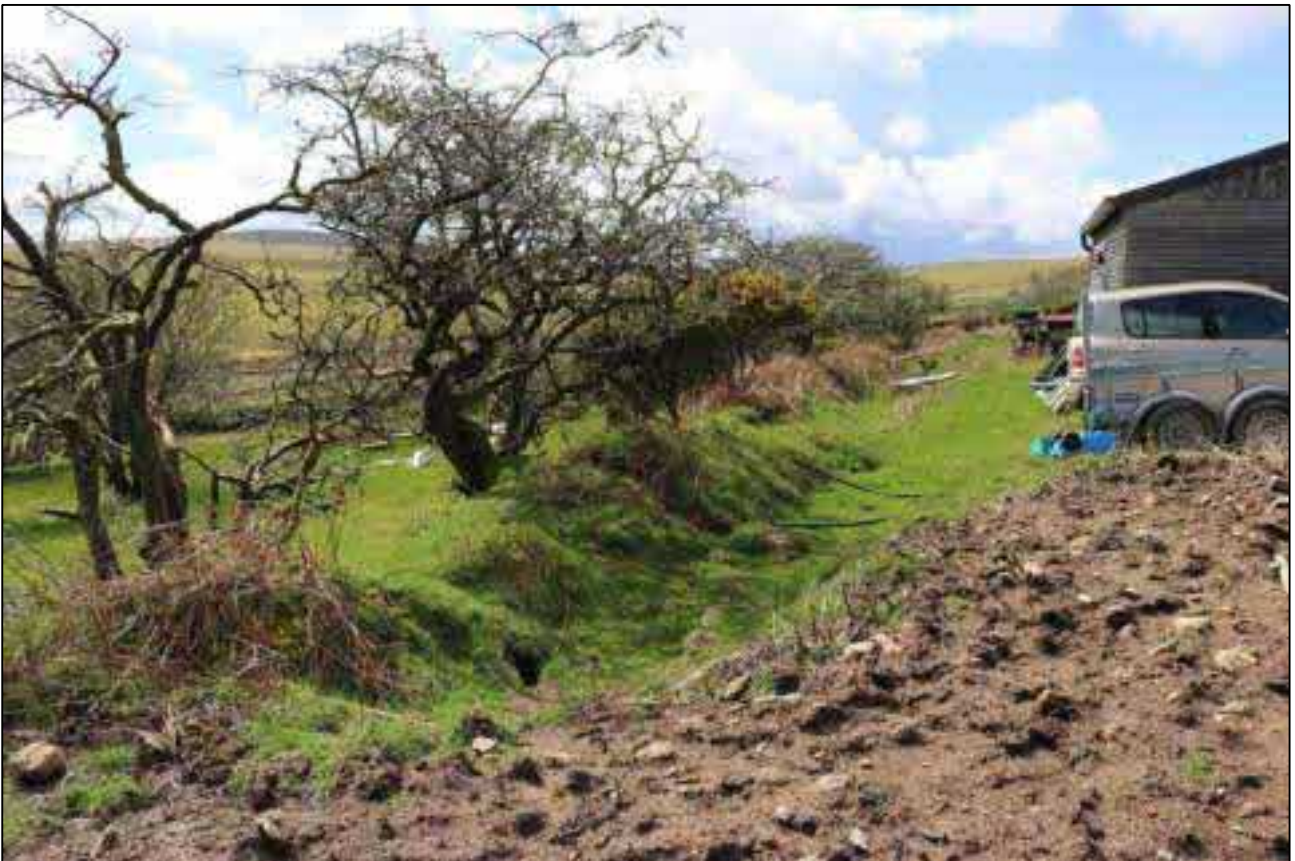
63. THE HEDGE BANK LOOKING TOWARDS BARN; VIEWED FROM THE NORTH.

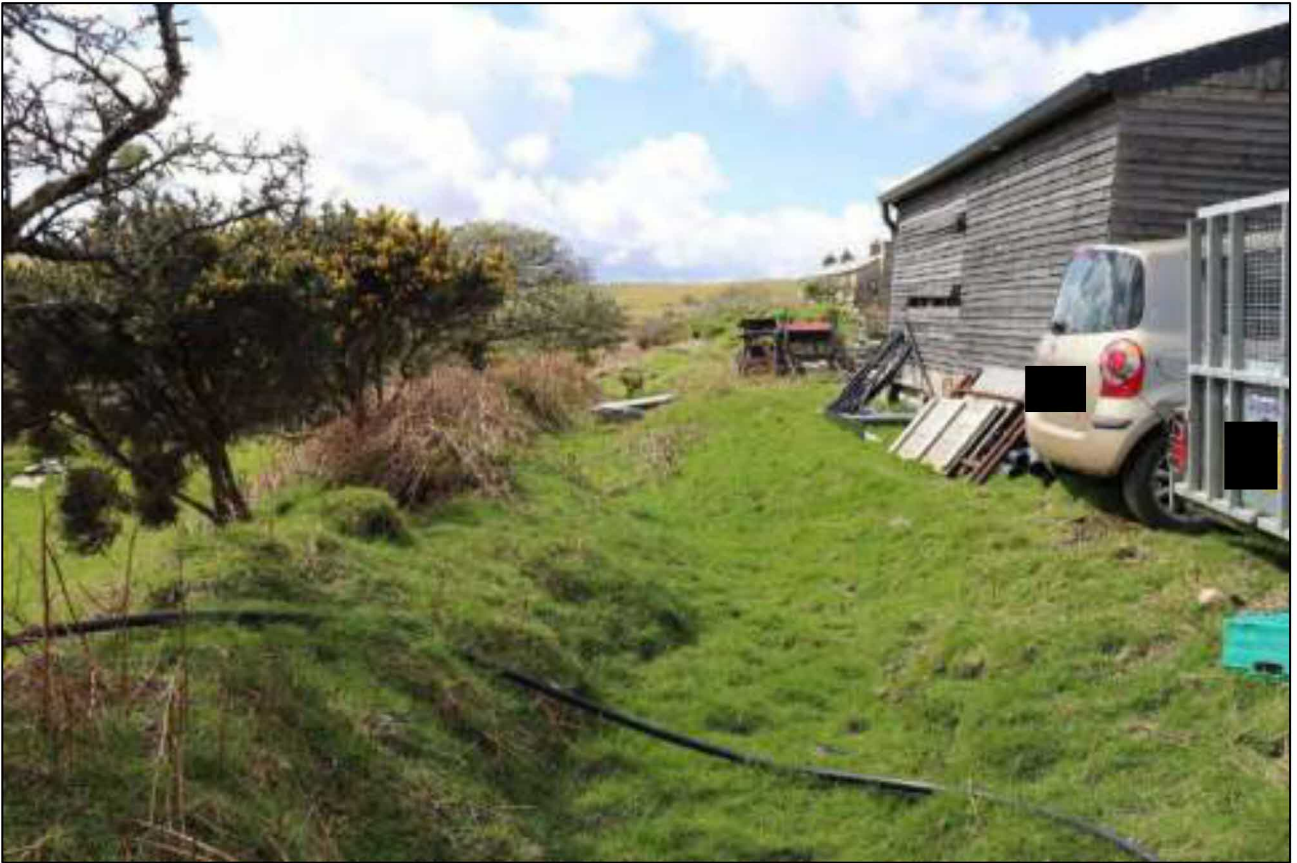
64. THE WIDER TERRACING SEEN TO THE NORTH OF SITE LOOKING BACK TO HOUSE; VIEWED FROM THE NORTH-EAST.

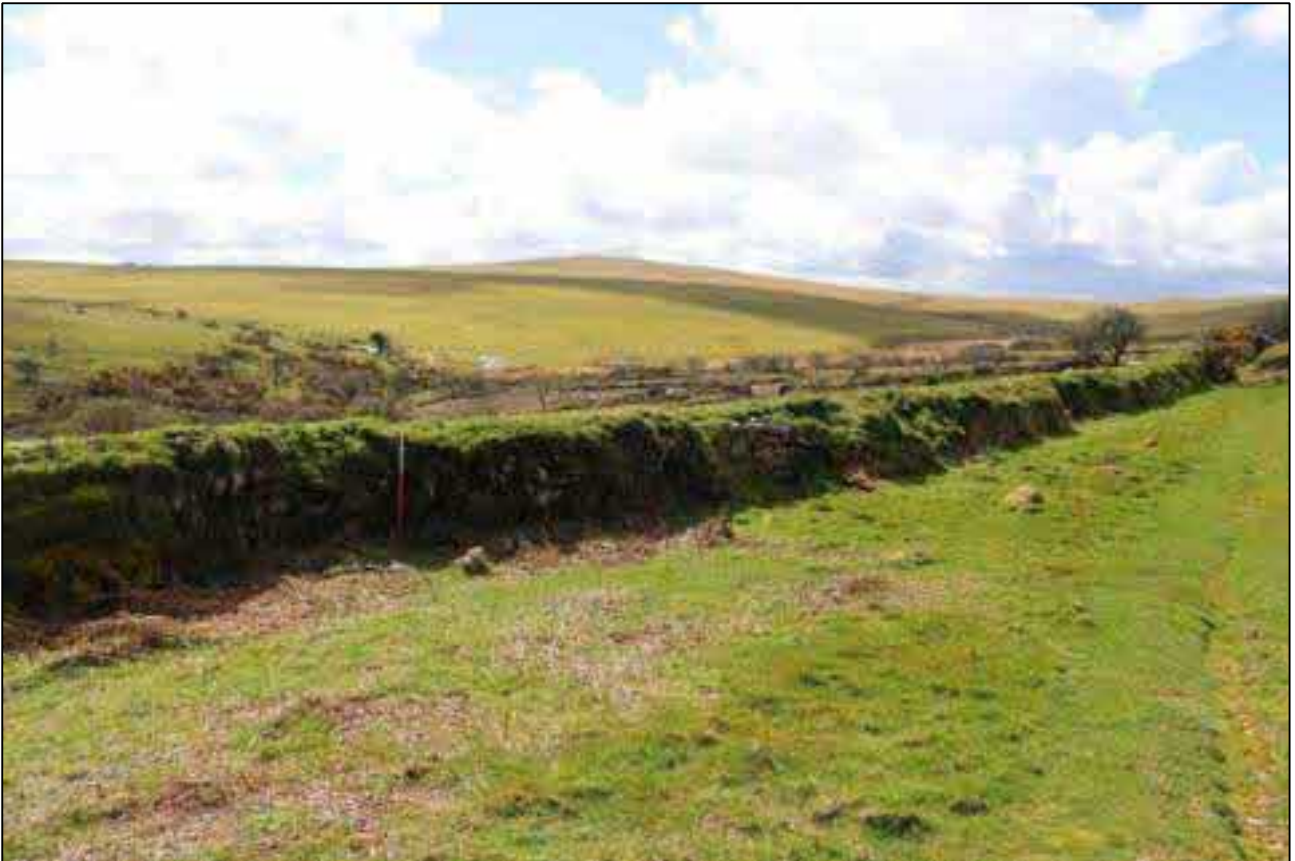
66. THE SLOPES OF CARNE DOWN, SHOWING ANOTHER POSSIBLE CIRCULAR ENCLOSURE (NOT LISTED TO HER); VIEWED FROM THE WEST.
