Purpose of Issue
PL and LBC APPLICATION

Project **Log Store Roof, Chimneys, Retaining Wall and Field Shelter at Villa Farmhouse, Main Road, Aust, Bristol**

Title **As Existing**

Drawing No. **SHS3335.80-**

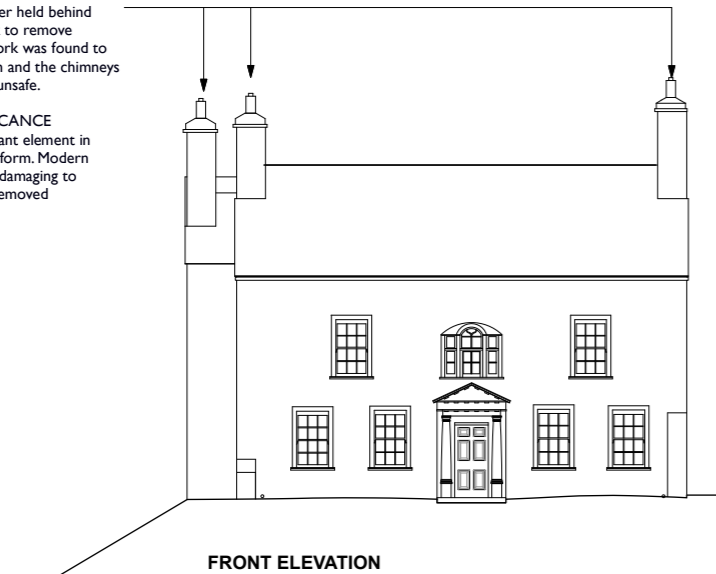
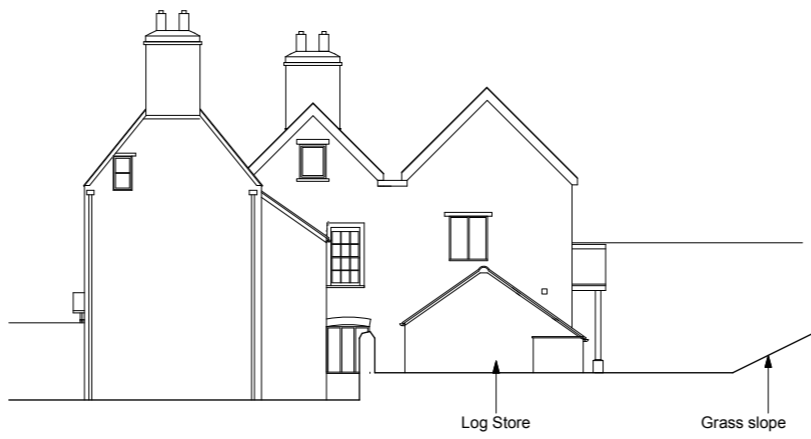
The log store roof structure was a mix of old and new timber. There was extensive rot in the old timber. See Photos right. The structure of the log store has heritage significance as part of the traditional form of construction, but the amount of rot meant that repair was un-viable. Replacement on a like-for-like basis follows good conservation principals
