GEOSLOPE STABILITY REPORT

SITE: FORMER G7 CONFERENCE FACILITY AT CARBIS BAY HOTEL, CARBIS BAY, CORNWALL

Our Ref: TJG/SSA/G003.Carbis Bay Hotel.Rev0

12th August 2023

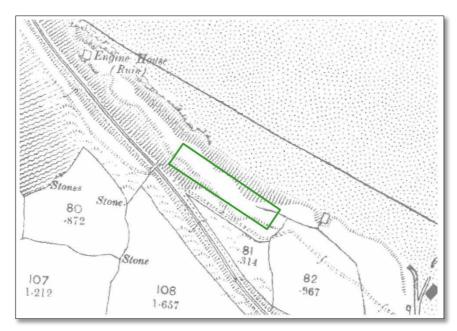
Figure 03: Ordnance Survey dataset from 1887 (proposed development site in green (appr outline)).

Historical Ordnance Survey (OS) maps indicate that prior to 1887 the site was extensively undeveloped and used as open agricultural ground. The St Ives Branch rail line is annotated to the south of the site and there is some development within Carbis Valley located approximately 140 metres southeast of the site, including Carbis Valley Station. There is a former Engine House (Ruins) annotated approximately 86 metres to the northwest of the site (not within the site extents) and the site itself appears to have been formed on a pre-existing plateau of land, which may have been formed to facilitate access to the engine house.⁴
