Carbis Bay Hotel St Ives, Cornwall

Ecological Appraisal For Habitat Restoration

Document Reference: 9747.001

February 2023

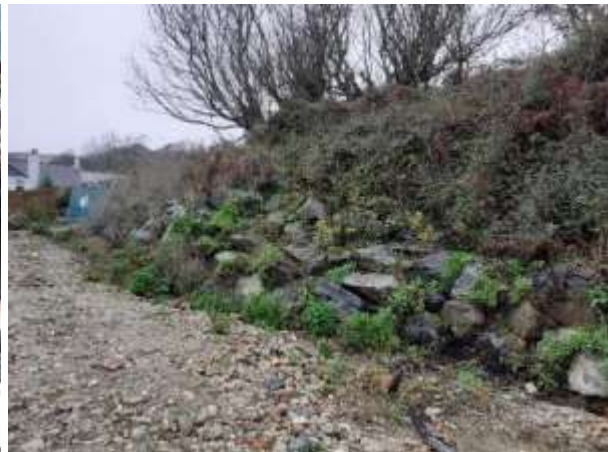
Figure 7: Vegetated cliff face (south boundary)

- 3.33 Several granite boulders are piled south of the tarmac platform, edging the slope down into the site. More boulders are present at the toe of cliff on the south boundary in the east which are planted with asters with some native forb species also colonising (Figure 6). The site is otherwise roughly levelled and comprises a mix of soil and hardcore. Ephemeral, ruderal and scrub plants are beginning to recolonise particularly along the southwestern edge (Figure 7).

- 3.35 A retaining wall approximately central to the site on the south boundary is a concrete structure with wooden cladding. The wall (Figure 8) is in good condition, although the wooden cladding is partly removed towards the bottom of the wall, exposing the cavities between the cladding and the concrete wall. The rest of the south boundary of the site is formed of what appears to be pre-existing near vertical cliff profile, vegetated with low scrub and herb cover. A group of sycamore trees is situated on the slope above (Figure 7).

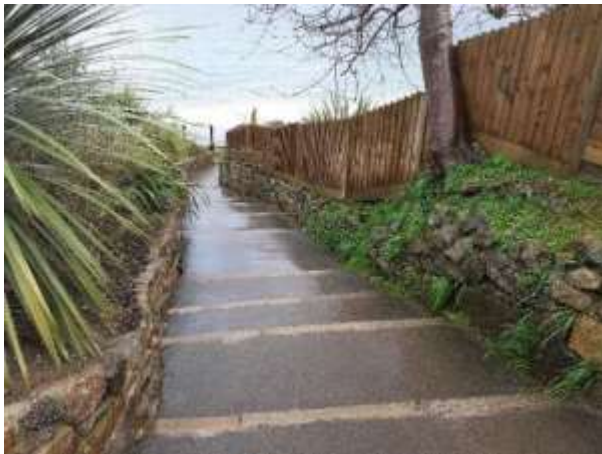
Figure 10: Stone faced wall topped with timber fence and landscape planting

- 3.36 The coastal path has been resurfaced into a series of steps passing the east side of the site (Figure 9). The steps have been landscaped with a stone-faced wall on the west side from the site extending down towards the beach. The wall is topped with a timber fence and landscape planting (Figure 10). The planting appears to be establishing well.

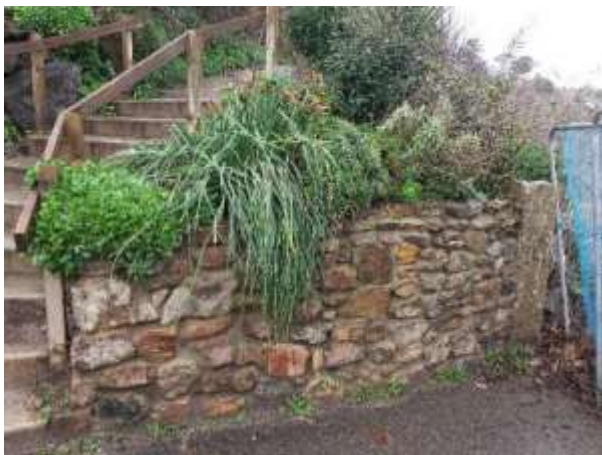
Figure 12: Tarmac track as it approaches the coastal path (view west, coastal path descending via steps)

- 3.38 The final area covered by the enforcement notice comprises a tarmac track leading from the coast path opposite the site entrance (Figure 12) around the back of the hotel to the car park. At this point, the south side of the track comprises a steep bank faced with boulders which is establishing with low growing bushy flowers (asters/osteospermums) (Figure 13). Further along, behind the hotel, the track has been edged with a stone-faced wall to both sides (Figure 14), with the height varying according to the adjacent land profile. The stone facing is beginning to colonise with species such as ivy-leaved toadflax and spleenworts. Lawn areas and landscape planting (pre-existing established areas and recent planting) form the majority of land uses adjacent to the track to the south.

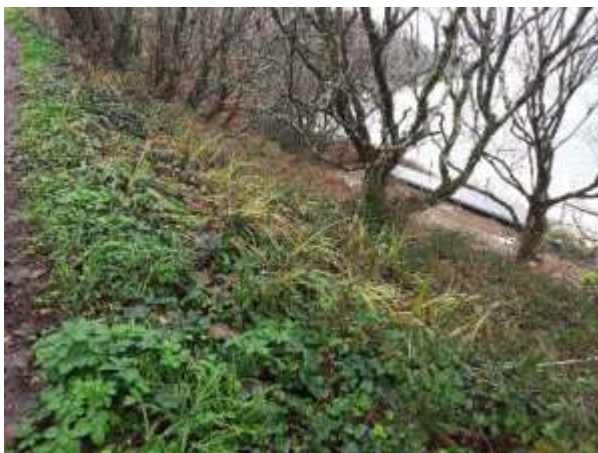
Figure 17: Slope south of site adjacent to coastal path

- 3.41 The slope above the site, between the site and the coastal path, is dominated by the group of sycamore trees (Figure 17). Ground flora is more diverse in this location, although dominated by ivy. Montbretia and three-cornered leek, non-native invasive species, were present. The sycamore trees continue up the slope between the coastal path and railway line (Figure 18), but the ground flora becomes more grass dominated on this side.

- 3.44 There were no Schedule 9 invasive non-native species recorded within the formerly developed platform of the site. However, the slope to the south, rising to the coastal path, contains a high proportion of non-native species including two listed on Schedule 9 montbretia and three-cornered leek. Non-native cotoneaster was noted adjacent to the site on the west edge (within scrub remaining offsite). While not identifiable to species level at the time of survey, it may also be one of several cotoneasters listed on Schedule 9. Winter heliotrope and buddleia, non-natives but not listed on Schedule 9, were also noted in the habitats south, west and north of the site.
- 3.45 In the absence of intervention, it is highly likely these non-native invasive species would readily colonise the site, probably to the detriment of some native species.

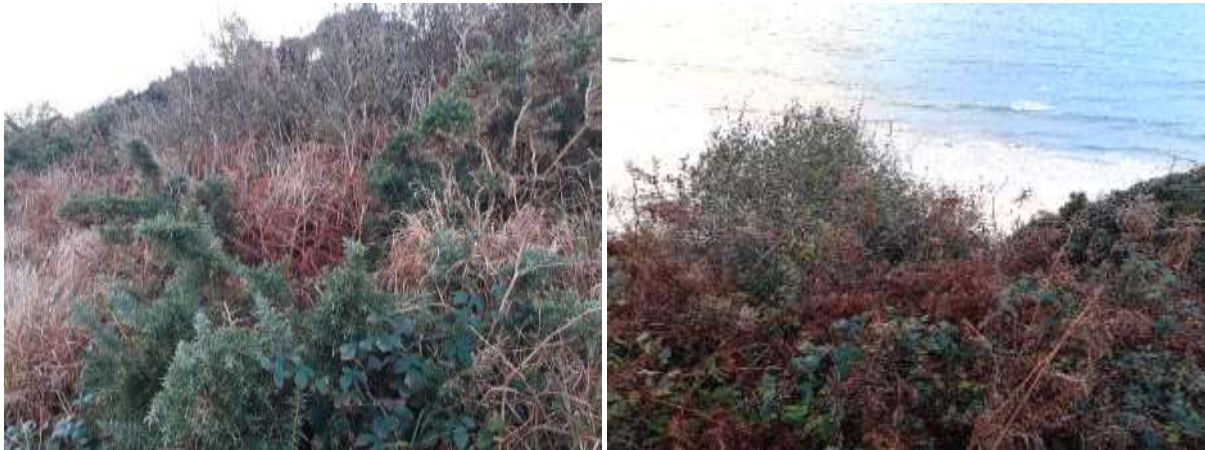
- 3.43 During the same site visit, surveyors walked a short section of the coastal path into the Hayle Estuary and Carrack Gladden SSSI, to the east of the hotel. While not an exhaustive survey, this habitat was viewed to provide comparison and context for cliffside habitat in the locality that is unlikely to have been subject to substantial disturbance or modification. It was noted that the scrub cover is broadly similar to that present adjacent to the site in the west, comprising mainly gorse (Figure 19). It lacked sycamore as an oversailing canopy but contained occasional small dense stands of woody scrub (willow, holly) on the steep slopes. Bracken and bramble were still frequent, but buddleia seemed absent from the short section walked. Additional flora noted included species such as columbine, early dog-violet and polypody.

Figure 19: Scrub habitat of the cliff slopes in nearby Hayle Estuary and Carrack Gladden SSSI
