REPORT
- on -
BARN AT BURNT HOUSE FARM
LITTLE CORNARD, SADBURY
SUFFOLK, CO10 0NU
- for -
THE ROYAL AGRICULTURAL
BENEVOLENT INSTITUTION (RABI)

HARCOURT-POWELL LTD
9 GAINSBOROUGH STREET
SADBURY
SUFFOLK CO10 2EU
NHP/JM/CBS0026

In accordance with the attached Terms & Conditions of Engagement dated 5th November 2018 and signed by Jeremy Zeid, Authorised Agent, The Royal Agricultural Benevolent Institution (RABI), c/o Whirledge & Nott, The Estate Office, White Hall, Margaret Roding, Chelmsford, Essex, CM6 1QL to inspect the above premises and prepare a Building Condition Survey to report on feasibility of residential conversion into a single dwelling without significant re-building.

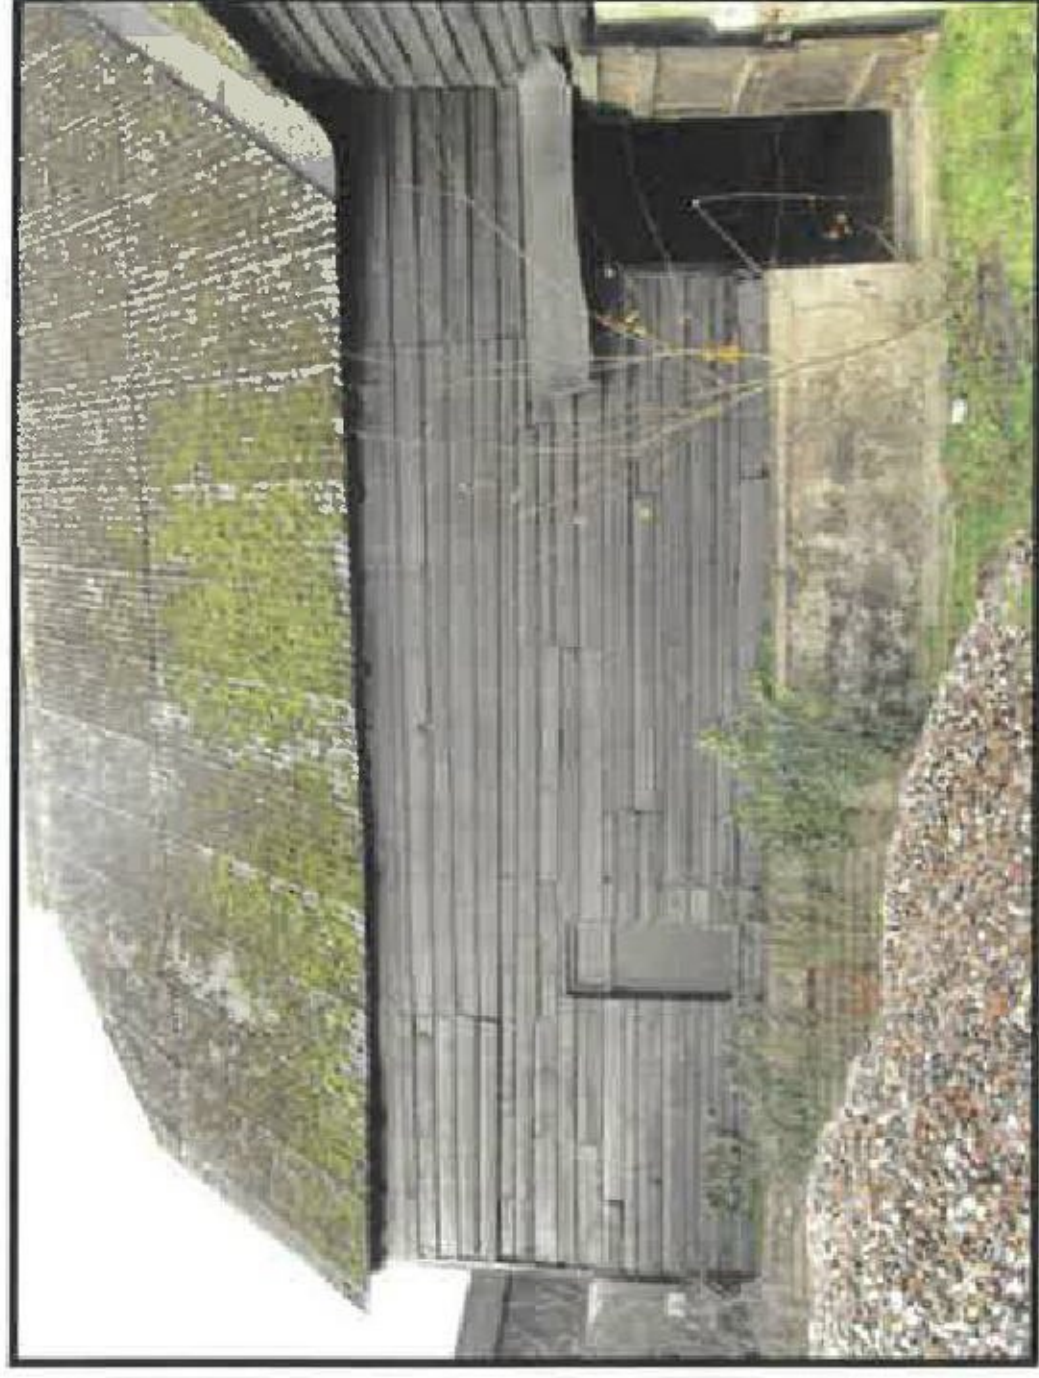
Front Elevation/South-East Side - Photo 6

The plinth to the south-east side has been covered with a thick shuttered concrete over the brick plinth which has compromised the brick plinth and this will need to be removed and an allowance made for repairs/re-forming the brick plinth work (**see Photos 6,7,11 & 13**). The remainder of the wall has been finished with 20th Century black painted feather edged horizontal weatherboards which are generally serviceable. Internally the sole plate has been concealed by red brickwork and cement render infill's and the cement will also need to be removed and the brickwork repaired (**see Photo 57**). The cement has been taken over brick plinths internally and this will also need to be removed. Most of the structure above is the original/older studwork and in similar condition to the remainder of the framework and will need to be treated for timber infestations but is otherwise generally serviceable.

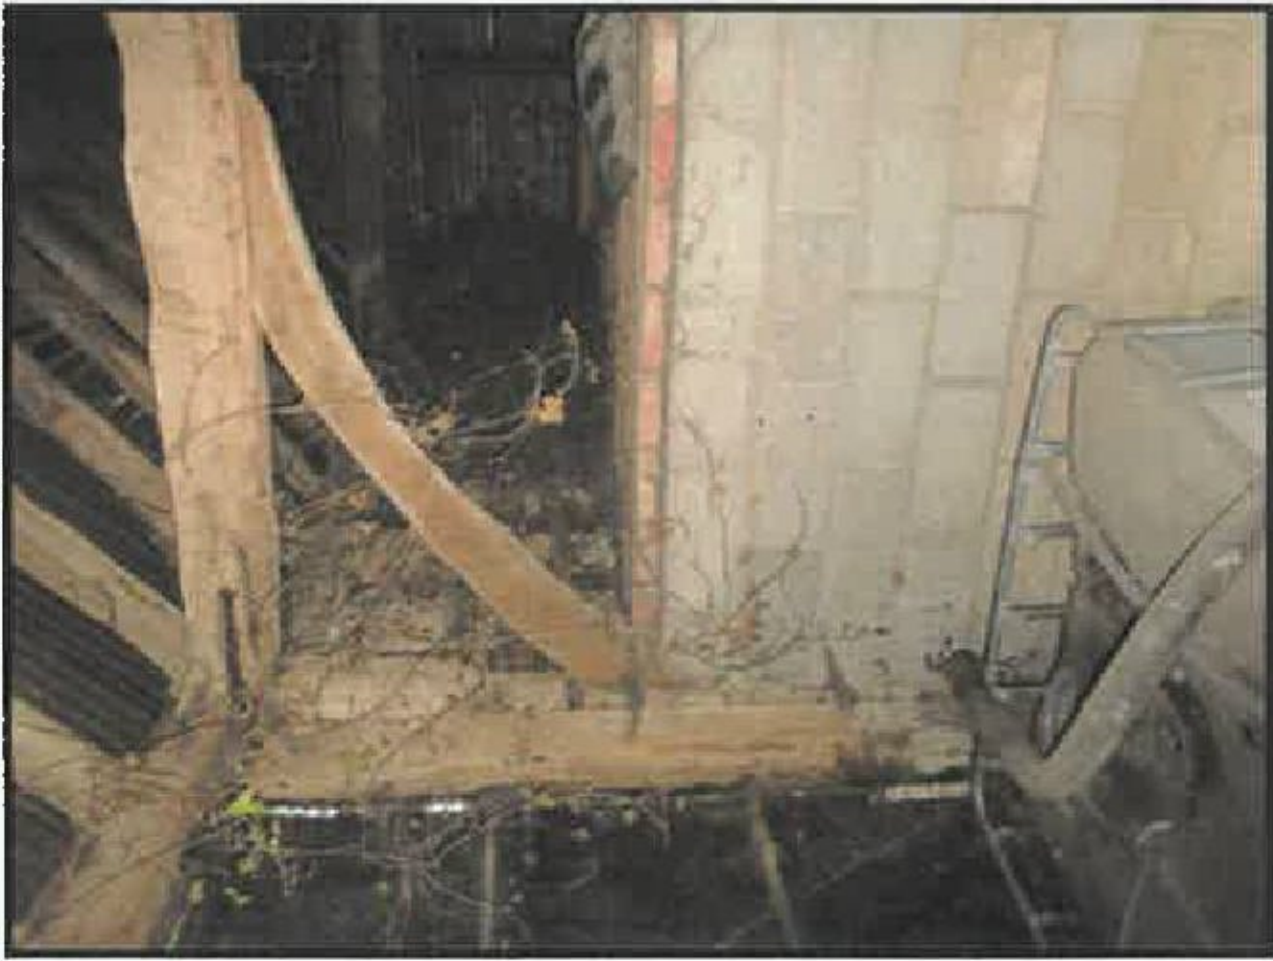
Bays 1 & 2 - Photo 43

The Barn has been formed from six roughly equal size bays with approx. 170mm x 170mm storey frame posts dividing the bays. The timber frame walls between comprise about 140mm wide x 110mm deep vertical studs at about 500mm centres built into horizontal sole plates and rising into horizontal eaves wall plates.. Some of the lower parts of the frame posts and studs have been enclosed by concrete/cement rendered finishes. The sole plates have been raised up onto solid brick (and later concrete) plinth walls varying from 1m to 1.85m above ground levels as shown labelled A-M on the attached floor plan at **Appendix B**. There are original timber knuckle braces to the storey frame posts and collar ties to each bay some with additional iron braces (*see Photo 43*). The framework has been clad externally with feather-edged horizontal weatherboarding.
