Tree Condition Assessment for Lady Smyth's Almshouses, Long Ashton

28th November 2023

Lady Smyth's Almshouses
13-27 Long Ashton Road
Long Ashton
Bristol
BS41 9HW

Almshouses_Cedar_TCA_112023

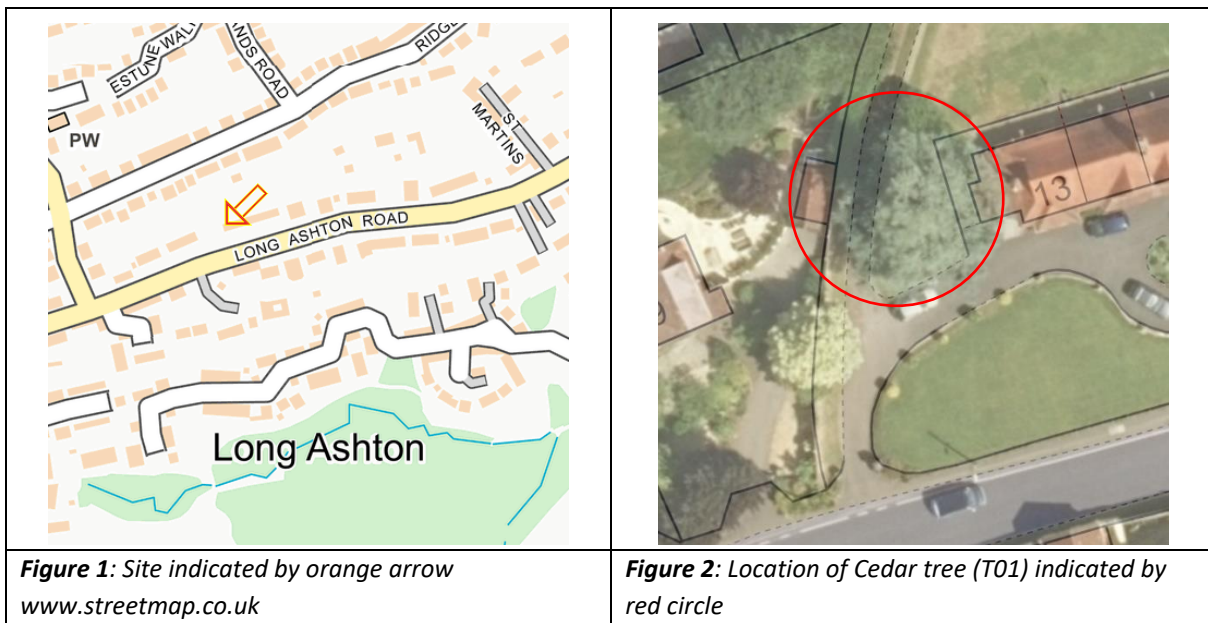
1.1 I am Stuart Roberts, a chartered arboricultural consultant, and I have been instructed by Sarah Leong to make a site visit to Lady Smyth's Almshouses in Long Ashton (figure 1), assess a mature Cedar (figure 2) and comment on the following:

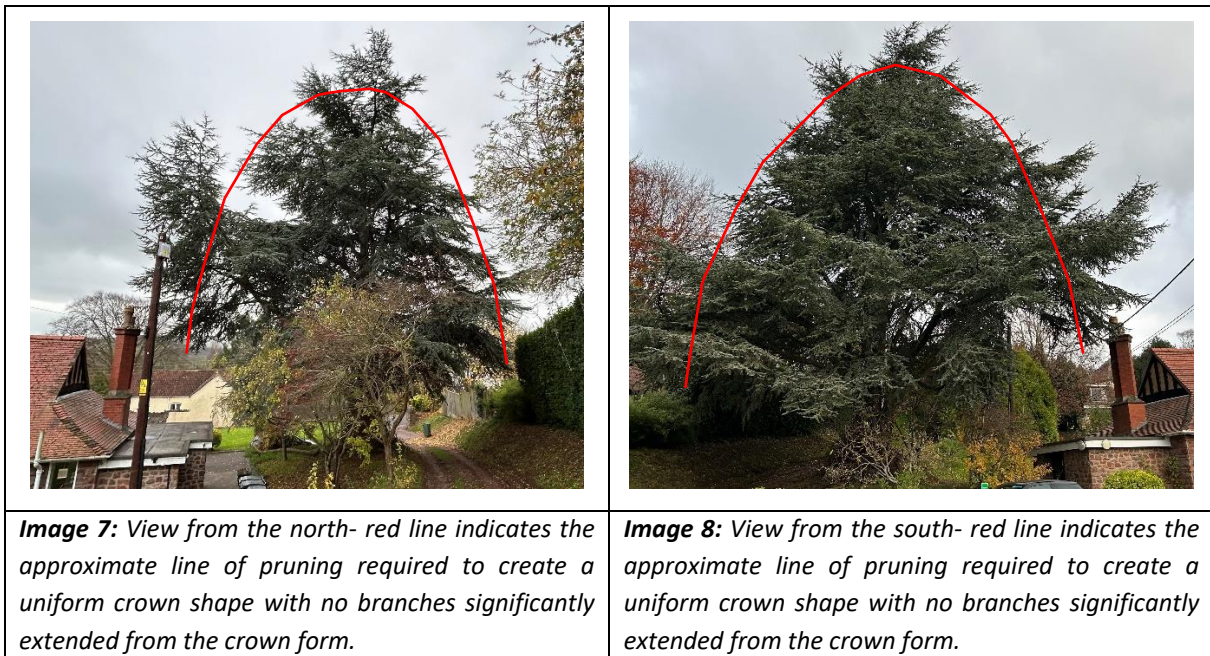
- 5.8 There are several branches around the remainder of the crown (images 7 and 8) that are also extended from the general crown form and subject to wind stress which could potentially cause failure, which would result in small diameter branches failing into the access roads to the south and west.

- 6.3 The exposed branches around the remainder of the crown have potential for failure but with less consequence than the branches to the east that overhang the building and electrical infrastructure. A minor reduction of extended branches to create a uniform crown shape will help to evenly dissipate wind stress and help prevent further branch failures as a result of high winds. Images 09 and 10 below are an approximate indication of where pruning will be necessary to produce a uniform crown shape. This is an indication only and the exact location of pruning cuts will have to be determined by a skilled climbing arborist.

- 7.1 Reduce 3 x extended and exposed lateral limbs to the east by 3-4 metres to create a uniform crown shape as feasible.
- 7.2 Reduce all limbs extended from the crown form around the remainder of the crown by 1-2 metres to create a uniform crown shape as feasible.
- 7.3 Reduce height by 2 metres.
- 7.4 Tree works must be carried out by reputable, skilled and insured tree work contractors working in accordance with the guidance contained within BS3998: 2010 Recommendations for Tree Work. A list of contractors approved by the Arboricultural Association can be found at the following link: <https://www.trees.org.uk/ARB-Approved-Contractor-Directory>
