**APPENDIX B**  
**CK CONSULTING AND GEOTECHNICAL LIMITED**  
**GEOTECHNICAL REPORT ON GROUND CONDITIONS**  
**NOVEMBER 2022**

The subject site is located at 15 Gordon Close, Sandown, Isle of Wight and comprises a detached bungalow with garden areas to the north and south of the property. The building has undergone movement causing cracking of external and internal walls, over the entire property, of varying magnitude. A ground investigation was requested by the appointed consultant engineer, Frankham Consultancy Group Ltd, to provide information on the ground conditions underlying the site, existing foundation type and likely cause(s) of building movement.

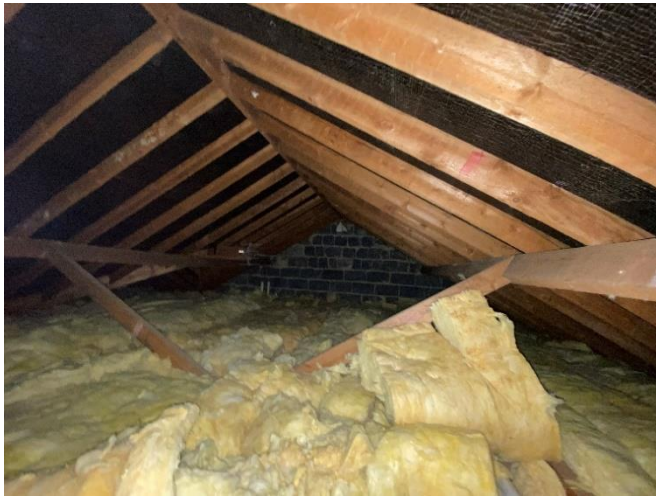
*Photo 85: Roof space above the main property*

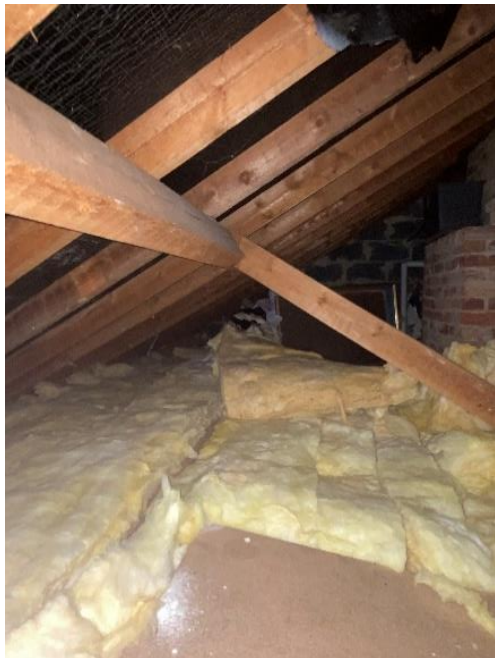
*Photo 87: Roof space above the main property*

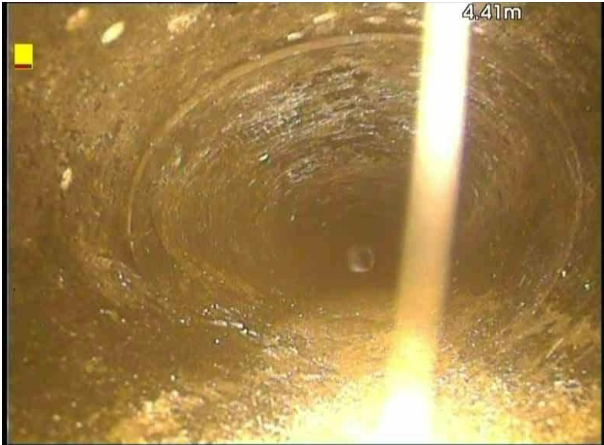
Sec\_5\_Insp\_1\_MH3X\_36059.jpg, 00:01:28, 4.41 m  
Deformed sewer or drain, 30%
