Asbestos Refurbishment Survey

**Ashfield House
West Nottinghamshire College
Chesterfield Road
Mansfield
NG19 7BB**

AA Projects Limited

Project Number:	Survey Date:	Issue Date:
B-36548	08 April 2022	22 April 2022

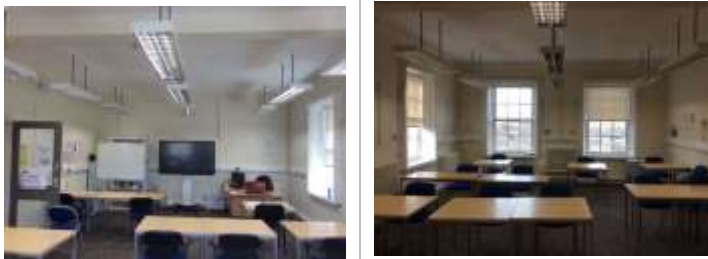
1st Floor	<p>101 Classroom</p> <p>Refurbishment Note: New suspended ceiling and lighting. Decoration. New carpets. New windows.</p> <p>Lath and plaster ceilings. Solid walls. Wood floor beneath carpet. Wood window casings and frames.</p>

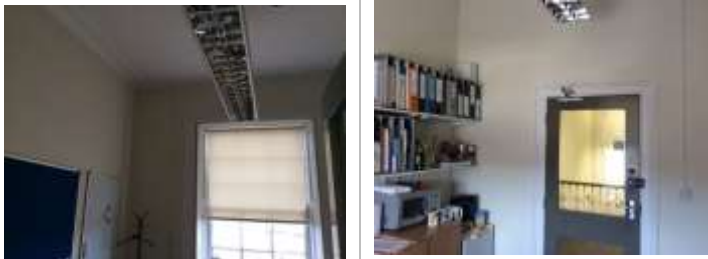
1st Floor	<p>102 Office</p> <p>Refurbishment Note: New suspended ceiling and lighting. Decoration. New carpets. New windows.</p> <p>Lath and plaster ceilings. Solid walls. Wood floor beneath carpet. Modern electrics. Wood window casings and frames.</p>

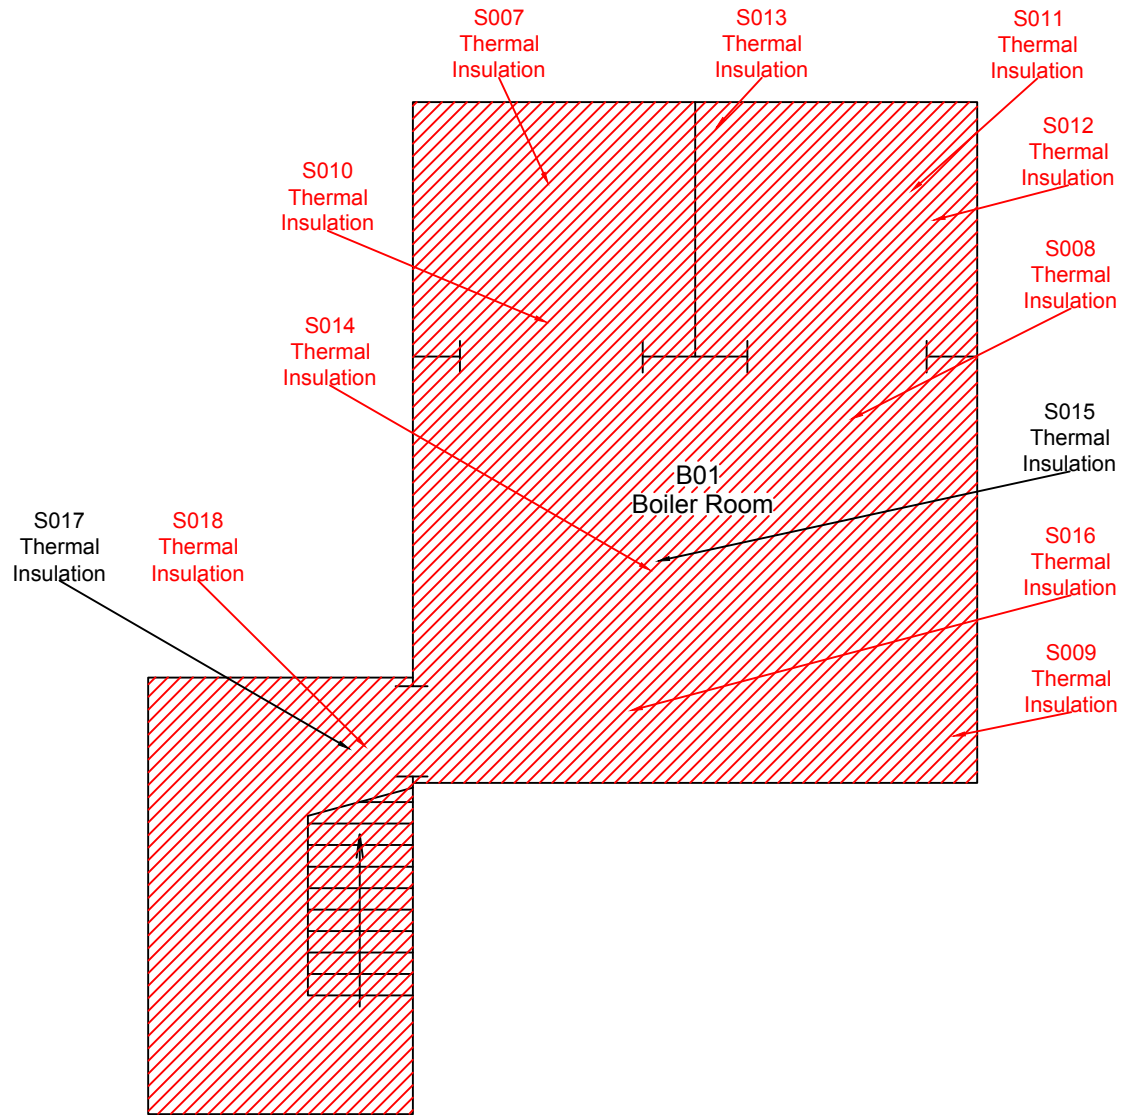
Ashfield House - Basement

Ashfield House	Basement	B01 - Boiler Room	Insulation to pipework within left hand chamber to back wall. Room Area approx 50m²	Easy	3	3	3	Amosite, Chrysotile	1 Lin M	16	Remove / Urgent Restrict Access
Ashfield House	Basement	B01 - Boiler Room	Insulation residues to pipework over boiler. Room Area approx 50m²	Easy	3	3	3	Amosite	10 Lin M	17	Remove / Urgent Restrict Access
Ashfield House	Basement	B01 - Boiler Room	Corrugated paper insulation to pipework through ceiling rear of boiler. Room Area approx 50m²	Easy	3	3	3	Chrysotile	1 Lin M	15	Remove / Urgent Restrict Access

Building	Floor	Room	Description	Accessibility	Product Type	Damage Extent	Surface Treatment	Analysis Result	Quantity	Risk Score	Action
Ashfield House	Basement	B01 - Boiler Room	Insulation debris to floor within left hand chamber entrance. Room Area approx 50m²	Easy	3	3	3	Amosite, Chrysotile	50 m ²	18	Remove / Urgent Restrict Access
Ashfield House	Basement	B01 - Boiler Room	Insulation debris to walls within RH chamber. Presumed throughout boiler room. Room Area approx 50m²	Easy	3	3	3	Amosite	50 Lin M	18	Remove / Urgent Restrict Access
Ashfield House	Basement	B01 - Boiler Room	Insulation debris to walls within RH chamber. Presumed throughout boiler room. Room Area approx 50m²	Easy	3	3	3	Amosite, Chrysotile	50 m ²	18	Remove / Urgent Restrict Access
Ashfield House	Basement	B01 - Boiler Room	Corrugated paper insulation to pipework through wall penetration. Room Area approx 50m²	Easy	3	3	3	Chrysotile	1 Lin M	15	Remove / Urgent Restrict Access
