Asbestos Demolition Survey

**Art Building
West Nottinghamshire College
Chesterfield Road
Mansfield
NG19 7BB**

AA Projects Limited

Project Number:	Survey Date:	Issue Date:
B-36461s2	28 June 2022	04 July 2022

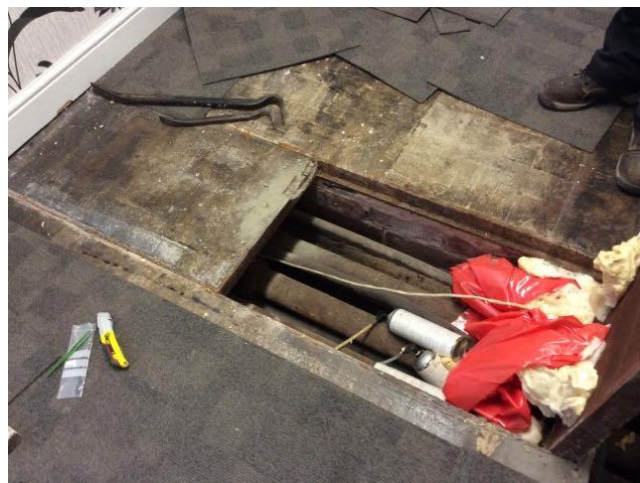
Building	Art Building
Floor	Ground Floor
Room	C02 - Corridor
Description	Insulation debris to pipework and throughout in floor trench across corridor. Continues into Room 130 Study Room
Sample Reference	S038
Quantity	2 m ²
Accessibility	Difficult

Analysis Result	Amosite, Chrysotile, Crocidolite	3
Product Type	Thermal Insulation	3
Condition	High Damage	3
Surface Treatment	Enclosed Insulation	1

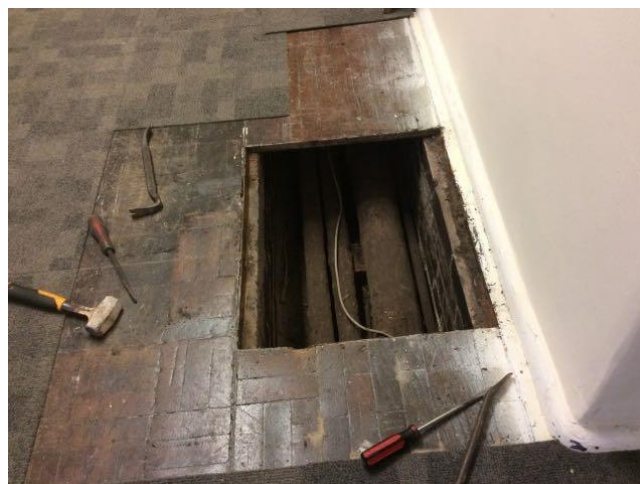
Building	Art Building
Floor	Ground Floor
Room	C02 - Corridor
Description	Insulation to pipework and debris within floor trench throughout
Sample Reference	S039
Quantity	25 m ²
Accessibility	Difficult

Analysis Result	Chrysotile	1
Product Type	Thermal Insulation	3
Condition	High Damage	3
Surface Treatment	Enclosed Insulation	1

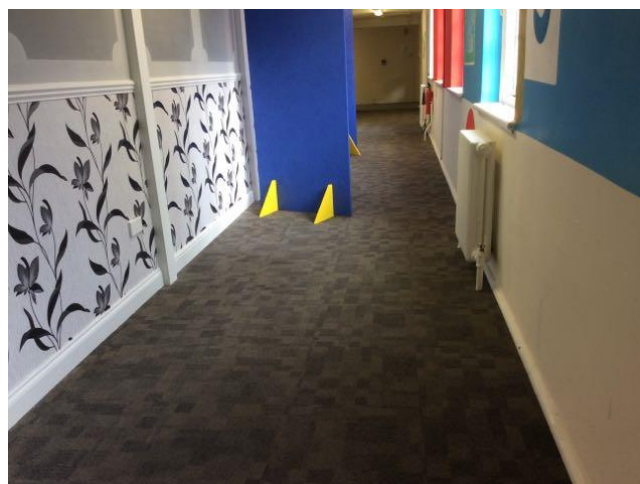
Building	Art Building
Floor	Ground Floor
Room	C02 - Corridor
Description	Resin panels to floor beneath carpet
Sample Reference	Ref S005
Quantity	100 m ²
Accessibility	Medium

Analysis Result	No Asbestos Detected	0
Product Type	Resin	1
Condition	Good Condition	0
Surface Treatment	Composite (Self Sealed)	0

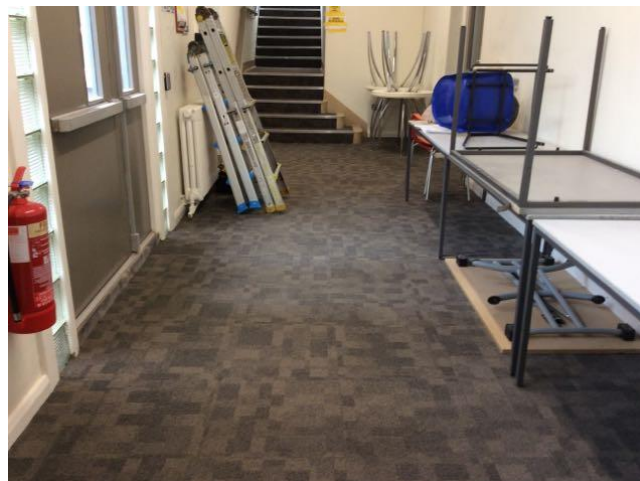
Building	Art Building
Floor	Ground Floor
Room	C03 - Corridor
Description	Bitumen adhesive beneath carpet tiles and screed
Sample Reference	S015
Quantity	20 m ²
Accessibility	Difficult

Analysis Result	Chrysotile	1
Product Type	Bitumen	1
Condition	Good Condition	0
Surface Treatment	Composite (Self Sealed)	0

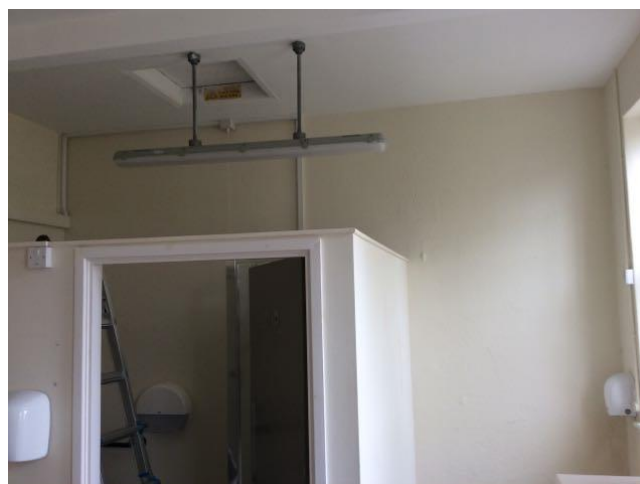
Building	Art Building
Floor	Ground Floor
Room	MWC1 - Male WC
Description	Textured coating to part walls
Sample Reference	S014
Quantity	16 m ²
Accessibility	Easy

Analysis Result	Chrysotile	1
Product Type	Textured Coating	1
Condition	Good Condition	0
Surface Treatment	Composite (Self Sealed)	0

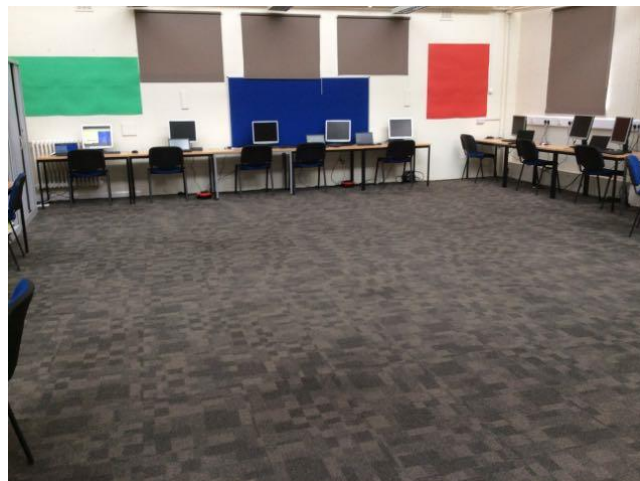
Building	Art Building
Floor	1st Floor
Room	144 - Classroom
Description	Bitumen adhesive to solid floor beneath carpet tiles
Sample Reference	S001
Quantity	93 m ²
Accessibility	Medium

Analysis Result	Chrysotile	1
Product Type	Bitumen	1
Condition	Good Condition	0
Surface Treatment	Composite (Self Sealed)	0

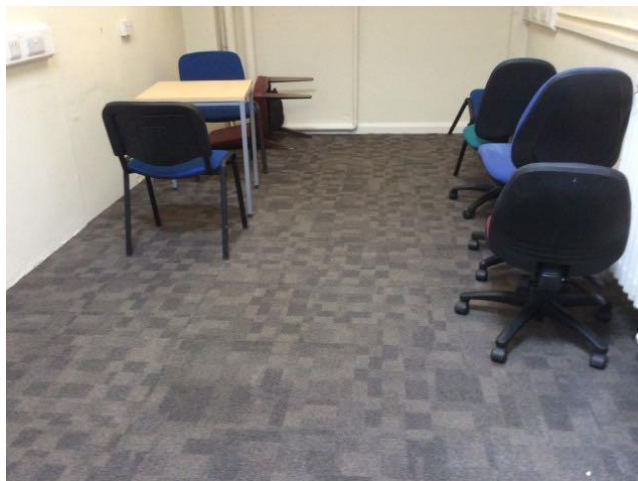
Building	Art Building
Floor	1st Floor
Room	144a - Store
Description	Vinyl sheet beneath carpet and screed
Sample Reference	S003
Quantity	19 m ²
Accessibility	Medium

Analysis Result	No Asbestos Detected	0
Product Type	Vinyl	1
Condition	Good Condition	0
Surface Treatment	Composite (Self Sealed)	0

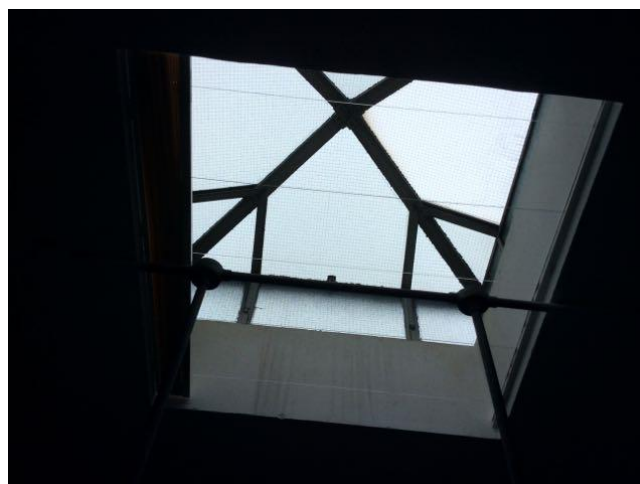
Building	Art Building
Floor	1st Floor
Room	144a - Store
Description	Mastic seals to skylights
Sample Reference	Ref S002
Quantity	4 m ²
Accessibility	Medium

Analysis Result	Chrysotile	1
Product Type	Mastic	1
Condition	Good Condition	0
Surface Treatment	Composite (Self Sealed)	0

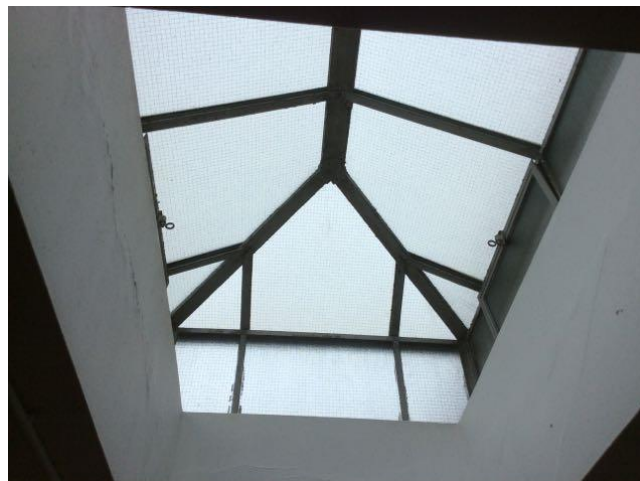
Building	Art Building
Floor	1st Floor
Room	144b - Store
Description	Mastic seals to skylight
Sample Reference	S002
Quantity	2 m ²
Accessibility	Medium

Analysis Result	Chrysotile	1
Product Type	Mastic	1
Condition	Good Condition	0
Surface Treatment	Composite (Self Sealed)	0

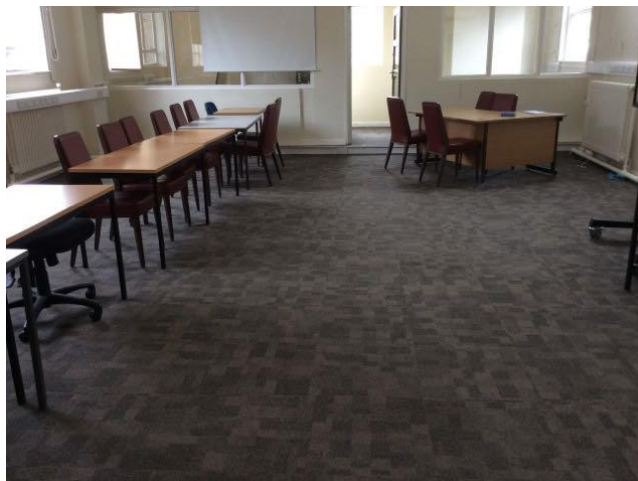
Building	Art Building
Floor	1st Floor
Room	145 - Classroom
Description	Bitumen adhesive to solid floor beneath carpet tiles
Sample Reference	Ref S001
Quantity	80 m ²
Accessibility	Medium

Analysis Result	Chrysotile	1
Product Type	Bitumen	1
Condition	Good Condition	0
Surface Treatment	Composite (Self Sealed)	0

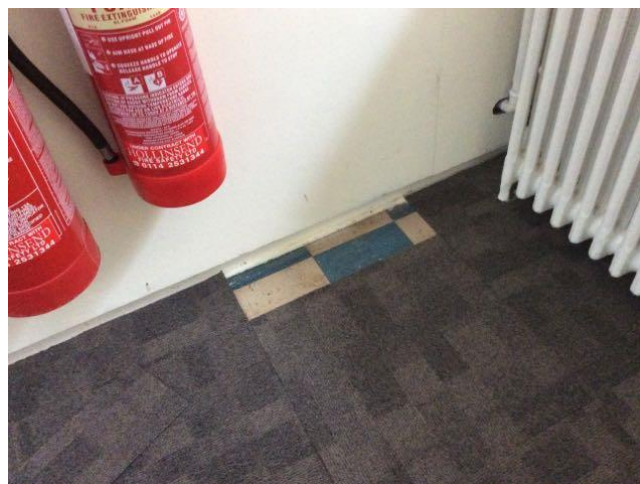
Building	Art Building
Floor	1st Floor
Room	L02 - Stair Lobby
Description	White and blue floor tiles and adhesive beneath carpet to upper area
Sample Reference	S004
Quantity	4 m ²
Accessibility	Medium

Analysis Result	Chrysotile (Tile and Bitumen)	1
Product Type	Thermoplastic Tiles & Bitumen Adhesive	1
Condition	Good Condition	0
Surface Treatment	Composite (Self Sealed)	0

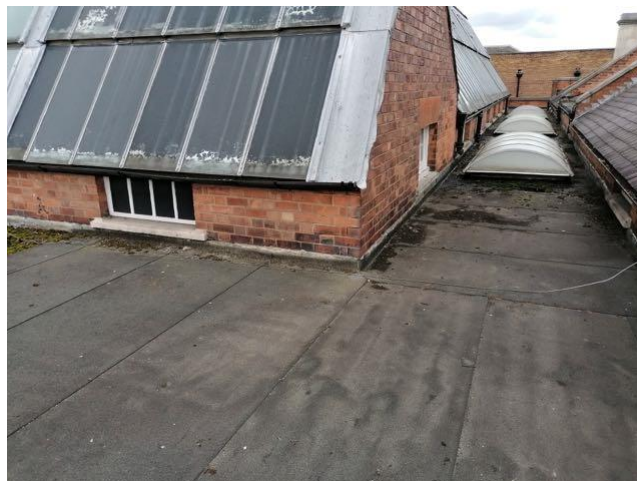
Building	Art Building
Floor	External
Room	99 - External
Description	Felt to flat roof areas
Sample Reference	S029
Quantity	150 m ²
Accessibility	Difficult

Analysis Result	No Asbestos Detected	0
Product Type	Felt	1
Condition	Good Condition	0
Surface Treatment	Composite (Self Sealed)	0

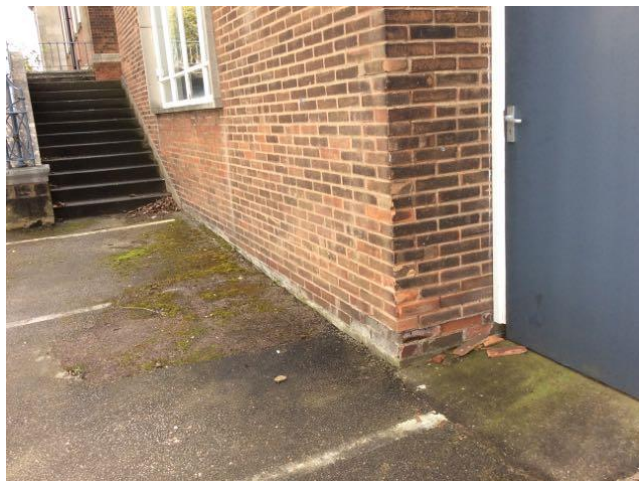
Building	Art Building
Floor	External
Room	99 - External
Description	Damp proof course to walls
Sample Reference	S030
Quantity	100 m ²
Accessibility	Difficult

Analysis Result	Chrysotile	1
Product Type	Felt	1
Condition	Good Condition	0
Surface Treatment	Composite (Self Sealed)	0

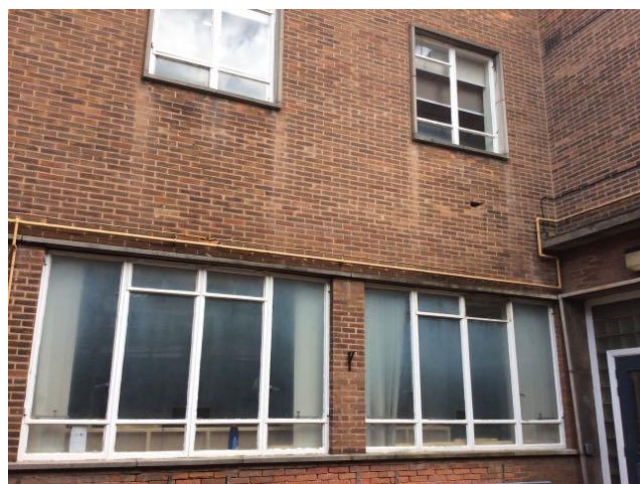
Building	Art Building
Floor	External
Room	99 - External
Description	Glazing putty to windows
Sample Reference	S031
Quantity	100 m ²
Accessibility	Difficult

Analysis Result	No Asbestos Detected	0
Product Type	Putty	1
Condition	Good Condition	0
Surface Treatment	Composite (Self Sealed)	0

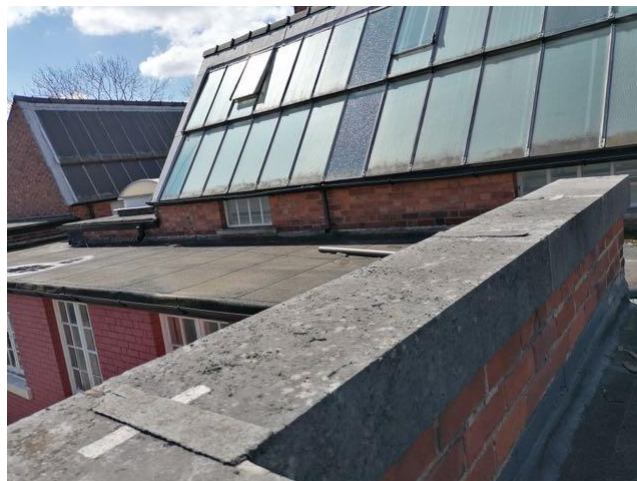
Building	Art Building
Floor	External
Room	99 - External
Description	Felt strips over coping stone joints to roof
Sample Reference	S032
Quantity	1 m ²
Accessibility	Difficult

Analysis Result	Chrysotile	1
Product Type	Felt	1
Condition	Good Condition	0
Surface Treatment	Composite (Self Sealed)	0
