Asbestos Refurbishment Survey

**BDU Building
West Nottinghamshire College
Chesterfield Road
Mansfield
NG19 7BB**

AA Projects Limited

Project Number:	Survey Date:	Issue Date:
B-36549	08 April 2022	22 April 2022

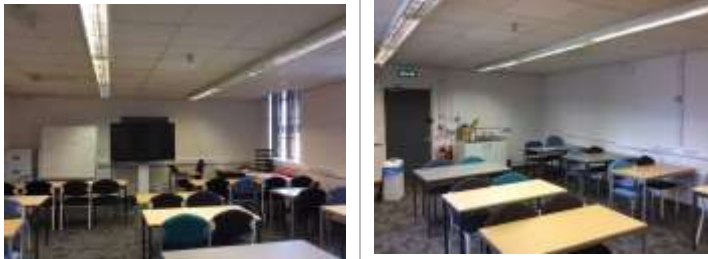
Building: BDU Building			
Location:	Construction Overview	Photos	
Ground Floor	<p>201 Classroom</p> <p>Refurbishment Note. New ceilings and lighting. Window replacement.</p> <p>MMMF ceiling tiles, wood panelling to underside of roof. plasterboard stud dividing wall. Brick walls to external. Solid floors. Metal window frames to brick walls. Floor trench accessed adjacent entry door.</p>
