## Additional 1

Document to support tpo application at 43 castle oak, Usk, NP151SG.

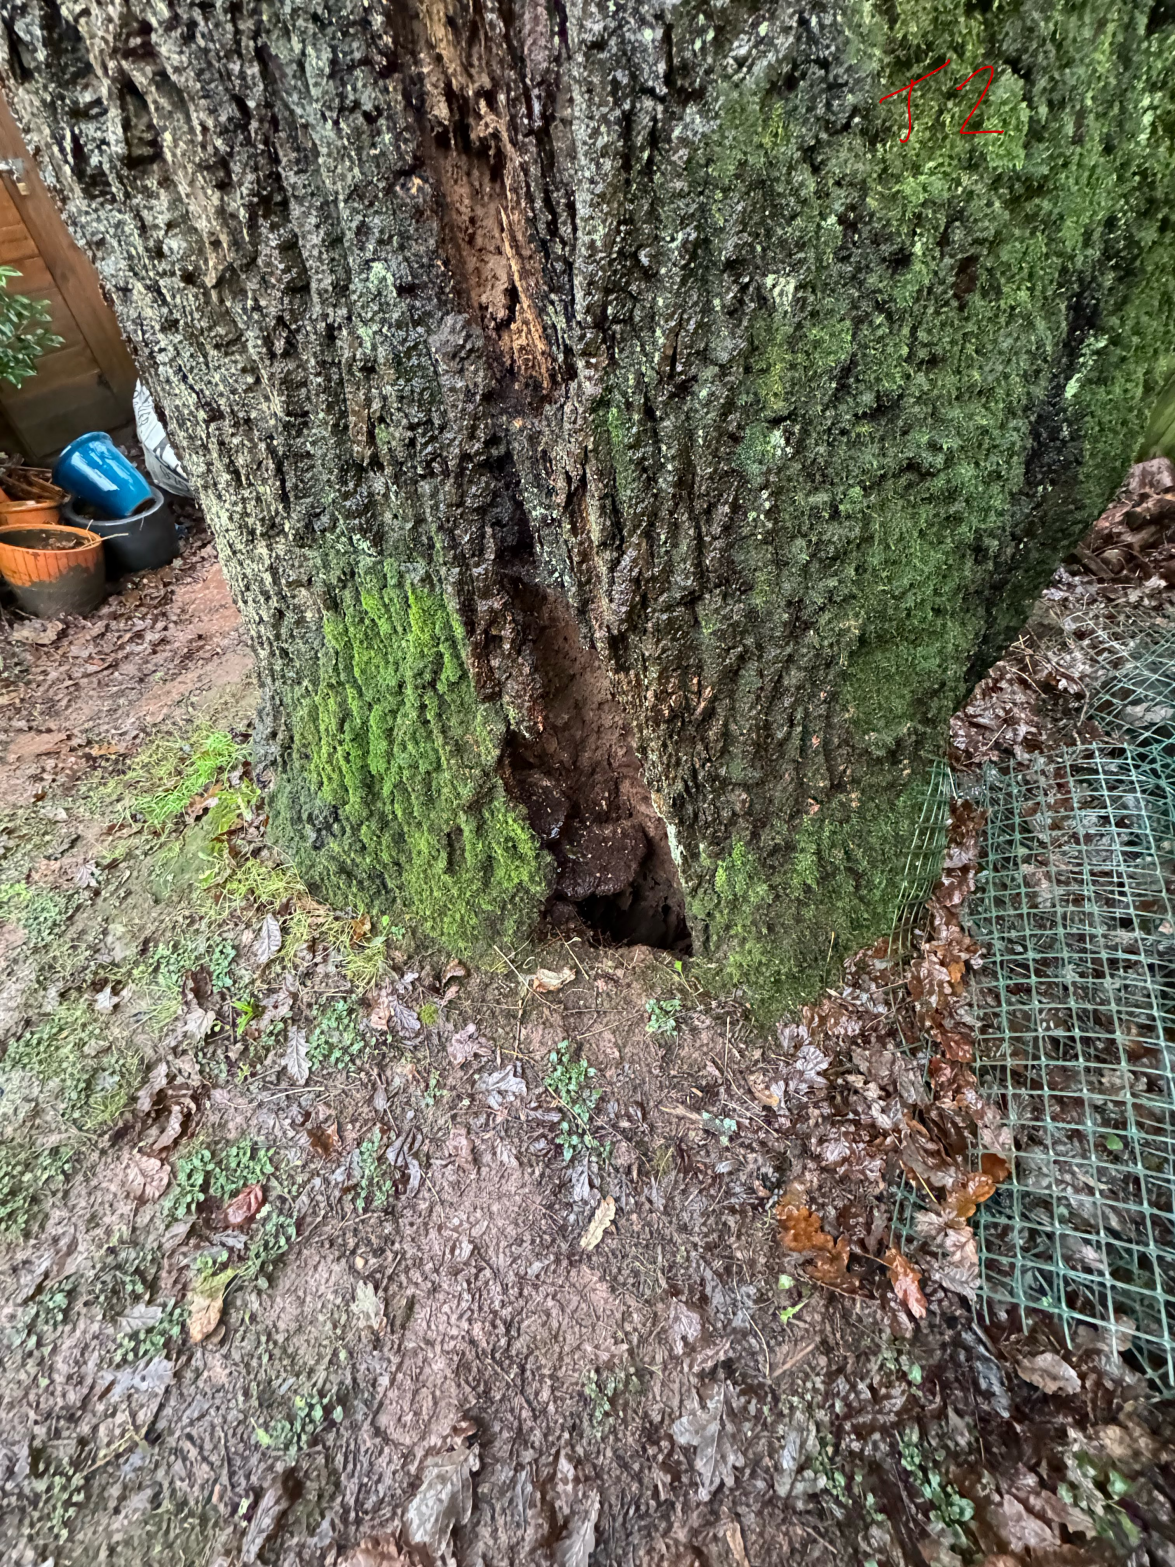
J2

T2 - Remove major deadwood, heavy lateral branch reduction. Slight decay forming at base to be observed periodically.
