Batchelor's Row, Christ Church Oxford

Structural Inspection of Roof Soffit

Prepared by: Ian Flewitt MEng MSc CEng MIStructE
Reviewed by: Stephen Williams MEng CEng MIStructE
Job Number: 29414

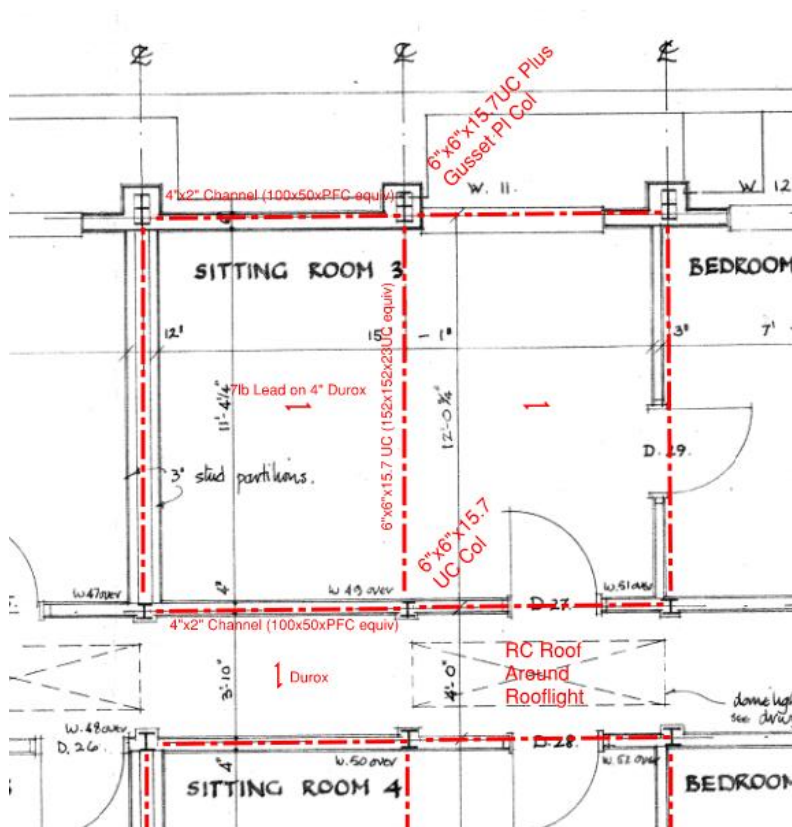
Figure 1 – Extract of Original Architect's Plan with Structure Overmarked

Record drawings show roof structure to consist of 7lb leadwork on 4" Durox (lightweight precast RAAC panels). The downstand beams spanning across rooms are shown as 6"x6"x15.7lb/ft UC sections, encased in concrete. These are supported on the equivalent section columns concealed within the corridor wall and a tapered column consisting of a 6"x6"x15.7lb/ft UC with a tapered gusset plate within the external walls. From the cross sections it appears that this tapered column transfers to via an RC corbel element to the original perimeter wall. There are no details of the reinforcement used. 4"x2" Channel sections run between columns perpendicular to the main beams, these act as tie beams, also supporting the corridor roof structure which spans the width of the corridor.

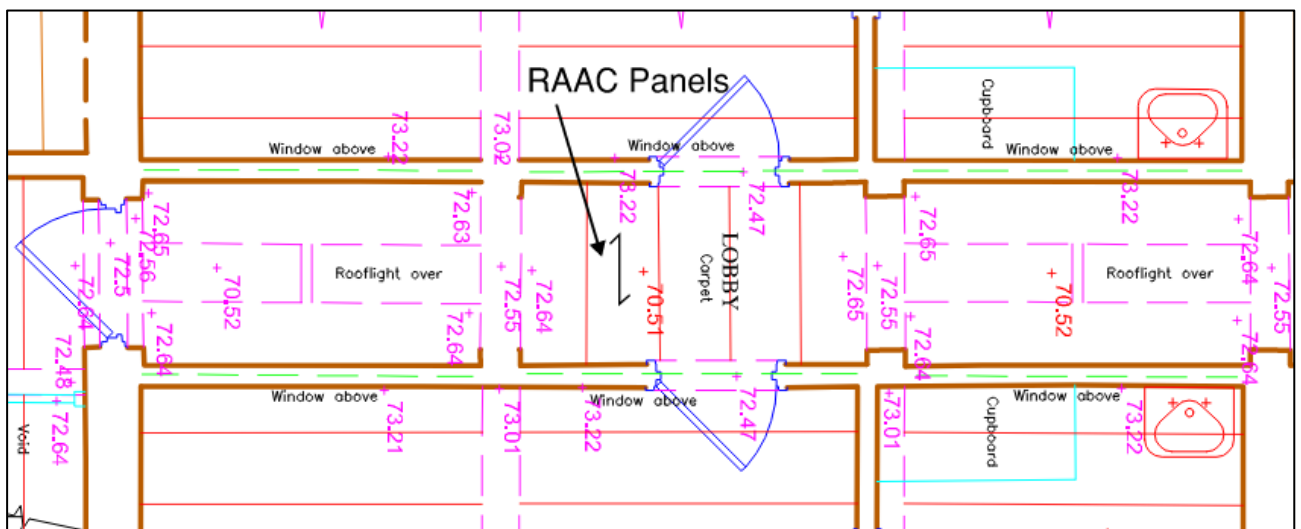
Figure 4- Corridor Soffit Arrangement (James Brennan Associates)

The corridor roof soffit is broken into bays, which correspond to the beam lines which run across the width of the building at approximately 2.15m centres. Alternate bays comprise linear rooflights spanning the length of the bay with a solid, assumed RC, infill either side. Intermediate bays comprise of RAAC panels spanning across the width of the corridor on to corridor wall lines. An extract from the James Brennan Associates survey below shows a typical section of corridor roof soffit. Photograph 1 shows a view from the southern end of the corridor.

Typically the corridor bays containing rooflights appear to be in good condition. An exception is the first bay when entering the corridor from the south. There is evidence of water ingress resulting in spalling plasterwork, most severely on the right side but also at the ends, see Photograph 2.

The intermediate bays formed using RAAC panels have a textured painted finish. There is little evidence of cracking within panels. There is very slight to slight cracking along the joint between adjacent panels, see Photograph 4. Joints are filled with a cement based mortar or plaster. The cracking is not thought to be significant, although over time there is a risk the joint fill will de-bond and fail resulting in spalling. There is a slight vertical misalignment between some panels however it is not known if this has been present since installation. The stepping in itself is not of concern given the apparent reasonable condition of the panels. There is no evidence of insufficient bearing or movement at bearing positions.

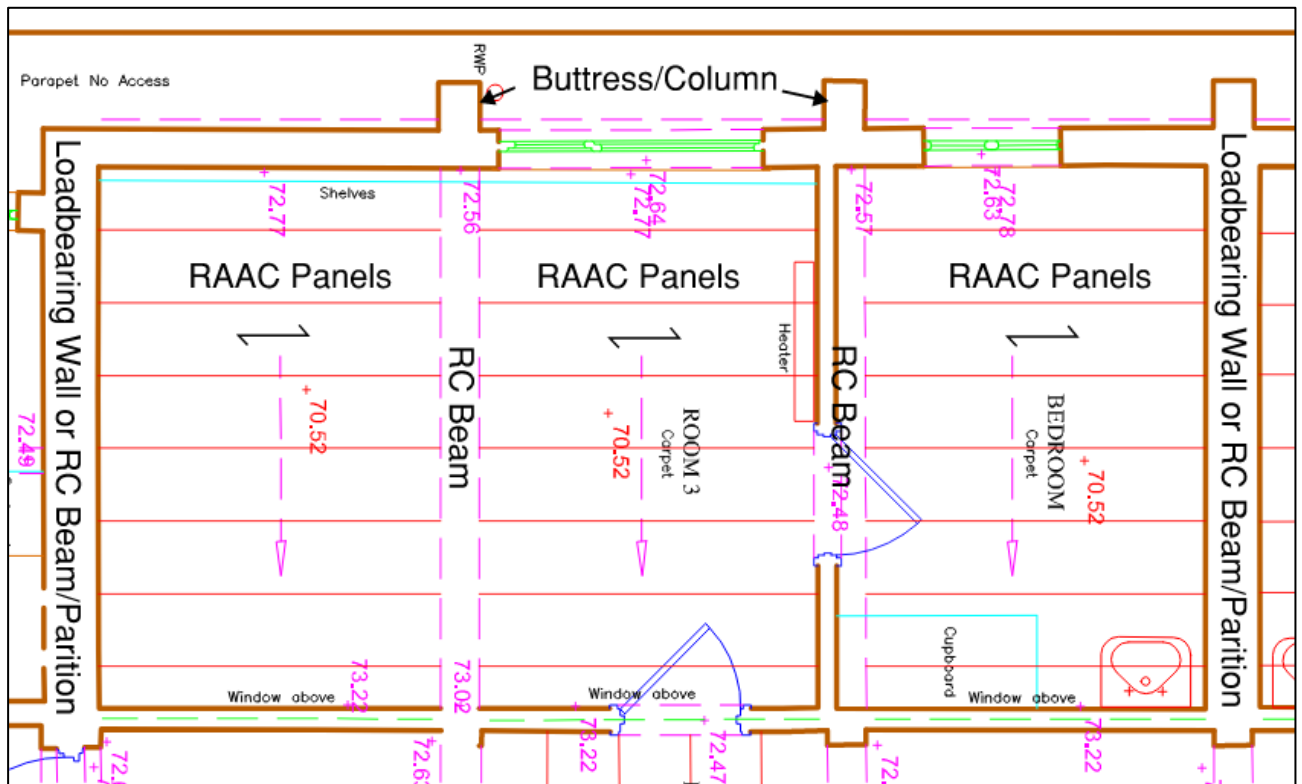
Figure 5- Typical Roof Structure Arrangement for Bedrooms (James Brennan Associates)

Bedrooms either side of the central corridor typically contain three bays of RAAC panels, spanning between party walls with two intermediate beams which run from the external wall to corridor wall, a typical panel arrangement is shown below in the extract of James Brennan Associates survey, Figure 5.

Many RAAC panels show fine cracks running perpendicular to span, these are usually reasonably well/evenly spaced along the panel's span, typically 4 to 6 cracks per panel. As the soffit of each panel is the tensile face of the panel it is unsurprising to see signs of this type of cracking, indeed most concrete beam and slab structures will crack in this way and it does not infer failure of the member.

The joints between panels have been filled with a plaster fillet. In many cases the joint is pronounced suggesting remedial repairs. In many cases there is a slight step between adjacent panels. The condition of these joints is variable, in some places the mortar is showing signs of de-bonding and in a few instances has failed

The bearing points of all panels appeared sound and there was no evidence of bearing failure or cracking around bearing positions. There was no sign of panels slippage on bearings. This suggests the panels have adequate bearing and sufficient reinforcement at the support, although this has not been verified by intrusive survey.
