Chestnut Cottage,  
Sheldons Lane,  
Hook,  
Hampshire,  
RG27 9LH

This report has been prepared along the guidance of B.S.5837:2012 the objective being to provide the case officer Miguel Martinez with information relating to the planning approval ref 21/00439/CON. Condition 7. This was issued in April 2021, With the main planning approval for the removal of the existing house and its replacement granted in February 2021.

Drawing  
 Tree Protection Plan (TPP)

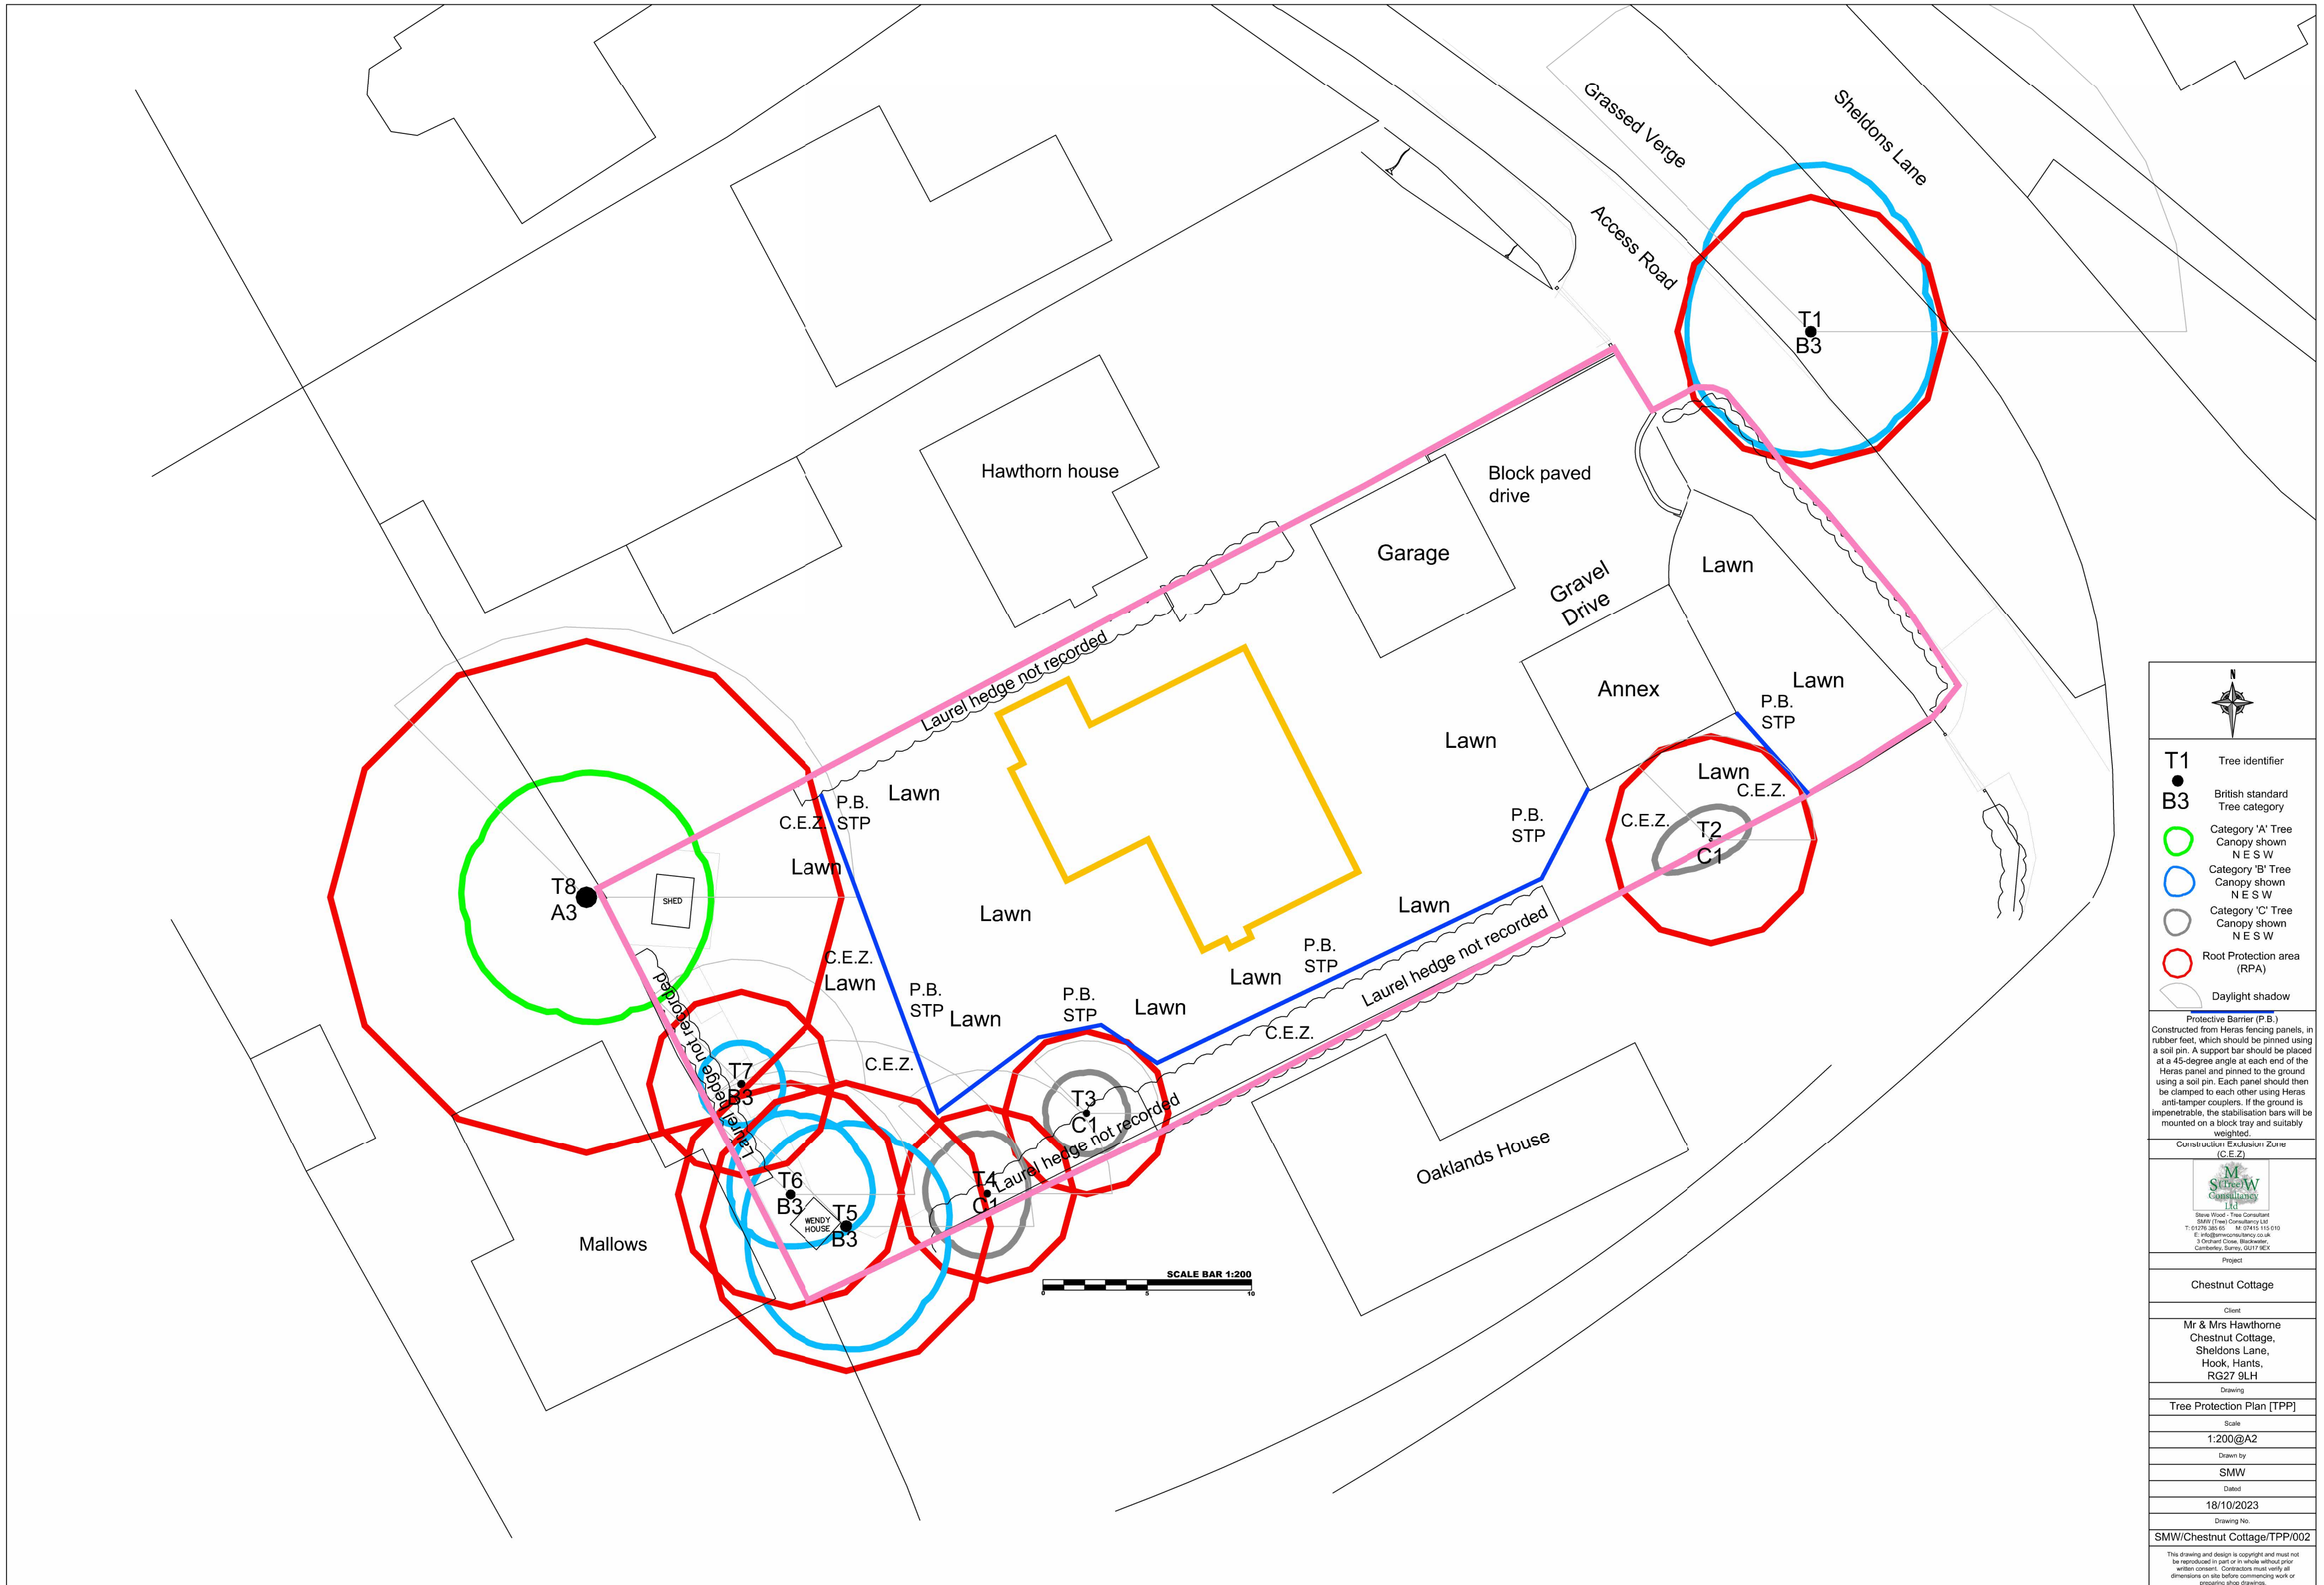
We have prepared from our own measurements, a new Tree Protection Plan. Then shown where our protective barriers would have been installed. There is a slight variation from Mr Honeys to ours , this is mainly due to our plan showing the correct RPA for all recorded trees. The main area of disparity is of considerable distance from the construction area, consequently this will not have resulted in any construction impingement.
