PROJECT DETAILS:
Monks Hall Refurbishment
Syleham
Eye, IP21 4LN

DRAWING REFERENCE:
Repair Details
Elevation 2 (North-East)

SCALE:	DATE:	DRAWN BY:	CHECKED BY:
As Noted A1	Oct 2023	DB	JF
PROJECT No:	DRAWING No:	REVISION:	
4289	R02	P1

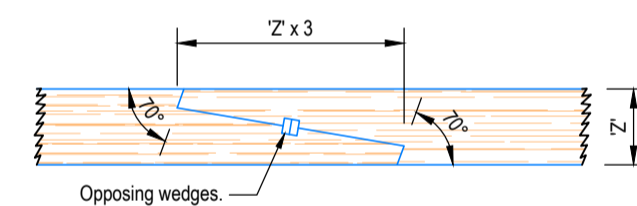
ELEVATION ON WEDGED SPLAYED SCARF JOINT

EXPLODED VIEW OF WEDGED SPLAYED SCARF JOINT
This detail to be used at eaves level ties requiring transfer of moments and compression/tension.
