PROJECT DETAILS:
Monks Hall Refurbishment
Syleham
Eye, IP21 4LN

DRAWING REFERENCE:
Repair Details
Elevation 1 (South-East)

SCALE:	DATE:	DRAWN BY:	CHECKED BY:
As Noted A1	Oct 2023	DB	JF
PROJECT No:	DRAWING No:	REVISION:	
4289	R01	P1

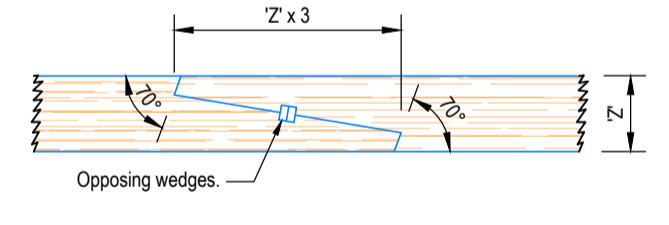
ELEVATION ON WEDGED SPLAYED SCARF JOINT

EXPLODED VIEW OF WEDGED SPLAYED SCARF JOINT
This detail to be used at eaves level ties requiring transfer of moments and compression/tension.
