Site Investigation Report

145660.1.USI

Brief	Auger were commissioned by Crawford & Co to undertake a site investigation and CCTV inspection of the underground drainage within the area of concern (AOC) at the property.
-------	--

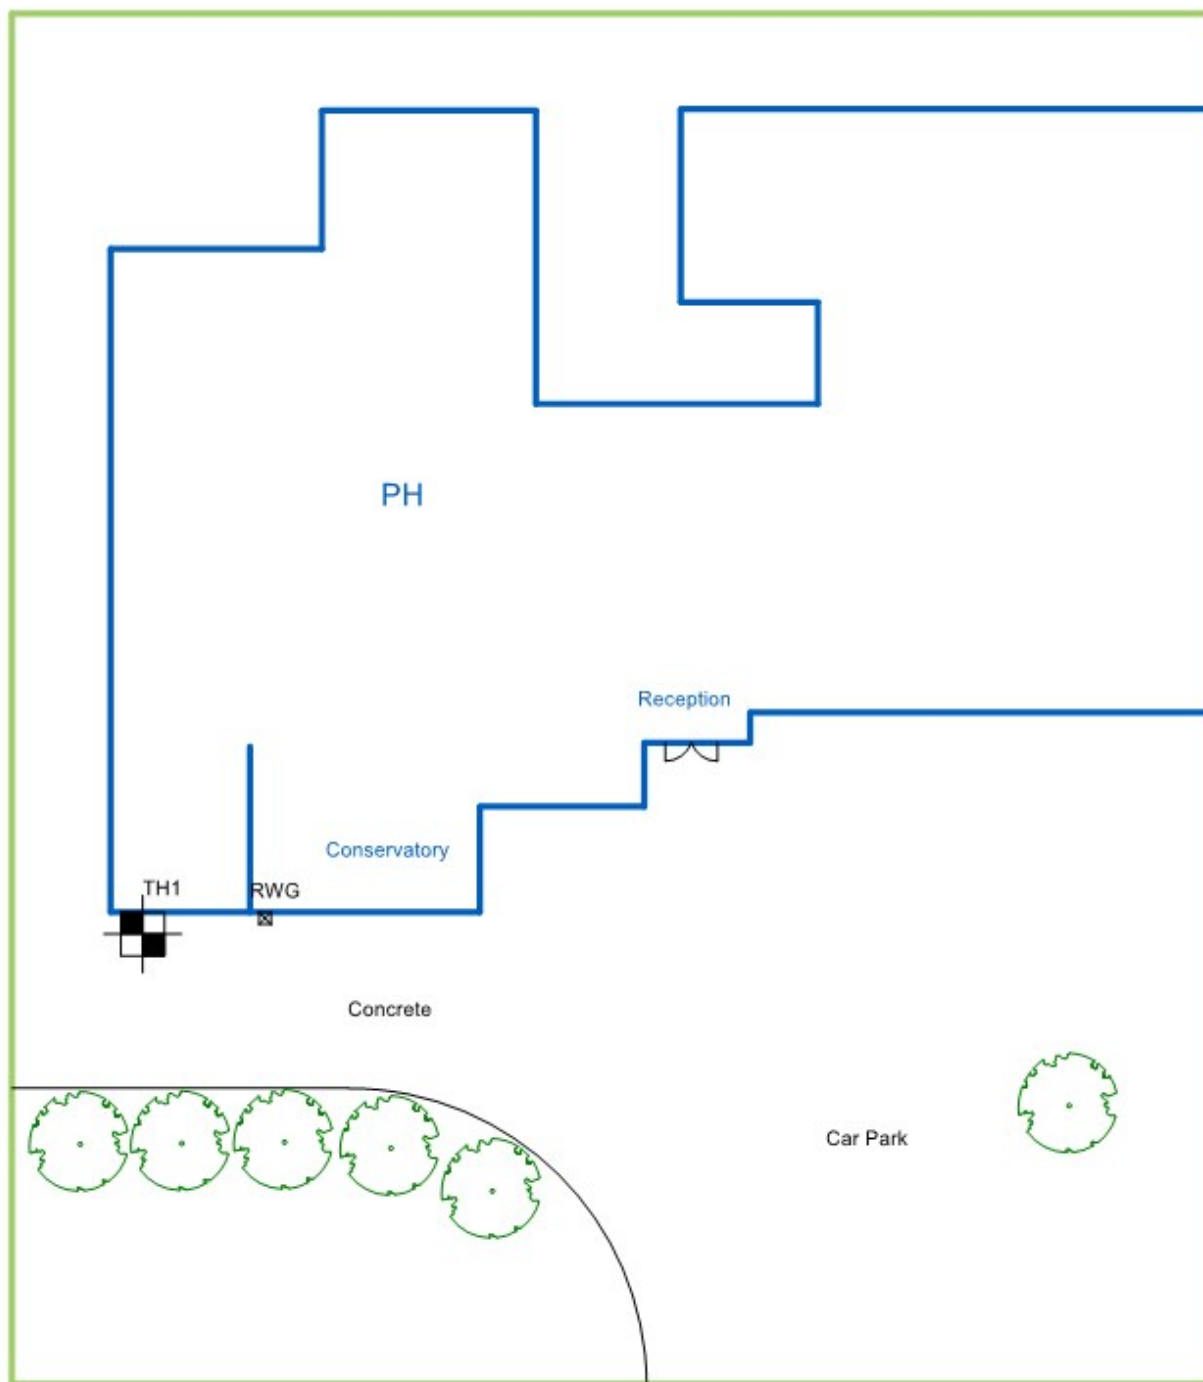
FRONT OF PROPERTY

Trial Hole Findings	TH1 was completed in the proposed location revealing the footing and taking soil and root samples.
Drain Survey	No CCTV survey of the underground drainage was undertaken whilst on site because the only drainage in the are of concern was a disused rainwater gully. This gully had an unusual raised design however had no guttering.

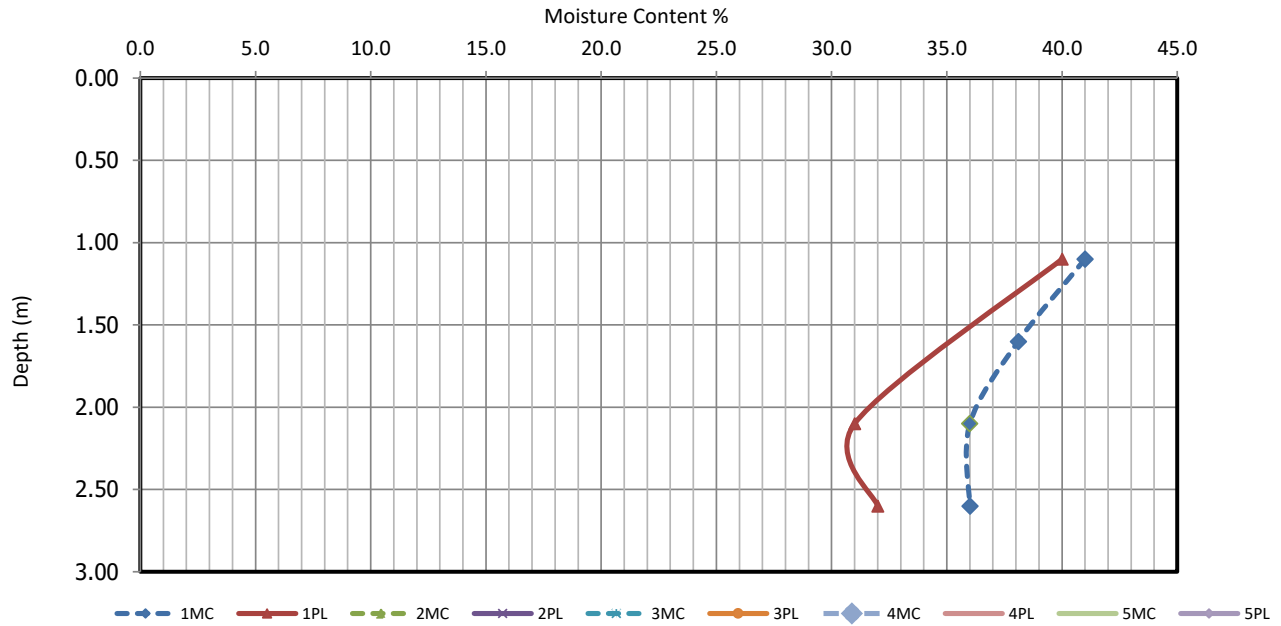
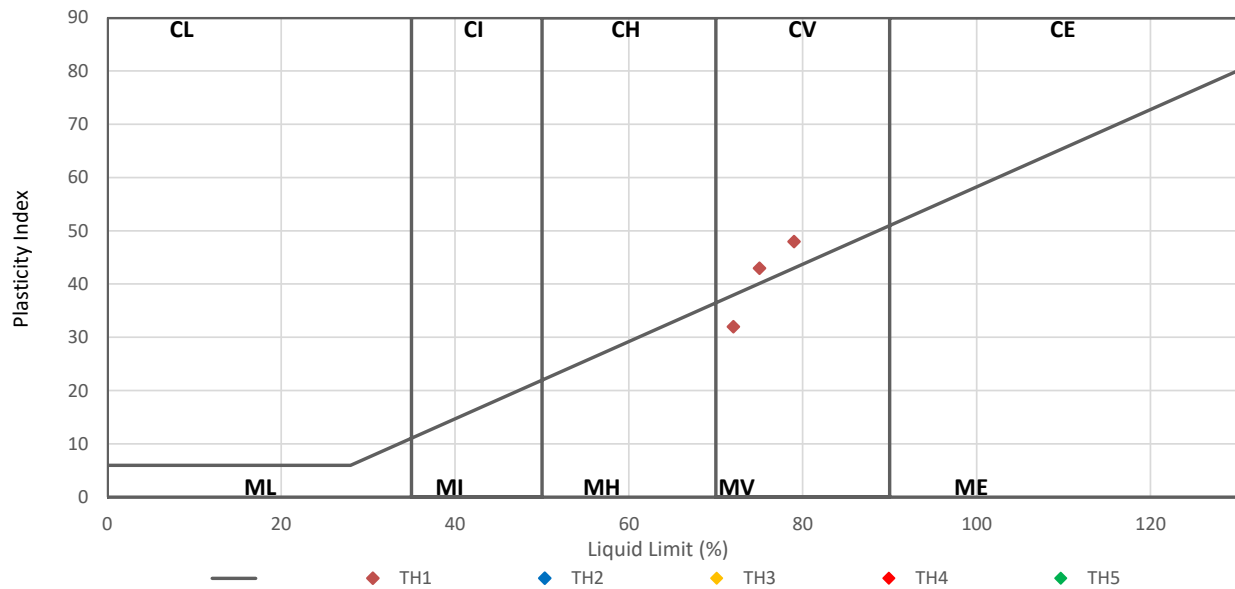
PLASTICITY CHART FOR CASAGRANDE CLASSIFICATION
BS 5930:1999+A2:2010

Modified Plasticity Index (PI) <10 : Non Classified
 Modified PI = 10 to <20 : Low volume change potential (LOW VCP)
 Modified PI = 20 to <40 : Medium volume change potential (Med VCP)
 Modified PI = 40 or greater : High volume change potential (HIGH VCP)
