The Old Crown, Weston Turville

Test panels conducted by Stewart Ivory for Lost Marble Conservation on 12th January 2024

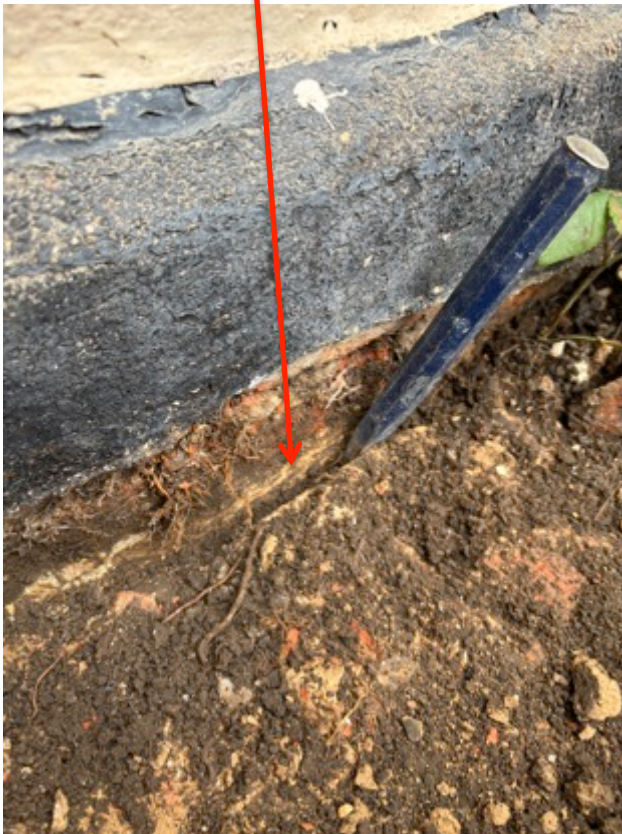
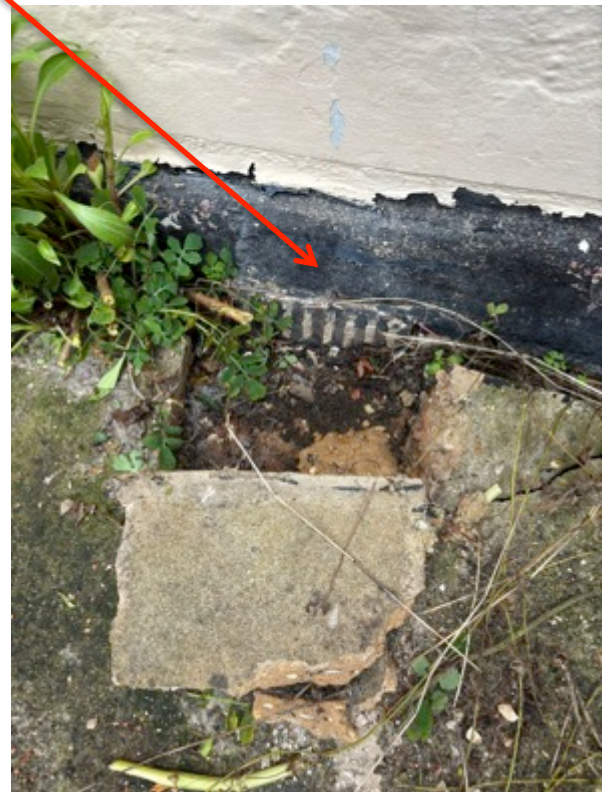
Front Test Panel #3

- Same single coat, very hard cement render
- Iron nails rendered over
- Cracks in render follow brick joints and not – as originally suspected – in line with timber frame
- Slate DPC is effective]
- Below DPC the brickwork is very damp
- The protruding plinth has evidence of an older skin of 2 inch thick render below ground level
- The plinth area is so damp it contains worms
- Concrete apron trapping moisture but not connected to the house wall
- Air brick found to be blocked with concrete and covered over by concrete apron

- Remove all the cement render to the front
- Remove all concrete apron – this may be enough to allow wall to dry out – there may be no need for French drain or even a small trench, just lower ground level and expose air bricks
- Consult with Conservation Officer to decide upon wall covering:
- 1. If the brick panels are all in a good condition use 4 coats of traditional hotmixed lime wash
- 2. If bricks not in suitable condition to be exposed, then 2no. coats of lime render

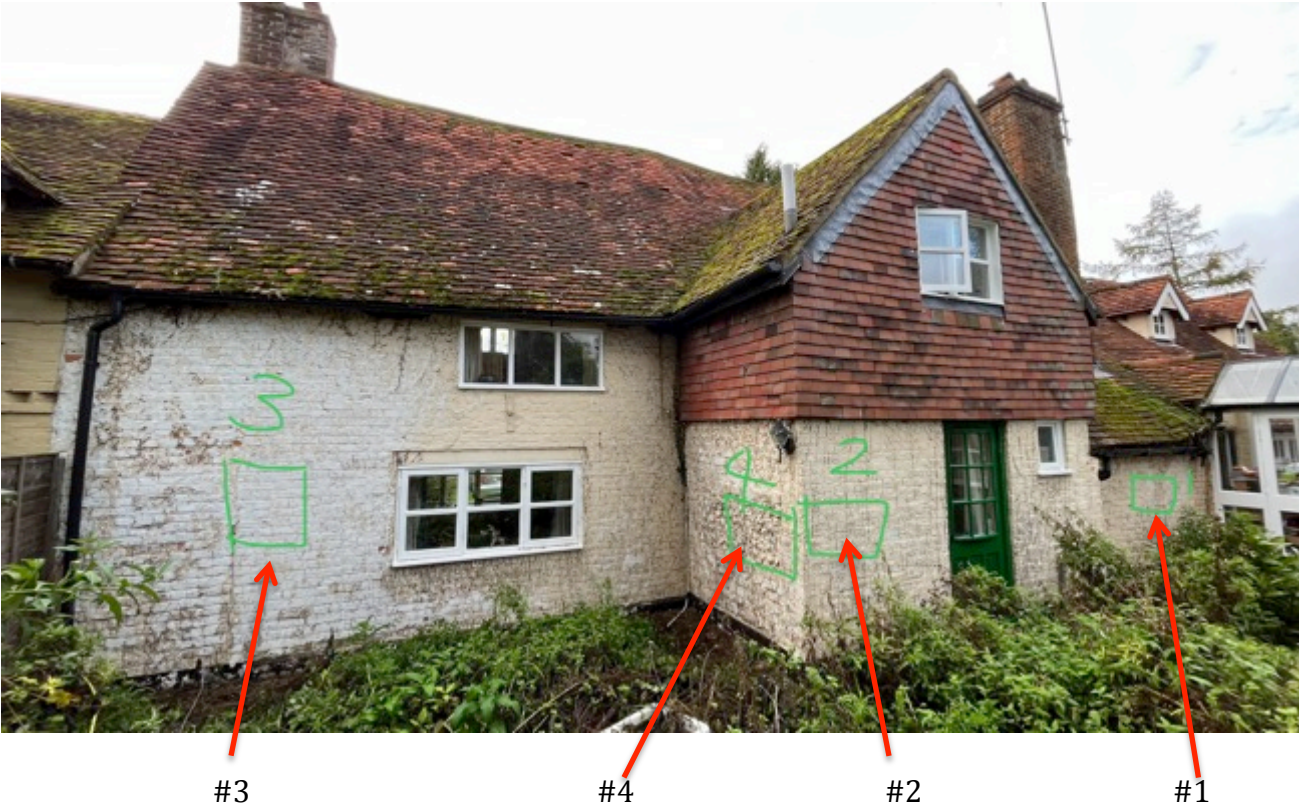
The Old Crown, Rear Test Panels - DOFF paint removal

All test panels subjected to 2no. applications of Paint-Rid™ – first coat left over night, second coat left for a few hours dwell time.

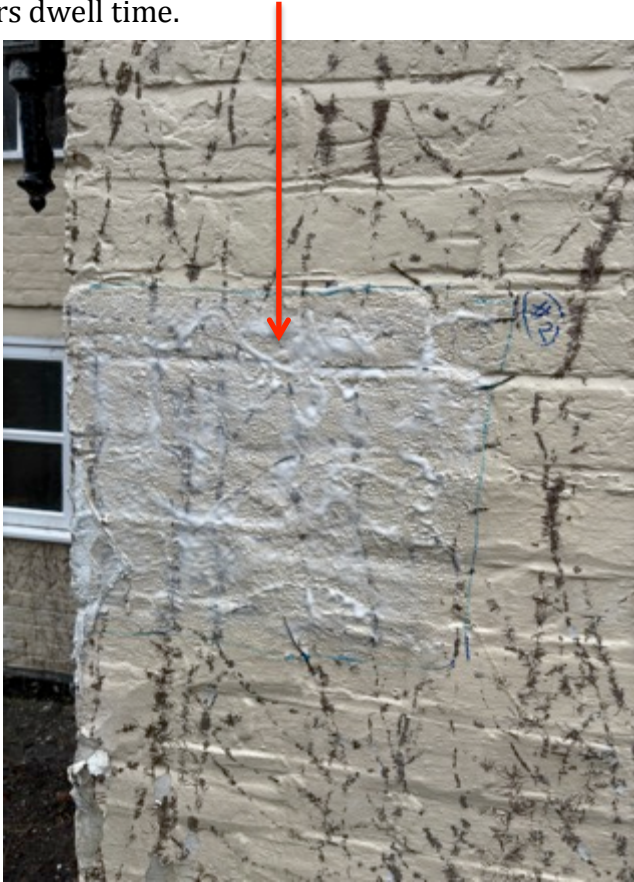
- All test panels subjected to super heated water at 150°C and at 40 bar pressure using the DOFF™ system to remove modern masonry paint:

- DOFF removed the plastic paint with ease, causing zero damage to the brickwork
- DOFF exposed areas that had previously been lime washed and, as seen above, areas that were added to the building after lime washing was the traditional coating
- The flint and brick test panel #4 was lime washed – an extensive build up of historical lime wash is evident
- Other areas around the base of the single story barn revealed cement pointing, trapping damp within the brick plinth of the barn. This – and other modern materials in conjunction, is causing failure of the wall coatings inside (gypsum and modern paints) caused primarily by damp trapped within.
