DESIGN, ACCESS & HERITAGE STATEMENT

Peverells, Tye Green, Glemsford, Suffolk CO10 7RQ (Ref:
53781)

January 2024

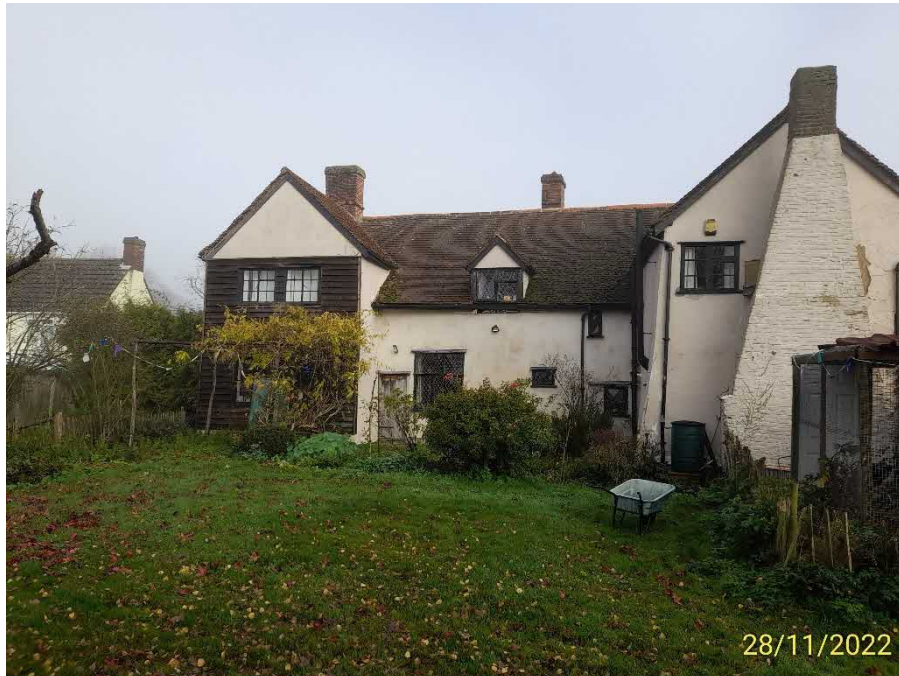
- 2.5 There are four brick-built chimney stacks to the property serving fireplaces to internal areas. The chimney stack in question as part of this application is to the rear of the south-east cross wing as indicated below.

Fig 2: Rear (southwest) Elevation of Peverells with the chimney stack to the right
