**CCTV REPORT FOR: 48 GWENDOLINE DRIVE
COUNTESTHORPE
LEICESTERSHIRE
LE8 5SE**

Site Visit: 17-Jan-23
Report Date: 28-Mar-23

Brief:	The Drainage Repair Company Ltd were commissioned to undertake a CCTV survey / inspection of the drainage at the property.
Specific Area of Interest:	Accessible drainage at the rear right of the property.
System Access:	Inspection chamber to rear right.
Visual Survey:	N/A
Water Pressure Test:	No

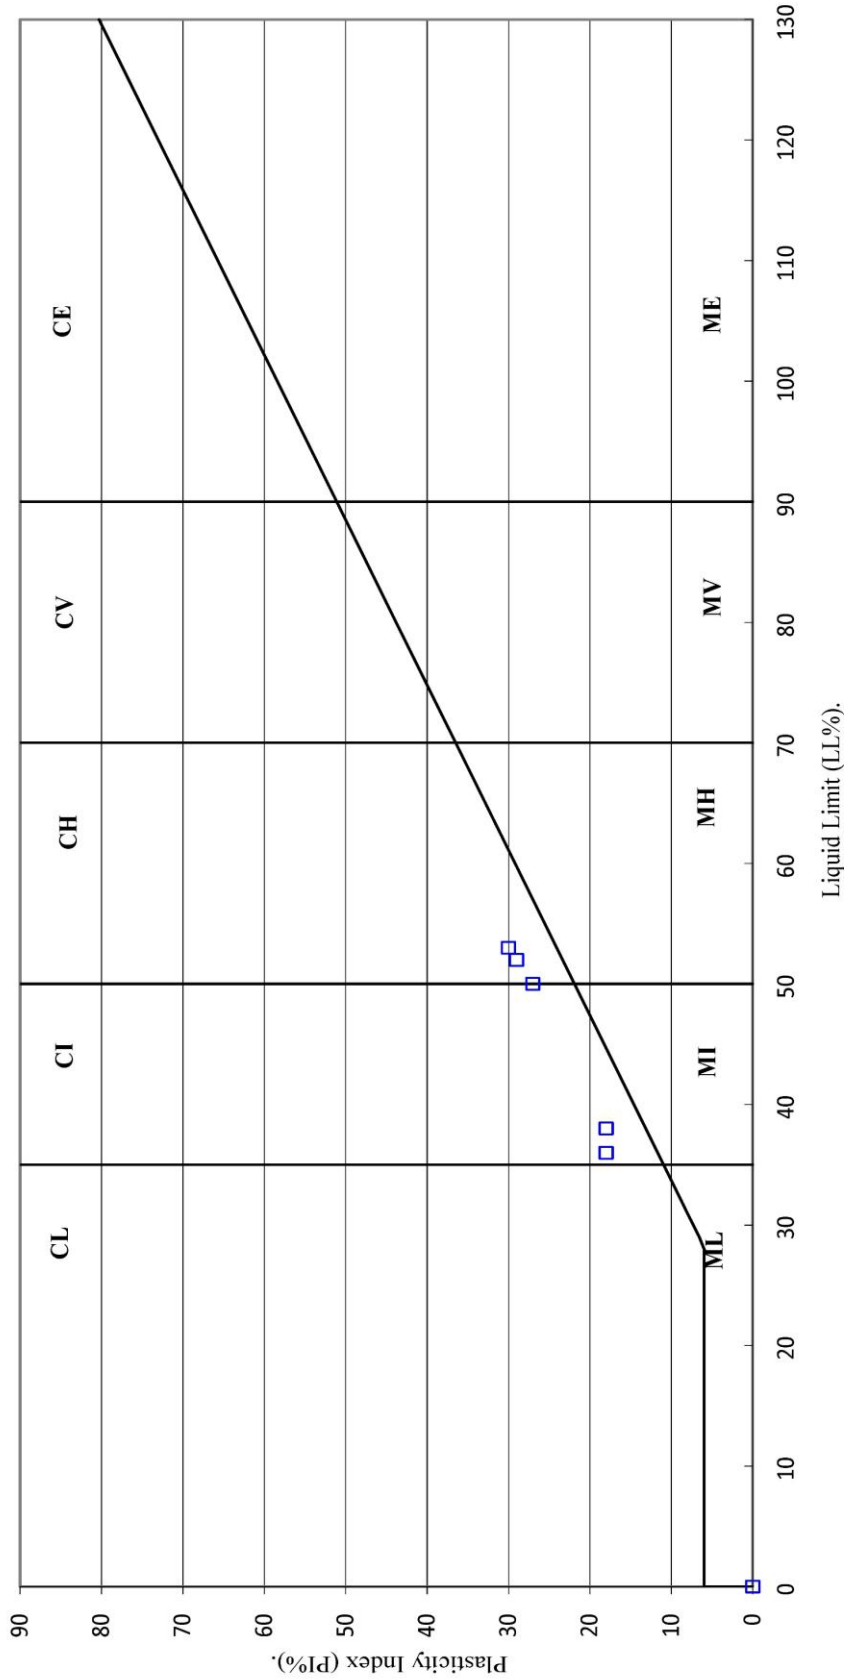
T/H2

Hole Number	Sample Number	Sample Type	Top Depth m	Base Depth m	Moisture Content % Clause 3.2	Linear Shrinkage % Clause 6.5	Particle Density Mg/m ³ Clause 8.2	Liquid Limit % Clause 4.3/4	Plastic Limit % Clause 5.3	Plasticity Index % Clause 5.4	Passing .425mm %	Remarks
TP/BH2			0.40	1.40	19			38	19	19	91	Intermediate Plasticity CI
TP/BH2			1.40	2.40	20			37	18	19	92	Intermediate Plasticity CI
TP/BH2			2.40	3.40	21			50	23	27	96	High Plasticity CH
TP/BH2			3.40	4.40	21			52	23	29	95	High Plasticity CH
TP/BH2			4.40	5.00	21			51	23	28	96	High Plasticity CH
