BS: 5837:2012 paragraphs relevant to Arboricultural Report, The Bull, Langley, Essex.

Conversion of Nissen Hut, Garage Out-building, Associated Landscaping and New/Revised Vehicle Access & Parking Layouts

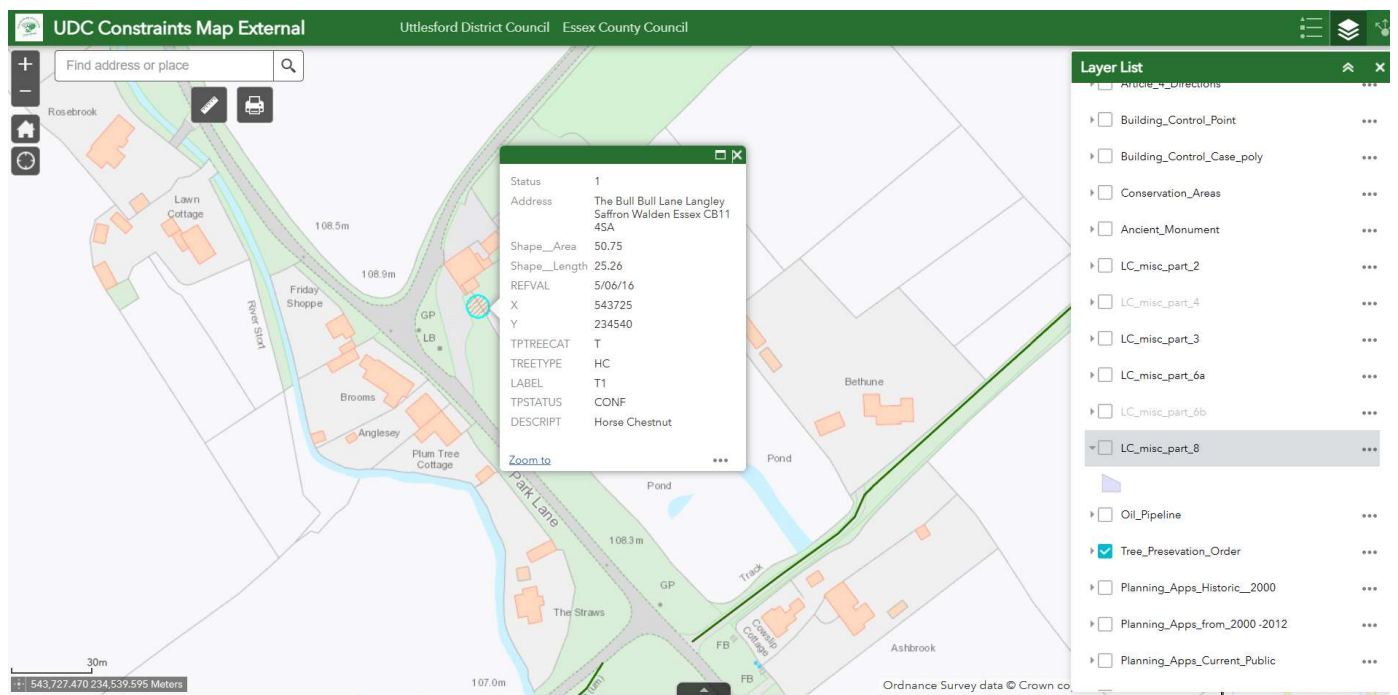
With reference to the Uttlesford DC Constraints map the site and surroundings are not in any Conservation Area. The Tree Preservation Order map name one *Aesculus hippocastanum*, White Horse Chestnut as seen below. I am informed that this protected tree developed progressive and irreversible structural weakness due to rot. One presumes the initial cause was *Pseudomonas syringae* pv *aesculi*, Bleeding Canker followed by a host of fungal agents resulting in structural weakness and limb failure. An application to fell was made to the Uttlesford DC Trees Officer circa 2012 or earlier and permission was granted to remove this tree. There appears to be no record of an application to remove on the planning portal, so no precise dates can be given. At present therefore no tree within the application area or immediate surroundings has any statutory protection either as a Scheduled TPO or in a Conservation Area.

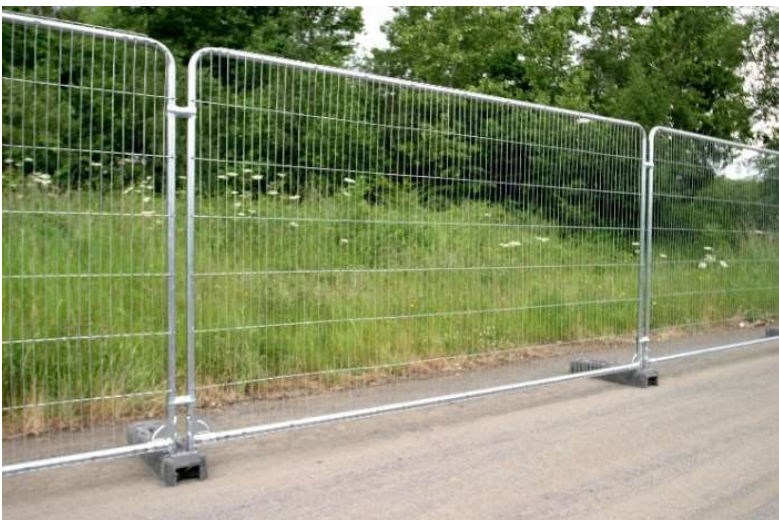
The proposed site security fencing would be Heras Fencing with concrete foot supports, mostly 2.00 mm high and 3500 mm in length. See below.
