U321 Land East of High Road, High Cross, Hertfordshire: Stage 1 Road Safety Audit Response For M Scott Properties
November 2023

# Stage 1 Road Safety Audit Sutes Farm, Ermine Street, Ware Residential Access Arrangements

Date: 03/11/2023

Report Title Stage 1 Road Safety Audit

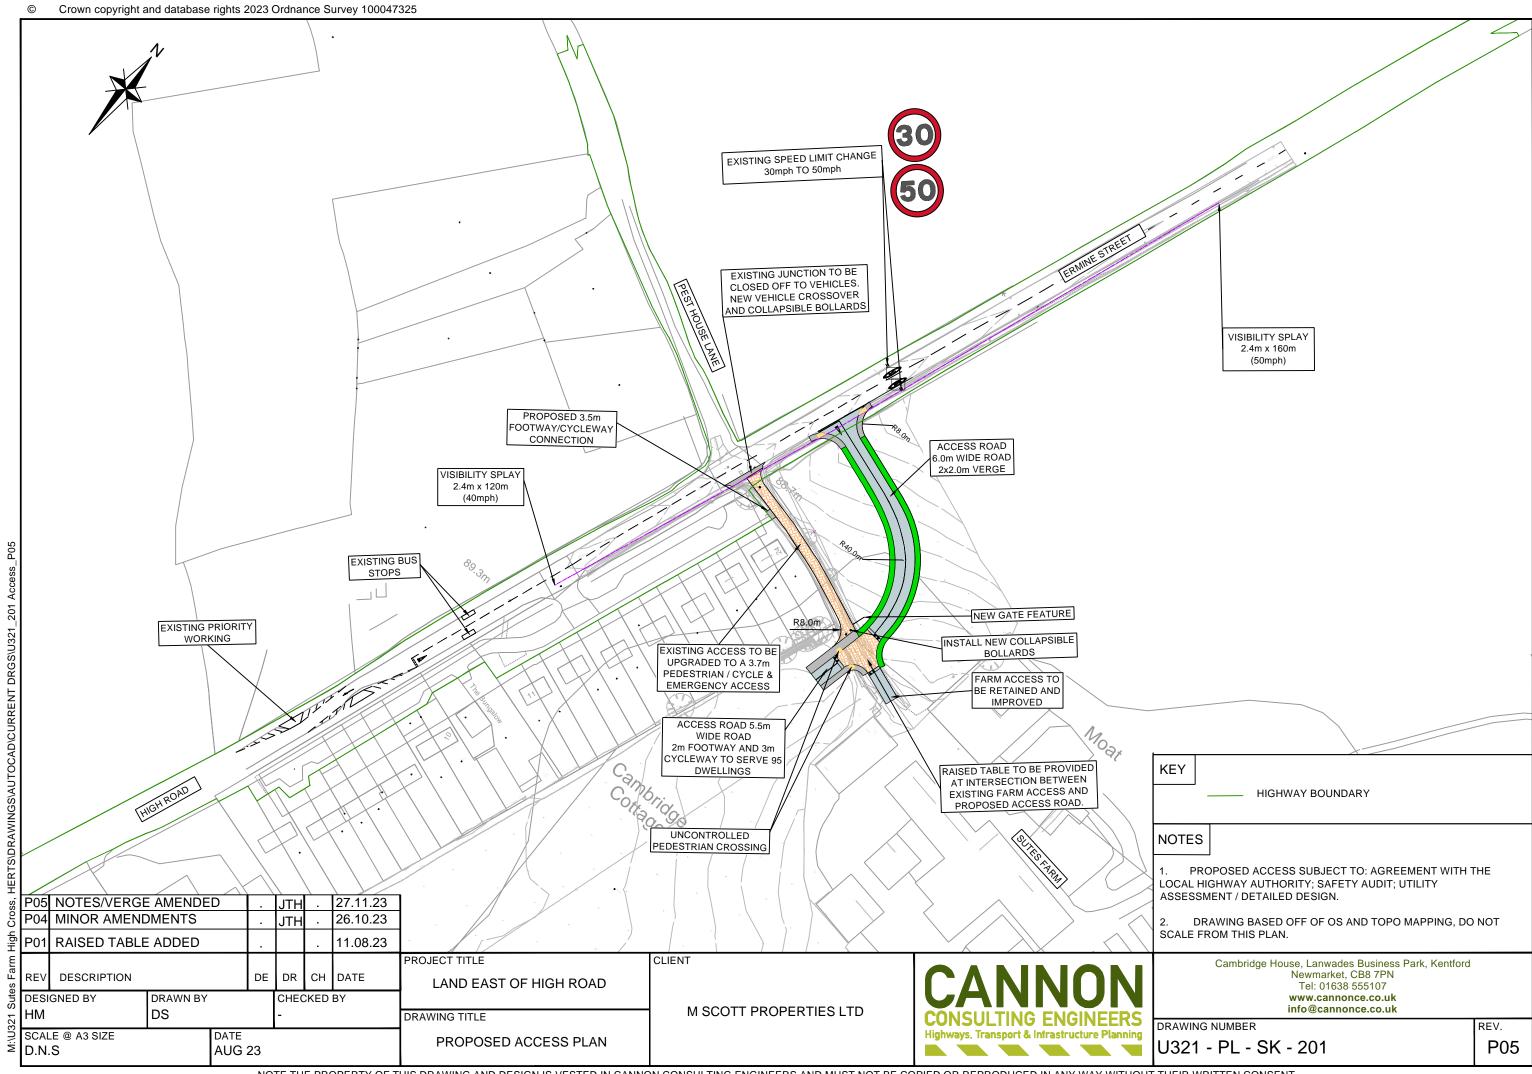
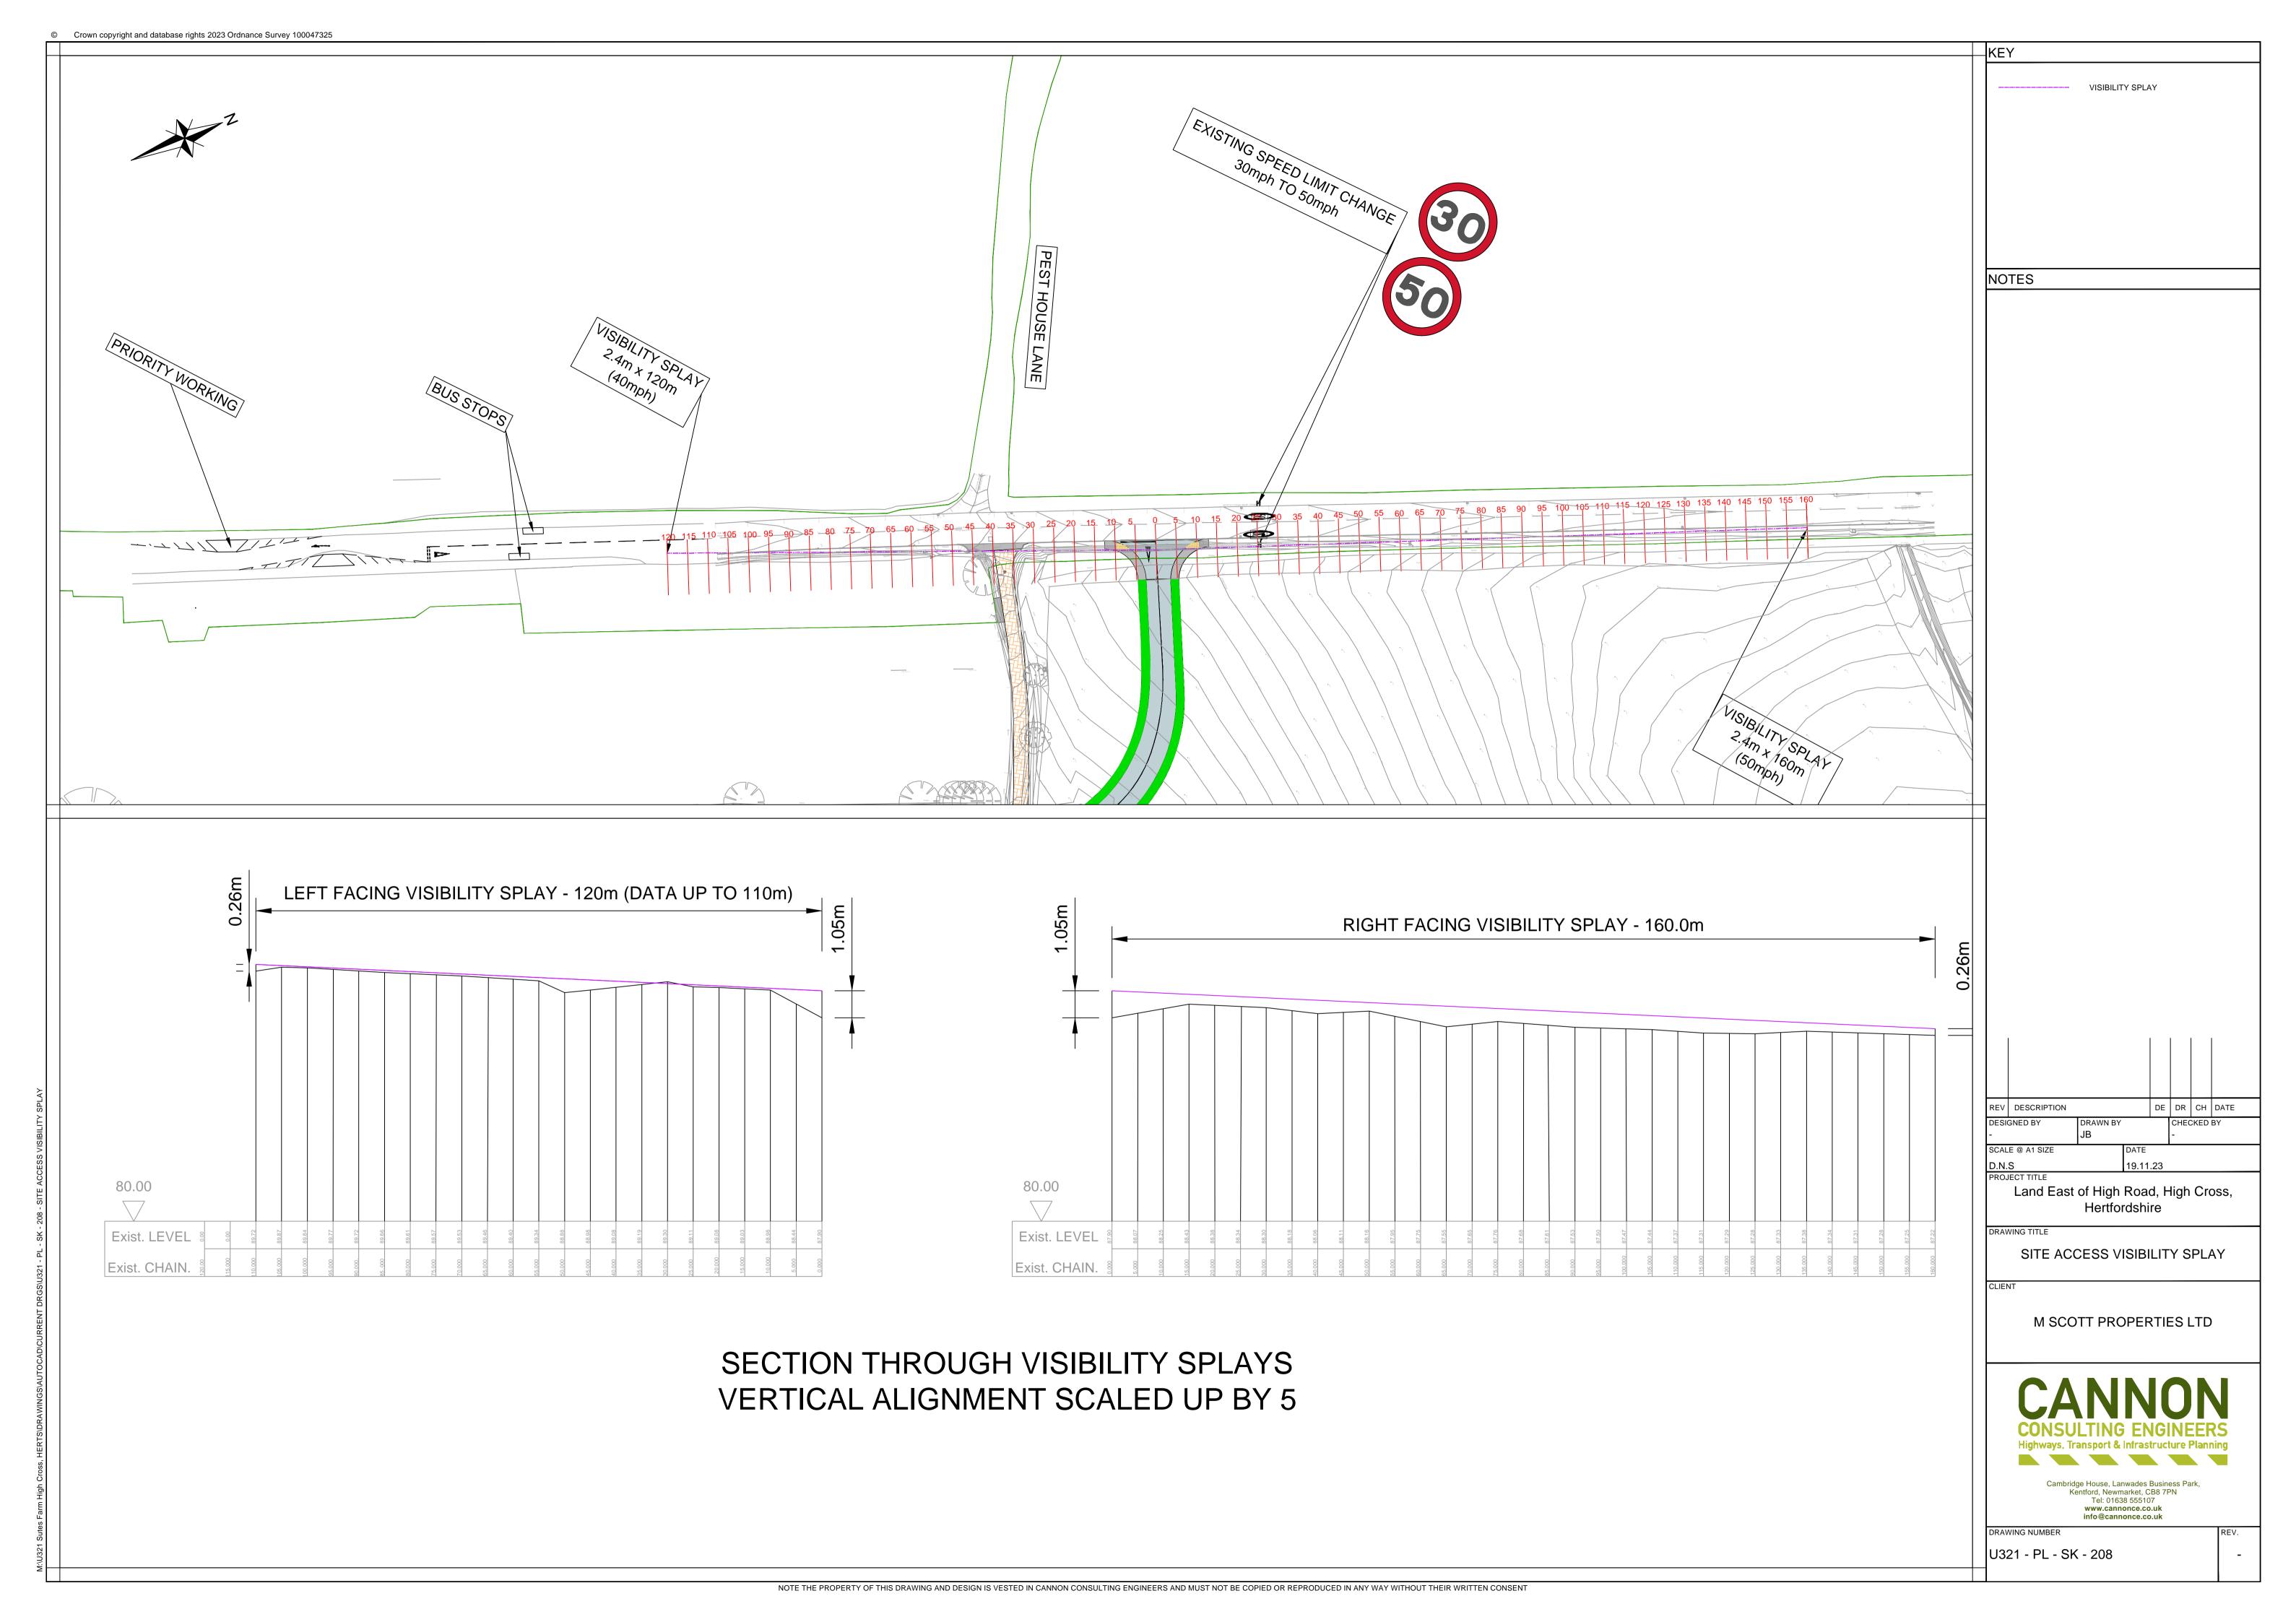
Drawings Drawing U321-PL-SK-201 P04 Drawing U321-PL-SK-208

Item	Problem	Auditor's Recommendation	Designer's Response	Highway Authority
		Addition 3 Necommentation	posignor s nesponse	Response
3.1 Junctions - 3.1.1	Location: Ermine Street at the development access Summary Review Reduced side road visibility may lead to failure to give way collisions.  It is acknowledged that a 2.4m x 160m visibility splay to the right is proposed at	It is recommended that adequate side road visibility to the right is provided, consistent with free flow 85 <sup>th</sup> percentile speeds. This may require the reprofiling of the banking and removal of some vegetation.	Accepted.  A vertical profile of the visibility splays at the site access has been prepared drawing U321-PL-SK-208. This demonstrates that visibility splays to the right are not affected by the banking.  Visibility splays will be provided in accordance with the posted speed limit, and will be cleared of vegetation and or banks re-profiled

the junction (this appears to be appropriate for the measured vehicle speeds provided), however, it is unclear whether the banking and existing vegetation will reduce the available visibility to the right for emerging users. Reduced side road visibility may lead to failure to give way type collisions.		where required to ensure they remain free from obstruction. This will form part of the detail design.

3.1.2	Location: Ermine Street at the development access Summary Review Side road downhill gradient may increase the likely of overshoot failure to give way type collisions.	It is recommended that a flat dwell area is provided on the development arm of the junction on the approach to the give way line, consistent with current best practise.	Accepted.  The access road profile will be designed in accordance with standards. This will form part of the detail design.	
	At the junction, the adjacent ground levels are higher than the carriageway channel level. This may lead to a downhill gradient to the give-way line. A downhill approach to the junction may lead to overshoot failure to give way type collisions, particularly in wet or icy conditions.

3.2 Walking, C 3.2.1	Cycling and Horse Riding – Problem	It is recommended that likely		
0.2.1	Location: At the internal development junction with Sutes Farm access  Summary Review  Unmet pedestrian crossing routes may lead to hazard for mobility impaired users.	vulnerable user desire lines are assessed and suitable crossing provision made. Away from crossing points detectable kerb heights should be provided to assist sight impaired users to negotiate the junction area.	Accepted.  Pedestrian crossing points will be designed and provided in accordance with standards and RM layout design and detail design.	
	At the proposed raised table junction pedestrians and other mobility impaired users may wish to cross the development access road. There appears to be no dropped kerb crossing point to facilitate such movements and this may present hazards for users, with upstand kerbs, or flush kerbs that may confuse sight impaired users. These issues may lead to hazards for mobility impaired or sight impaired users and to vulnerable user injury.

3.2.2	Location: At the proposed emergency access on to High Road.  Summary Review  Lack of cycle route continuity may lead cycle to vehicle collisions.  At the proposed High Road emergency access (also to be dual use shared footnath link) it is unclear how cyclists.	It is recommended that the need for suitable crossing facilities at this location is assessed to ensure cyclists can safely access / egress the proposed dual use facility.	The cycle route will be via the High Road (service road), where a transition kerb will be provided, leading cycles onto a quiet length of carriageway.  From the service road, cyclists can transition onto High Road and into the village, at the junction.  Where the proposed emergency access meets	
	footpath link), it is unclear how cyclists will be returned to the carriageway, or encouraged to leave the carriageway to access the facility. The lack of facilities may lead to an increased likelihood of cycle to vehicle collisions, particularly involving cyclists turning right from the High Road on to the dual use facility.		High Road, suitable vehicle transition kerbs can be provided that facilitate emergency access but provide a deterrent to cycles.
