## ARBORICULTURAL ASSESSMENT - SPORT WALES NATIONAL CENTRE

<b>Location:</b>	Sport Wales National Centre, Sophia Gardens, Cardiff CF11 9SW		
<b>Client:</b>	Sport Wales	<b>Reference:</b>	S240102.2
<b>Author:</b>	John Mitchener	<b>Report Date:</b>	12 January 2024
<b>Surveyor:</b>	John Mitchener	<b>Survey Date:</b>	05 January 2024

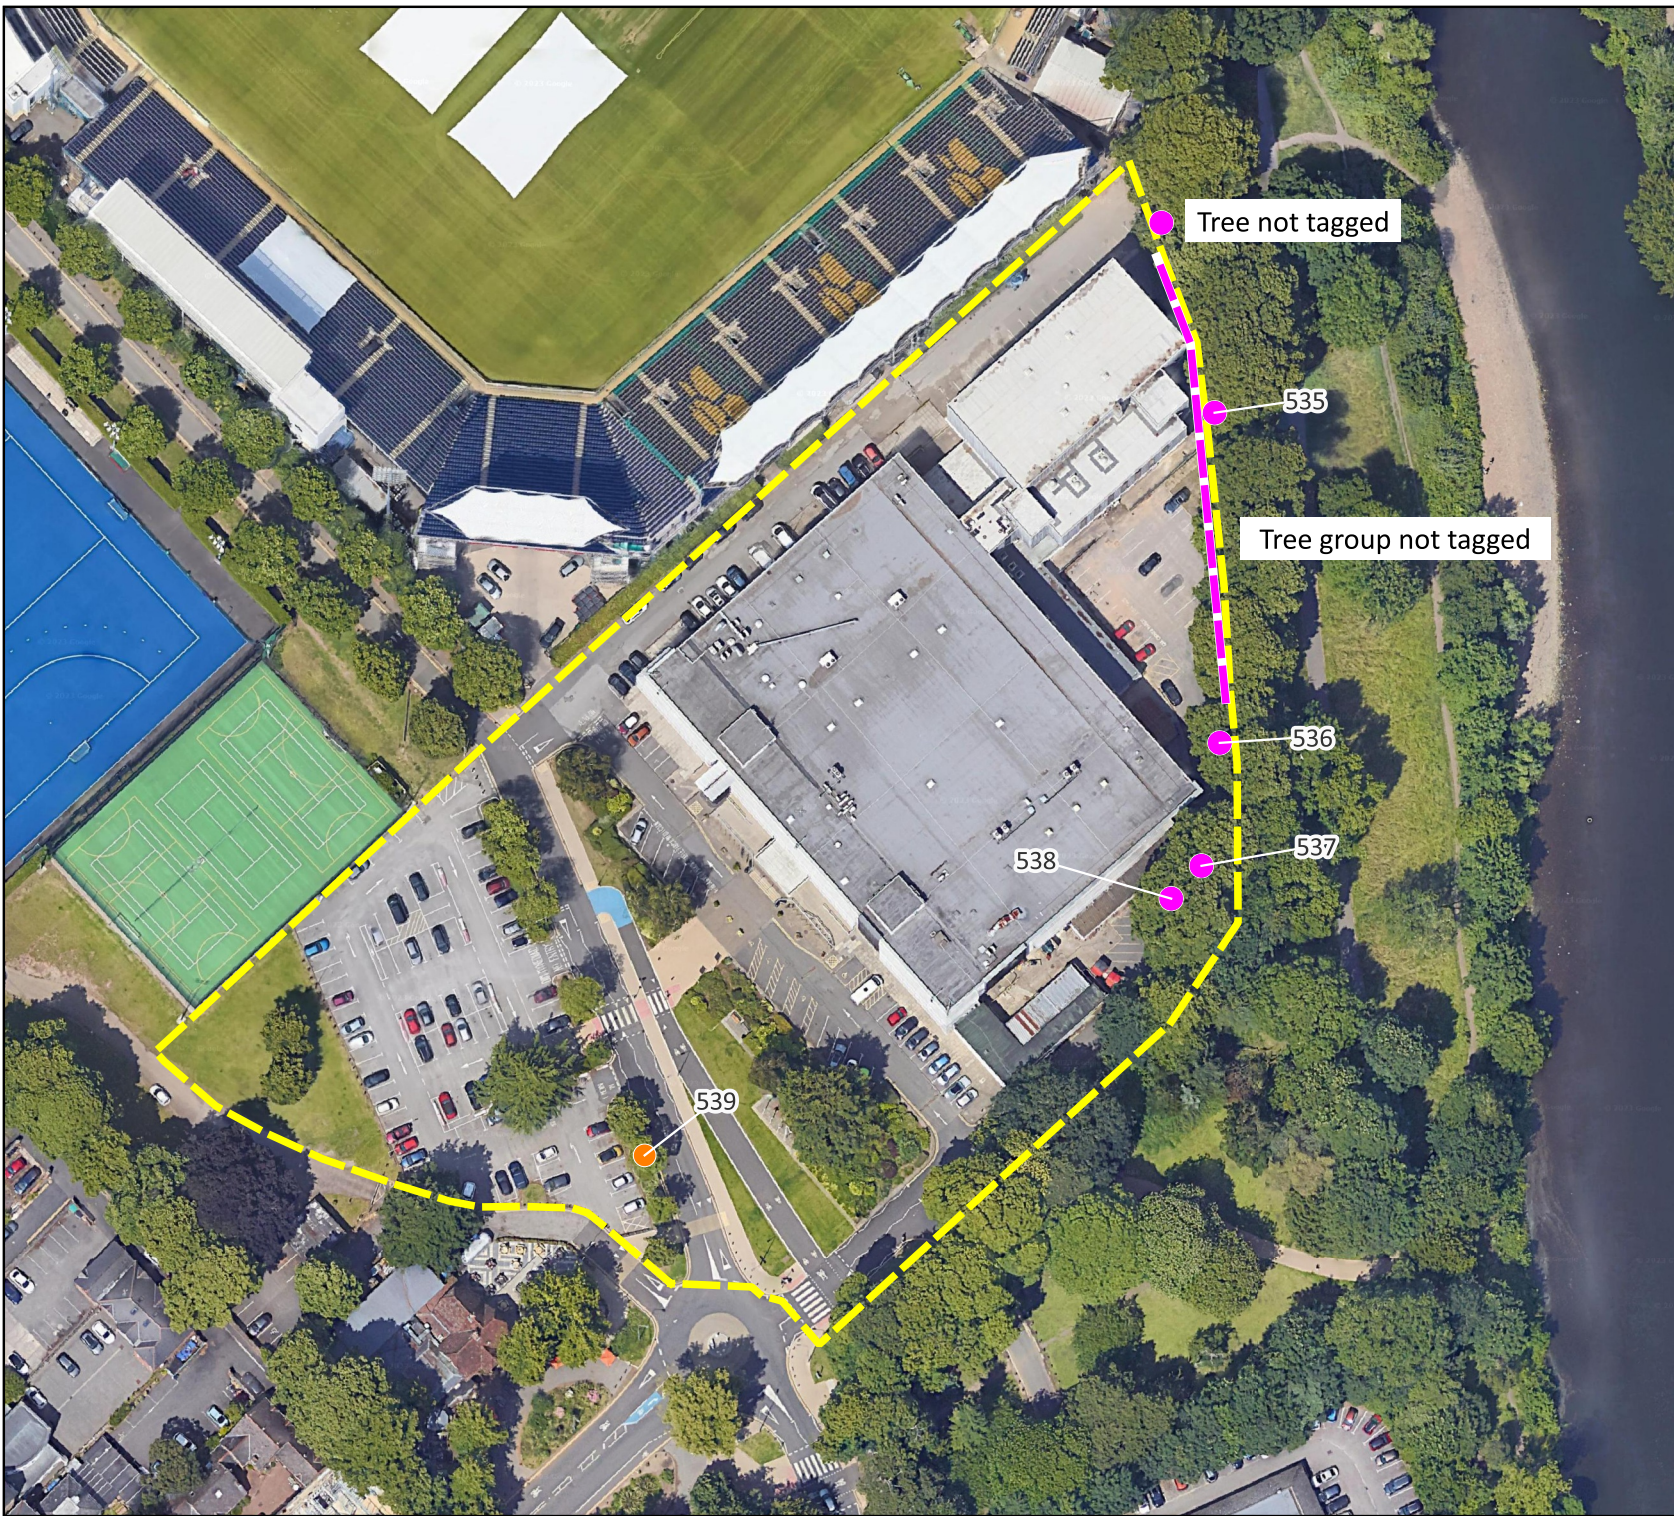
DRAWING TITLE:  
**Tree Location Plan**

<b>536</b>	Tilia sp. (lime)	26	1300	8	Deadwood within crown >25mm diameter	Management Recommendation	-	Remove deadwood >25mm diameter from crown over access road, smoking shelter and prefabricated building

Tag Number	Species	Height (m)	Stem Diameter (mm)	Crown Spread (m)	Notes	Risk	Highest Risk Is	Recommended Remedial Work
537	Tilia sp. (lime)	26	1000	7	Deadwood within crown >25mm diameter; Epicormic growth to lower stem	Management Recommendation	-	Remove deadwood >25mm diameter from crown; Remove epicormic growth from stem up to crown break
538	Tilia sp. (lime)	26	1000	7	Deadwood within crown >25mm diameter; Canopy low over access road	Management Recommendation	-	Remove deadwood >25mm diameter from crown; Remove epicormic from lower branches; Reduce re-growth back to historical pruning points on lower limbs to a height of approximately 5.2m
539	Liriodendron tulipifera (tulip tree)	13	350	4	Dead/dying branches over car park	Not Tolerable	Deadwood failure into car park	Remove dead/dying branches; Re-inspect before August 2025 to confirm whether further deadwood has formed within the crown
