Erection of Two Houses at Site at Craigrory, Artafallie, North Kessock

TREE SURVEY, PROTECTION PLAN, ARBORICULTURAL METHOD STATEMENT AND LANDSCAPE PLAN AS PER BS 5837:2012

Compiled by:
Dietrich Pannwitz FICFor
Sylvestrus Ltd.
Inverness
December 2023

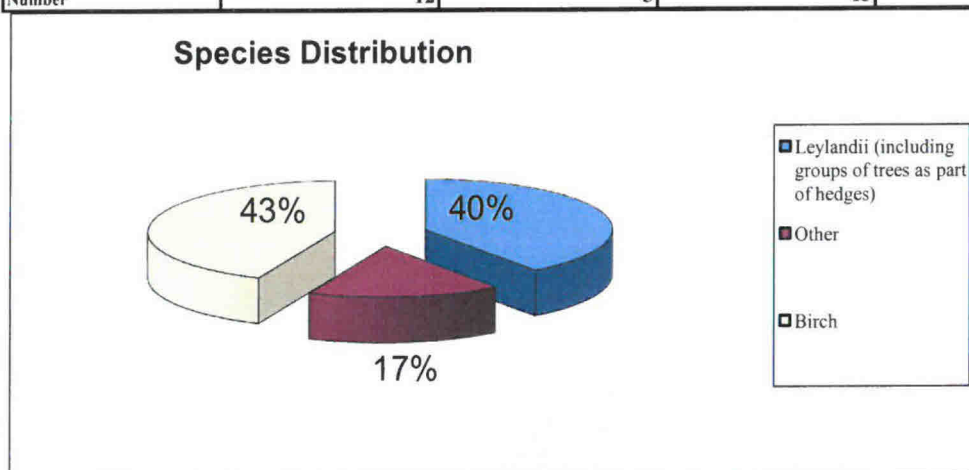
No fungal fruit bodies were noted on the trees. But there are some broken tops in the Leylandii, some have been "topped" before, one is dead, a dead elm is present and the group of Birch to the East is leaning very heavily towards the East over a stock fence (exposure?). T15 (Beech) shows damage to the trunk possibly by machine impact.

Broken Top of Tree No. 6
