Prepared by:	Maplebeck Tree Care
Address:	Clay Barn, Southwell NG22 0BS
Work Package:	St John's Church, Mansfield, NG18 1QH
Site Name/Order No:	<input type="text" value="St John's Church, Mansfield, NG18 1QH"/>
Inspector's Name:	<input type="text" value="Andrew Fairhurst"/>
Date of Report:	<input type="text" value="16-10-2023"/>

Executive Summary:

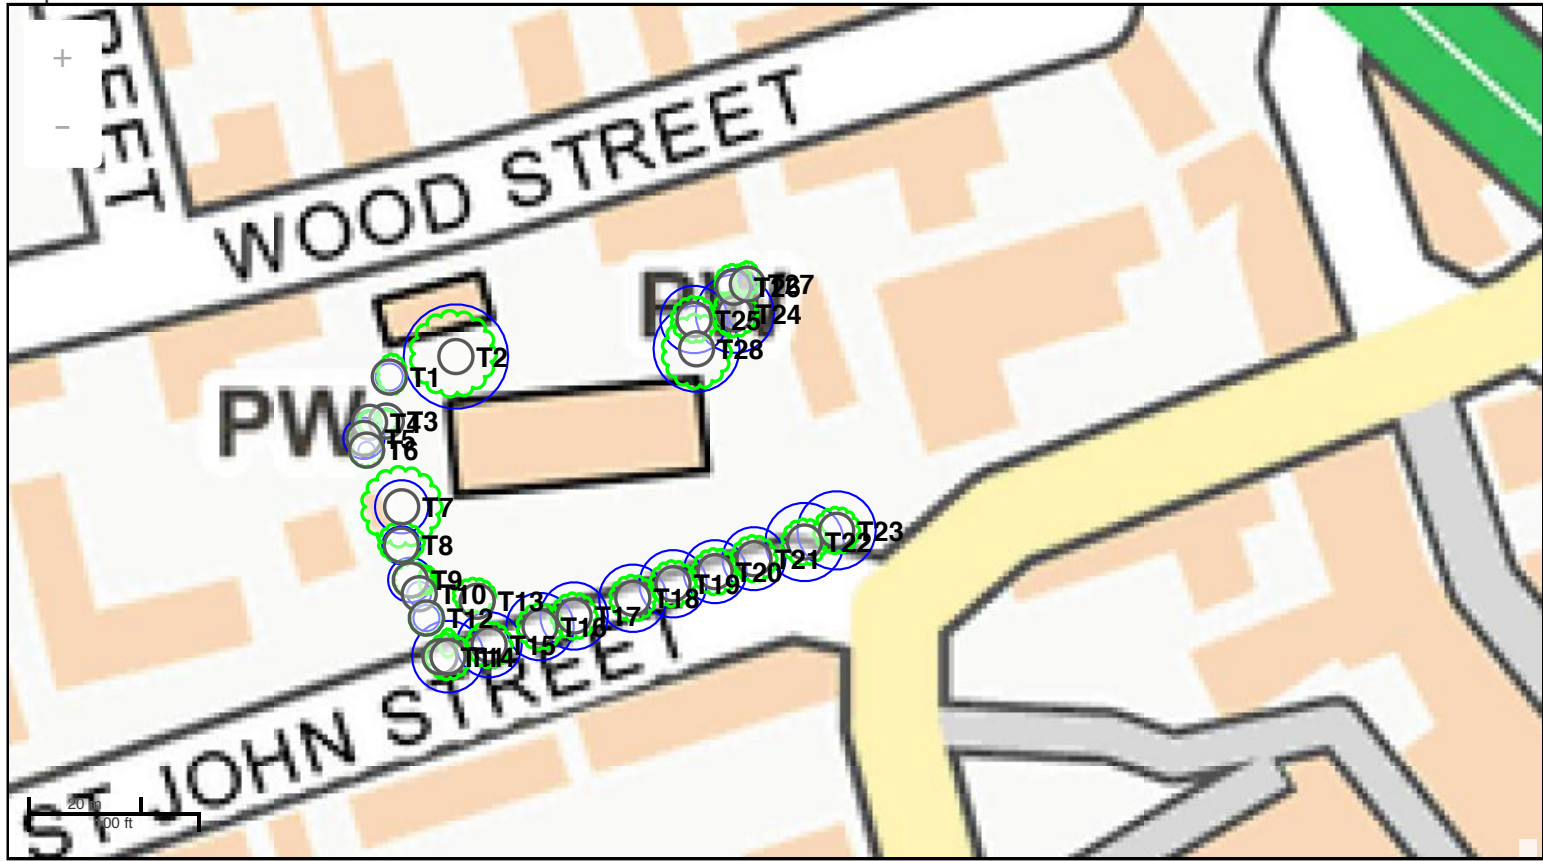
MapNo: T1 KTIId: 110126940
Date: 2023-10-16

No	Species	Height (m)	Age Class	Next Inspection	Priority	Est. Duration
T1	Prunus avium (Wild Cherry)	6	EarlyMature	16-10-2028		0
	GENERAL OBSERVATIONS Multiple wounds on the stem from 0.5m to 2.5m which have accluded well biased towards the north most likely due to neighbouring tree being removed at some point. Phone line just in contact with outer canopy of no concern. PHYSICAL_CONDITION Good ; STRUCTURAL_CONDITION Fair ; KT ASSET ID 110126940 ; STEM DIAMETERS 21cm ; CAVAT FUNCTIONAL VALUE 75% ; CAVAT CASH VALUE - ; USER NAME Maplebeck Tree Care ; LAST INSPECTED 16-10-2023		NO WORKS REQUIRED AT THE TIME OF INSPECTION			
T2	Fraxinus excelsior (Common Ash)	20	Mature	16-10-2026	4	0
	GENERAL OBSERVATIONS Moderate deadwood in canopy as to be expected with the species with some over the footpaths, canopy within 1m of the hall. No signs of ash die back. PHYSICAL_CONDITION Good ; STRUCTURAL_CONDITION Good ; KT ASSET ID 110126941 ; STEM DIAMETERS 80cm ; CAVAT FUNCTIONAL VALUE 75% ; CAVAT CASH VALUE - ; USER NAME Maplebeck Tree Care ; LAST INSPECTED 16-10-2023		PRELIMINARY RECOMMENDATIONS Remove Deadwood (Degree Moderate) (Remove deadwood over 30mm diameter which over hangs footpaths) Priority 4; Cut back from property (Prune to give 3m clearance of hall) Priority 4

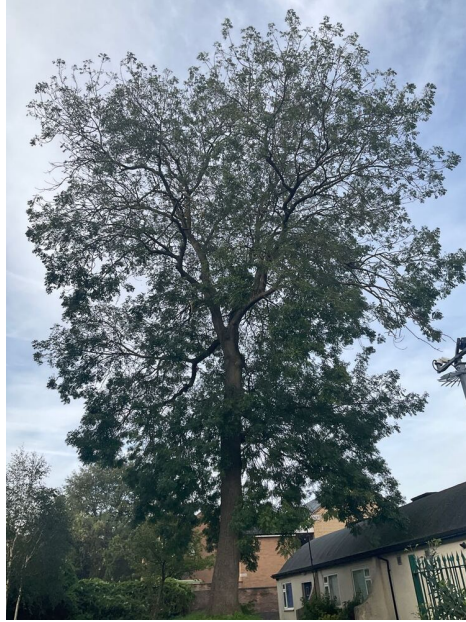
MapNo: T3 KTIId: 110126942
Date: 2023-10-16

T3	Betula papyrifera (Paper-bark Birch)	8	SemiMature	16-10-2028		0
	GENERAL OBSERVATIONS PHYSICAL_CONDITION Good ; STRUCTURAL_CONDITION Good ; KT ASSET ID 110126942 ; STEM DIAMETERS 19cm ; CAVAT FUNCTIONAL VALUE 75% ; CAVAT CASH VALUE - ; USER NAME Maplebeck Tree Care ; LAST INSPECTED 16-10-2023		NO WORKS REQUIRED AT THE TIME OF INSPECTION			
T4	Betula papyrifera (Paper-bark Birch)	7	SemiMature	16-10-2028		0
	GENERAL OBSERVATIONS PHYSICAL_CONDITION Good ; STRUCTURAL_CONDITION Good ; KT ASSET ID 110126943 ; STEM DIAMETERS 18cm ; CAVAT FUNCTIONAL VALUE 75% ; CAVAT CASH VALUE - ; USER NAME Maplebeck Tree Care ; LAST INSPECTED 16-10-2023		NO WORKS REQUIRED AT THE TIME OF INSPECTION			
T5	Laburnum anagyroides (Laburnum)	7	Mature	16-10-2027	4	0
	GENERAL OBSERVATIONS Phoneline running through canopy and being redirected by growth requires pruning to free up wire. PHYSICAL_CONDITION Good ; STRUCTURAL_CONDITION Good ; KT ASSET ID 110126944 ; STEM DIAMETERS 13cm ; CAVAT FUNCTIONAL VALUE 75% ; CAVAT CASH VALUE - ; USER NAME Maplebeck Tree Care ; LAST INSPECTED 16-10-2023		PRELIMINARY RECOMMENDATIONS Clear street lamp (Prune to free up phoneline giving as much clearance as possible 0.2m if possible.) Priority 4

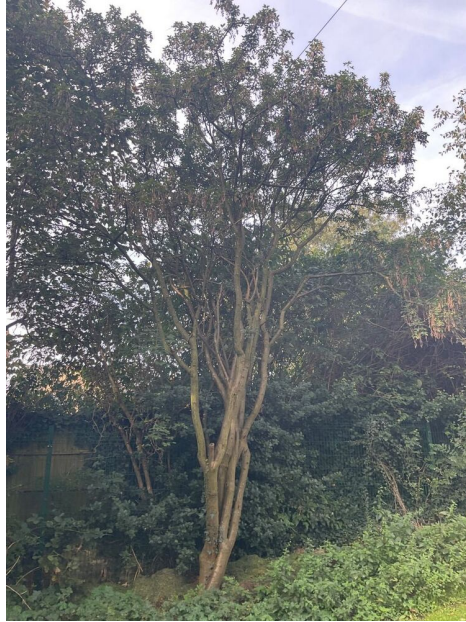
MapNo: T6 KTIId: 110126945
Date: 2023-10-16

T6	Acer pseudoplatanus (Sycamore)	8	SemiMature	16-10-2028		0
	GENERAL OBSERVATIONS Most likely a self set tree may cause damage to fences but in the future but of no concern currently PHYSICAL_CONDITION Good ; STRUCTURAL_CONDITION Good ; KT ASSET ID 110126945 ; STEM DIAMETERS 12cm ; COMMENT In between fence line owner unclear ; CAVAT FUNCTIONAL VALUE 75% ; CAVAT CASH VALUE - ; USER NAME Maplebeck Tree Care ; LAST INSPECTED 16-10-2023		NO WORKS REQUIRED AT THE TIME OF INSPECTION			
T7	Prunus avium (Wild Cherry)	11	Mature	16-10-2028	3	0
	GENERAL OBSERVATIONS Minor root girdling of no concern, canopy below 2m over path and within 1m of church PHYSICAL_CONDITION Good ; STRUCTURAL_CONDITION Good ; KT ASSET ID 110126946 ; STEM DIAMETERS 41cm ; CAVAT FUNCTIONAL VALUE 75% ; CAVAT CASH VALUE - ; USER NAME Maplebeck Tree Care ; LAST INSPECTED 16-10-2023		PRELIMINARY RECOMMENDATIONS Cut back from property (Prune to give 2m clearance from chirch) Priority 4; Raise Crown (Raise canopy to 3m all around.) Priority 3

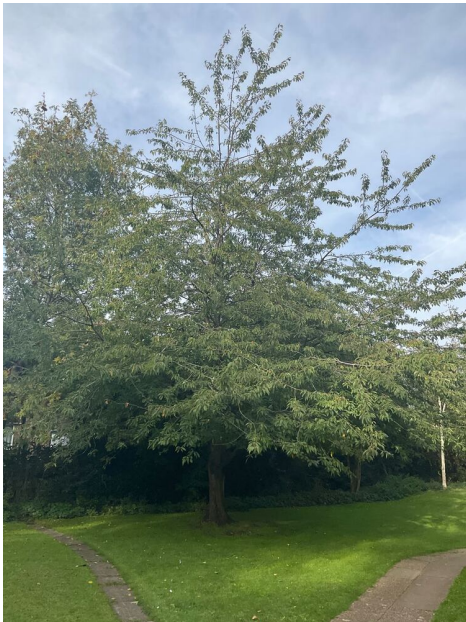
MapNo: T8 KTIId: 110126947
Date: 2023-10-16

T8	Fraxinus excelsior (Common Ash)	11	EarlyMature	16-10-2028	4	0
	GENERAL OBSERVATIONS Biased towards neighbouring property, not in contact with fence yet. PHYSICAL_CONDITION Good ; STRUCTURAL_CONDITION Good ; KT ASSET ID 110126947 ; STEM DIAMETERS 29cm ; CAVAT FUNCTIONAL VALUE 75% ; CAVAT CASH VALUE - ; USER NAME Maplebeck Tree Care ; LAST INSPECTED 16-10-2023		PRELIMINARY RECOMMENDATIONS Cut back from property (Prune to give 2m clearance from neighbours garage) Priority 4			
T9	Fraxinus excelsior (Common Ash)	10	EarlyMature	16-10-2028		0
	GENERAL OBSERVATIONS Multi stemmed species, with ivy establishing on the tree PHYSICAL_CONDITION Good ; STRUCTURAL_CONDITION Good ; KT ASSET ID 110126948 ; STEM DIAMETERS 21cm, 18cm, 19cm ; CAVAT FUNCTIONAL VALUE 75% ; CAVAT CASH VALUE - ; USER NAME Maplebeck Tree Care ; LAST INSPECTED 16-10-2023		NO WORKS REQUIRED AT THE TIME OF INSPECTION			
T10	Prunus laurocerasus (Cherry Laurel)	6	Mature	16-10-2028		0

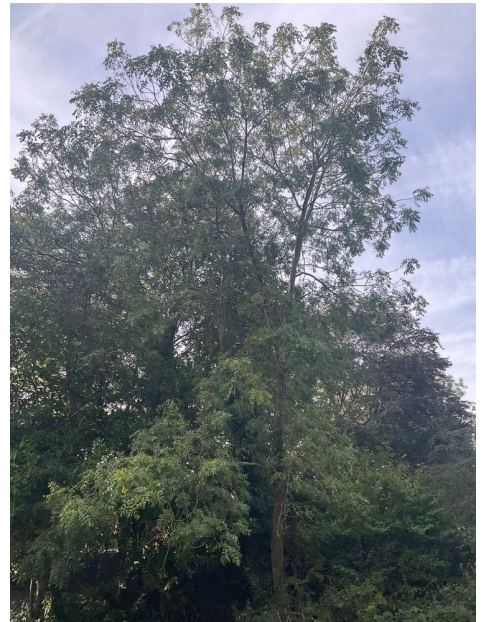
MapNo: T10 KTId: 110126949
Date: 2023-10-16

GENERAL OBSERVATIONS Heavily biased over grassed area due to competition. PHYSICAL_CONDITION Good ; STRUCTURAL_CONDITION Good ; KT ASSET ID 110126949 ; STEM DIAMETERS 12cm, 13cm ; CAVAT FUNCTIONAL VALUE 75% ; CAVAT CASH VALUE - ; USER NAME Maplebeck Tree Care ; LAST INSPECTED 16-10-2023		NO WORKS REQUIRED AT THE TIME OF INSPECTION			
T11	Prunus laurocerasus (Cherry Laurel)	5	Mature	16-10-2028		0
	GENERAL OBSERVATIONS Heavily biased over grassed area due to competition. Pruned clear of the path PHYSICAL_CONDITION Good ; STRUCTURAL_CONDITION Good ; KT ASSET ID 110126950 ; STEM DIAMETERS 12cm, 13cm, 17cm ; CAVAT FUNCTIONAL VALUE 75% ; CAVAT CASH VALUE - ; USER NAME Maplebeck Tree Care ; LAST INSPECTED 16-10-2023		NO WORKS REQUIRED AT THE TIME OF INSPECTION			
T12	Sorbus aucuparia (Rowan)	9	Mature	16-10-2028		0
	GENERAL OBSERVATIONS Minor deadwood in canopy of no concern. PHYSICAL_CONDITION Good ; STRUCTURAL_CONDITION Good ; KT ASSET ID 110126951 ; STEM DIAMETERS 19cm, 6cm ; CAVAT FUNCTIONAL VALUE 75% ; CAVAT CASH VALUE - ; USER NAME Maplebeck Tree Care ; LAST INSPECTED 16-10-2023		NO WORKS REQUIRED AT THE TIME OF INSPECTION

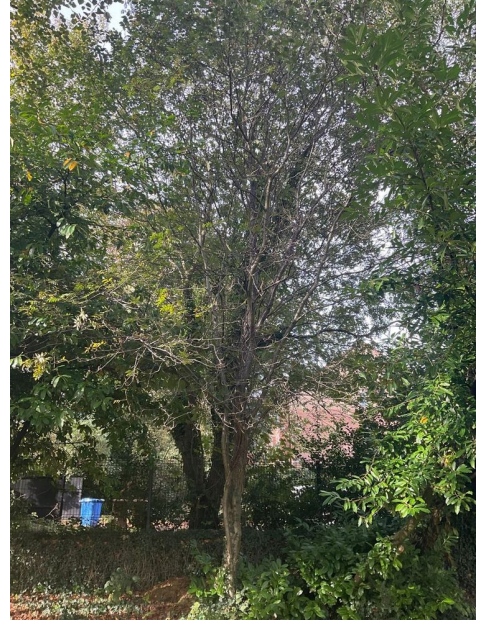
MapNo: T13 KTId: 110126952
Date: 2023-10-16

No	Species	Height (m)	Age Class	Next Inspection	Priority	Est. Duration
	GENERAL OBSERVATIONS Minor deadwood in canopy of no concern PHYSICAL_CONDITION Good ; STRUCTURAL_CONDITION Good ; KT ASSET ID 110126952 ; CAVAT FUNCTIONAL VALUE 75% ; CAVAT CASH VALUE - ; USER NAME Maplebeck Tree Care ; LAST INSPECTED 16-10-2023					NO WORKS REQUIRED AT THE TIME OF INSPECTION
T14	Tilia cordata (Small-leaved Lime)	12	Mature	16-10-2028	3	0
	GENERAL OBSERVATIONS Moderate deadwood in canopy over path, canopy encroaching onto carriageway. PHYSICAL_CONDITION Good ; STRUCTURAL_CONDITION Good ; KT ASSET ID 110126953 ; STEM DIAMETERS 55cm ; CAVAT FUNCTIONAL VALUE 75% ; CAVAT CASH VALUE - ; USER NAME Maplebeck Tree Care ; LAST INSPECTED 16-10-2023					PRELIMINARY RECOMMENDATIONS Raise Crown (Raise canopy to 5.2m over carriageway) Priority 3; Remove Deadwood (Degree Moderate) (Remove deadwood over 30mm diameter over footway side only) Priority 3

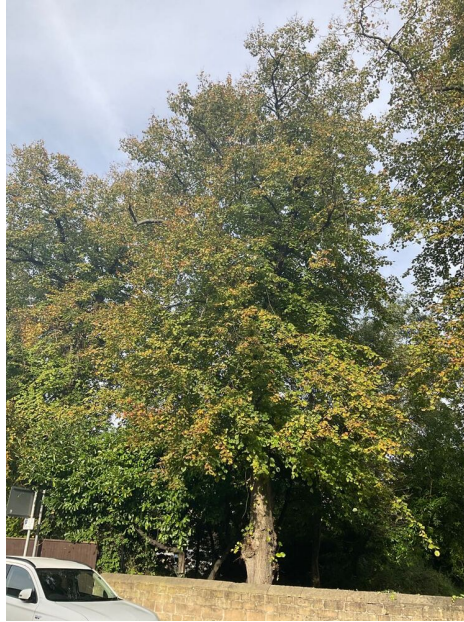
MapNo: T15 KTId: 110126954
Date: 2023-10-16

T15	Tilia cordata (Small-leaved Lime)	12	Mature	16-10-2028	3	0
	GENERAL OBSERVATIONS canopy encroaching onto carriageway. Minor deadwood over footway PHYSICAL_CONDITION Good ; STRUCTURAL_CONDITION Good ; KT ASSET ID 110126954 ; STEM DIAMETERS 50cm ; CAVAT FUNCTIONAL VALUE 75% ; CAVAT CASH VALUE - ; USER NAME Maplebeck Tree Care ; LAST INSPECTED 16-10-2023					PRELIMINARY RECOMMENDATIONS Raise Crown (Raise canopy to 5.2m over carriageway.) Priority 3; Remove Deadwood (Degree Minor) (Remove deadwood over 30mm diameter over footway side only) Priority 3
T16	Tilia cordata (Small-leaved Lime)	12	Mature	16-10-2028	3	0
	GENERAL OBSERVATIONS canopy encroaching onto carriageway. PHYSICAL_CONDITION Good ; STRUCTURAL_CONDITION Good ; KT ASSET ID 110126955 ; STEM DIAMETERS 52cm ; CAVAT FUNCTIONAL VALUE 75% ; CAVAT CASH VALUE - ; USER NAME Maplebeck Tree Care ; LAST INSPECTED 16-10-2023					PRELIMINARY RECOMMENDATIONS Raise Crown (Raise canopy to 5.2m over carriageway.) Priority 3

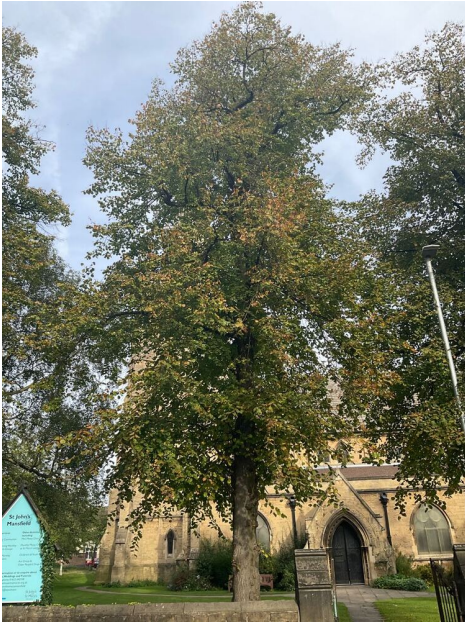
MapNo: T17 KTId: 110126956
Date: 2023-10-16

T17	Tilia cordata (Small-leaved Lime)	12	Mature	16-10-2028	3	0
	GENERAL OBSERVATIONS canopy encroaching onto carriageway. And requires clearing around streetlight. PHYSICAL_CONDITION Good ; STRUCTURAL_CONDITION Good ; KT ASSET ID 110126956 ; STEM DIAMETERS 52cm ; CAVAT FUNCTIONAL VALUE 75% ; CAVAT CASH VALUE - ; USER NAME Maplebeck Tree Care ; LAST INSPECTED 16-10-2023					PRELIMINARY RECOMMENDATIONS Clear street lamp (Prune to give 1.5m clearance from streetlight) Priority 3; Raise Crown (Raise canopy to 5.2m over carriageway.) Priority 3
T18	Tilia cordata (Small-leaved Lime)	12	Mature	16-10-2028	3	0
	GENERAL OBSERVATIONS canopy encroaching onto carriageway. Moderate deadwood over footway. PHYSICAL_CONDITION Good ; STRUCTURAL_CONDITION Good ; KT ASSET ID 110126957 ; STEM DIAMETERS 52cm ; CAVAT FUNCTIONAL VALUE 75% ; CAVAT CASH VALUE - ; USER NAME Maplebeck Tree Care ; LAST INSPECTED 16-10-2023					PRELIMINARY RECOMMENDATIONS Remove Deadwood (Degree Moderate) (Remove deadwood over 30mm diameter over footway) Priority 3; Raise Crown (Raise canopy to 5.2m over carriageway.) Priority 3

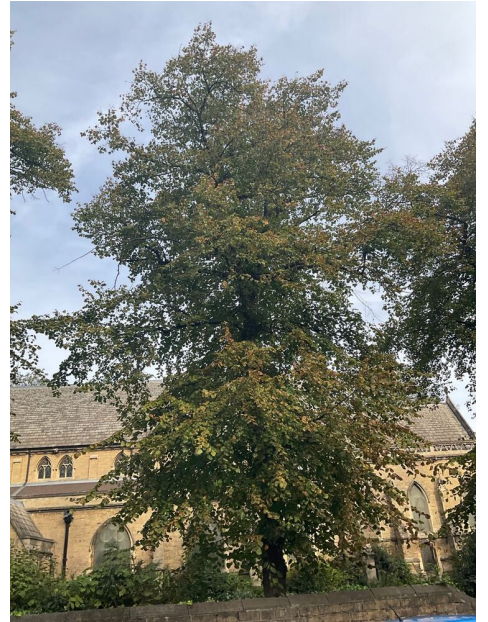
MapNo: T19 KTId: 110126958
Date: 2023-10-16

T19	Tilia cordata (Small-leaved Lime)	12	Mature	16-10-2028	3	0
	GENERAL OBSERVATIONS canopy encroaching onto carriageway. Minor deadwood over carriageway. PHYSICAL_CONDITION Good ; STRUCTURAL_CONDITION Good ; KT ASSET ID 110126958 ; STEM DIAMETERS 52cm ; CAVAT FUNCTIONAL VALUE 75% ; CAVAT CASH VALUE - ; USER NAME Maplebeck Tree Care ; LAST INSPECTED 16-10-2023					PRELIMINARY RECOMMENDATIONS Remove Basal Suckers Priority 4; Remove Deadwood (Degree Minor) (Remove deadwood over 30mm diameter over footway) Priority 3; Raise Crown (Raise canopy to 5.2m over carriageway.) Priority 3
T20	Tilia cordata (Small-leaved Lime)	11	Mature	16-10-2028	3	0
	GENERAL OBSERVATIONS canopy encroaching onto carriageway. Moderate deadwood over carriageway. Basal epicormic growth. PHYSICAL_CONDITION Good ; STRUCTURAL_CONDITION Good ; KT ASSET ID 110126959 ; STEM DIAMETERS 48cm ; CAVAT FUNCTIONAL VALUE 75% ; CAVAT CASH VALUE - ; USER NAME Maplebeck Tree Care ; LAST INSPECTED 16-10-2023					PRELIMINARY RECOMMENDATIONS Remove Basal Suckers Priority 4; Remove Deadwood (Degree Moderate) (Remove deadwood over 30mm diameter over footway and footpath in church grounds.) Priority 3; Raise Crown (Raise canopy to 5.2m over carriageway.) Priority 3

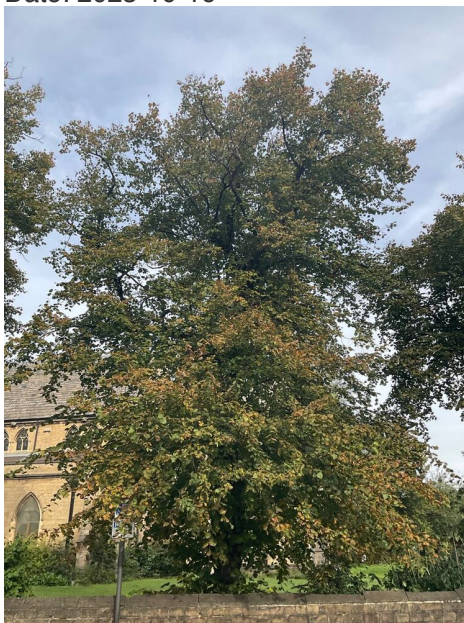
MapNo: T21 KTId: 110126960
Date: 2023-10-16

T21	Tilia cordata (Small-leaved Lime)	11	Mature	16-10-2028	3	0
	GENERAL OBSERVATIONS canopy encroaching onto carriageway. Moderate deadwood over carriageway and folate inside church grounds. Basal epicormic growth. PHYSICAL_CONDITION Good ; STRUCTURAL_CONDITION Good ; KT ASSET ID 110126960 ; STEM DIAMETERS 48cm ; CAVAT FUNCTIONAL VALUE 75% ; CAVAT CASH VALUE - ; USER NAME Maplebeck Tree Care ; LAST INSPECTED 16-10-2023					PRELIMINARY RECOMMENDATIONS Remove Basal Suckers Priority 4; Remove Deadwood (Degree Minor) (Remove deadwood over 30mm diameter over carriageway way and footpath inside church grounds.) Priority 3; Raise Crown (Raise canopy to 5.2m over carriageway.) Priority 3
T22	Tilia cordata (Small-leaved Lime)	12	Mature	16-10-2028	3	0
	GENERAL OBSERVATIONS Basal epicormic growth. PHYSICAL_CONDITION Good ; STRUCTURAL_CONDITION Good ; KT ASSET ID 110126961 ; STEM DIAMETERS 60cm ; CAVAT FUNCTIONAL VALUE 75% ; CAVAT CASH VALUE - ; USER NAME Maplebeck Tree Care ; LAST INSPECTED 16-10-2023					PRELIMINARY RECOMMENDATIONS Raise Crown (Raise canopy for future clearance and to keep the aesthetics down the run of limes the same.) Priority 3; Remove Basal Suckers Priority 4

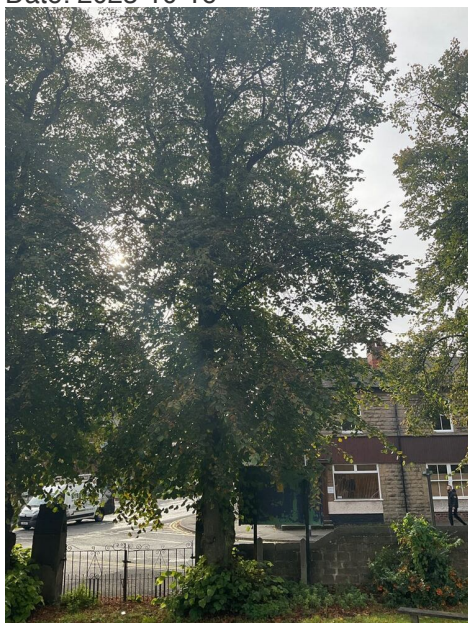
MapNo: T23 KTId: 110126962
Date: 2023-10-16

T23	Tilia cordata (Small-leaved Lime)	12	Mature	16-10-2028	3	0
	GENERAL OBSERVATIONS Basal epicormic growth. PHYSICAL_CONDITION Good ; STRUCTURAL_CONDITION Good ; KT ASSET ID 110126962 ; STEM DIAMETERS 60cm ; CAVAT FUNCTIONAL VALUE 75% ; CAVAT CASH VALUE - ; USER NAME Maplebeck Tree Care ; LAST INSPECTED 16-10-2023					PRELIMINARY RECOMMENDATIONS Raise Crown (Raise canopy for future clearance and to keep the aesthetics down the run of limes the same.) Priority 3; Remove Basal Suckers Priority 4
T24	Tilia cordata (Small-leaved Lime)	12	Mature	16-10-2028	4	0
	GENERAL OBSERVATIONS Basal epicormic growth, restricting inspection of the base of the tree, minor dieback in the upper canopy of no concern due to no targets. PHYSICAL_CONDITION Good ; STRUCTURAL_CONDITION Good ; KT ASSET ID 110126963 ; STEM DIAMETERS 60cm ; CAVAT FUNCTIONAL VALUE 75% ; CAVAT CASH VALUE - ; USER NAME Maplebeck Tree Care ; LAST INSPECTED 16-10-2023					PRELIMINARY RECOMMENDATIONS Remove Basal Suckers Priority 4

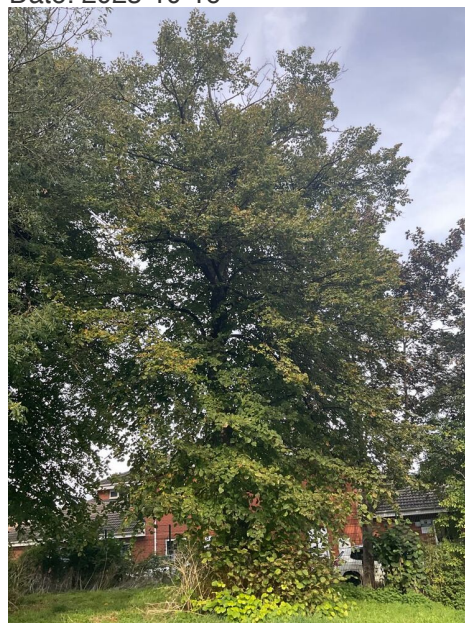
MapNo: T25 KTId: 110126964
Date: 2023-10-16

No	Species	Height (m)	Age Class	Next Inspection	Priority	Est. Duration
	<p>GENERAL OBSERVATIONS Basal epicormic growth, restricting inspection of the base of the tree.</p> <p>PHYSICAL_CONDITION Good; STRUCTURAL_CONDITION Good; KT ASSET ID 110126964; STEM DIAMETERS 52cm; CAVAT FUNCTIONAL VALUE 75%; CAVAT CASH VALUE -; USER NAME Maplebeck Tree Care; LAST INSPECTED 16-10-2023</p>					
			<p>PRELIMINARY RECOMMENDATIONS Remove Basal Suckers Priority 4</p>			
T26	Acer pseudoplatanus (Sycamore)	11	EarlyMature	16-10-2027		0
	<p>GENERAL OBSERVATIONS</p> <p>PHYSICAL_CONDITION Good; STRUCTURAL_CONDITION Good; KT ASSET ID 110126965; STEM DIAMETERS 28cm; CAVAT FUNCTIONAL VALUE 75%; CAVAT CASH VALUE -; USER NAME Maplebeck Tree Care; LAST INSPECTED 16-10-2023</p>		<p>NO WORKS REQUIRED AT THE TIME OF INSPECTION</p>			
T27	Sambucus nigra (Elder)	6	Mature	16-10-2028		0
	<p>GENERAL OBSERVATIONS Heavily biased over neighbouring fence line.</p> <p>PHYSICAL_CONDITION Good; STRUCTURAL_CONDITION Fair; KT ASSET ID 110126966; STEM DIAMETERS 15cm; CAVAT FUNCTIONAL VALUE 75%; CAVAT CASH VALUE -; USER NAME Maplebeck Tree Care; LAST INSPECTED 16-10-2023</p>		<p>NO WORKS REQUIRED AT THE TIME OF INSPECTION</p>

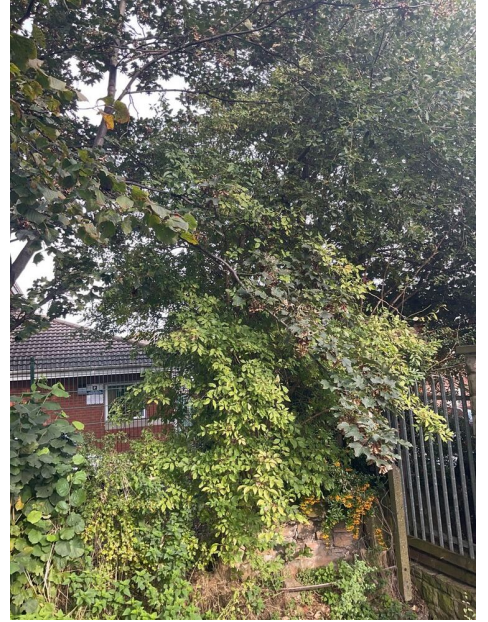
MapNo: T28 KTId: 110126967
Date: 2023-10-16

T28	Fraxinus excelsior (Ash)	19	Mature	16-10-2026	3	0
	<p>GENERAL OBSERVATIONS Canopy encroaching towards church, canopy below 3m over path. Limb at 8m in height to the west over the footpath is overextending the natural canopy line.</p> <p>PHYSICAL_CONDITION Good; STRUCTURAL_CONDITION Good; KT ASSET ID 110126967; STEM DIAMETERS 66cm; CAVAT FUNCTIONAL VALUE 75%; CAVAT CASH VALUE -; USER NAME Maplebeck Tree Care; LAST INSPECTED 16-10-2023</p>		<p>PRELIMINARY RECOMMENDATIONS Reduce Crown (Meters 3m) (Reduce limb to the west at 8m in height back to within the natural canopy line by 3m) Priority 4; Cut back from property (Prune to give 3m clearance from church) Priority 4; Raise Crown (Raise crown to 4m all around) Priority 3</p>
