VERIFICATION REPORT

30 Radford Way,
Billericay,
CM12 0DA

Job No: P2647J1906/SEJ

Date: 18 December 2023

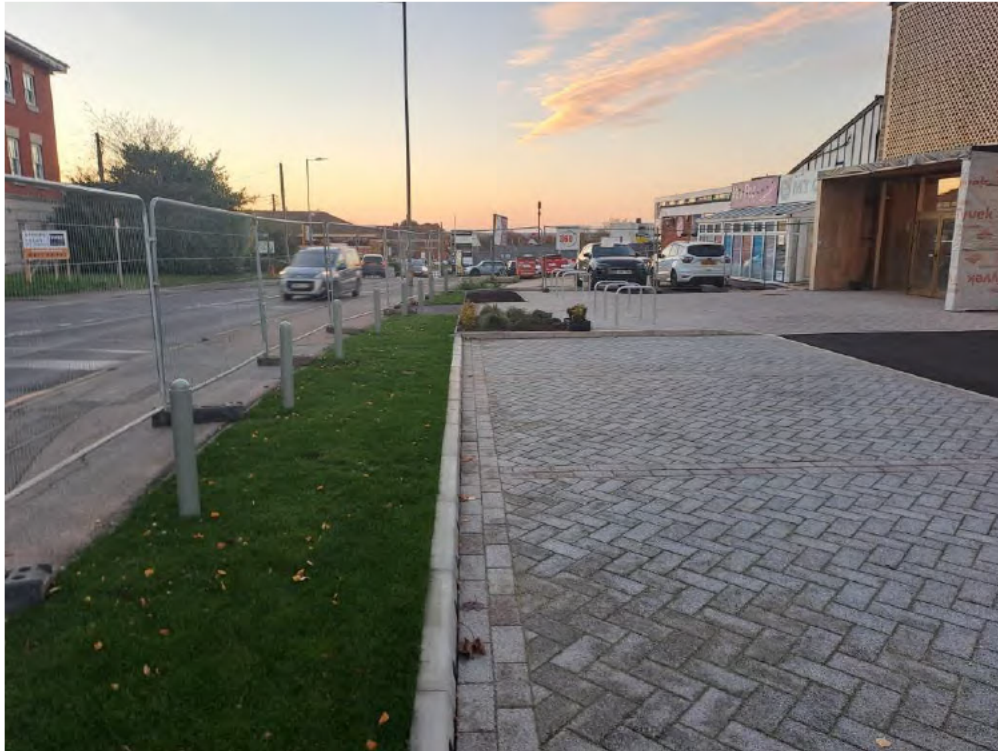
PROJECT NAME	30 Radford Way	CLIENT	Clontara Developments Ltd
TITLE	Topsoil validation Photoplan – November 2023	FIGURE	3
Photo 11: TP5 and TP6 positioned in landscaped area parallel to the road.		Photo 12: View of the front of the building on site.

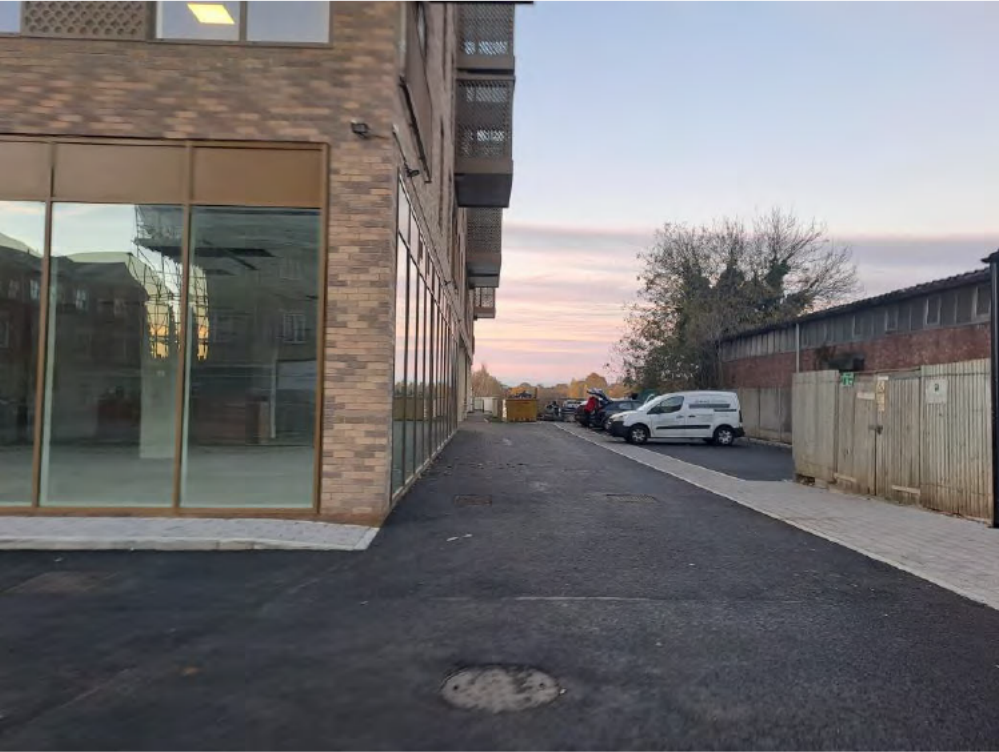
PROJECT NAME	30 Radford Way	CLIENT	Clontara Developments Ltd
TITLE	Topsoil validation Photoplan – November 2023	FIGURE	3
Photo 13: View of the south facing side of site.
