Our Ref: BEK/20771/201023/EG

Land at the north of Rhallt Lane, Welshpool - BRE 365 Percolation Test

BEK Enviro (BEK) have been commissioned by Euro Garages Ltd to determine soil infiltration rates at the above site using the BRE 365 methodology (2016) to assess the viability of disposal of surface water from the site via infiltration.

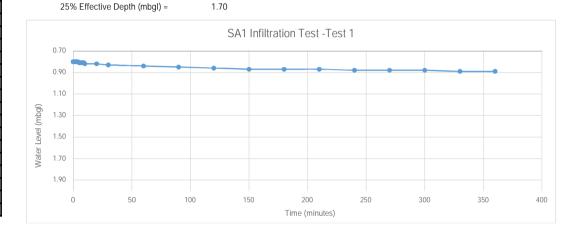
Infiltration Test Results

It can be seen from the above table that the water did not reach 75% effective depth after 6 hours of the test. Furthermore, 3 tests are required to be undertaken with the slowest infiltration rate used for design purposes therefore the test is considered to have failed.

T: ( : . )	1 5 4 / 1 8
Time (minutes)	Depth (mbgl)
0	0.80
1	0.80
2	0.80
3	0.80
4	0.80
5	0.81
6	0.81
7	0.81
8	0.81
9	0.81
10	0.82
20	0.82
30	0.83
60	0.84
90	0.85
120	0.86
150	0.87
180	0.87
210	0.87
240	0.88
270	0.88
300	0.88
330	0.89
360	0.89

Length (m)	Width (m)	Depth (m)	Area (m³)
Pit Dimensions:	1.80	0.80	2.00	2.88
Start water level (mb		0.80		
Total Depth of test =		1.20		
50% Effective Depth =		0.6
