HERITAGE STATEMENT

43-47 HIGH STREET NEWMARKET CB8 8NA

John Johnstone MRICS Keylocks Ltd Chartered Surveyors and Valuers Rothsay House, 124 High Street Newmarket CB8 8JP

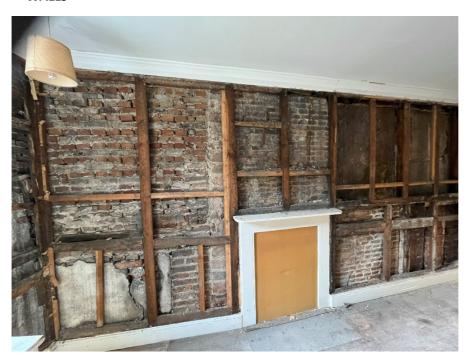
Fig 18

The first floor consists of the two rear wings with the front elevation being a later addition. The area immediately at the top of the stairs from ground to first floor contains a landing area of irregular proportions with a chimney breast and modern fireplace to what is the external wall. Fig 18.

Figures 19 & 20 show the wall between landing area (Fig 18) and adjacent stairwell to the second floor. Figure 20 shows the opposite side of the wall to Fig 19 and the stairwell.

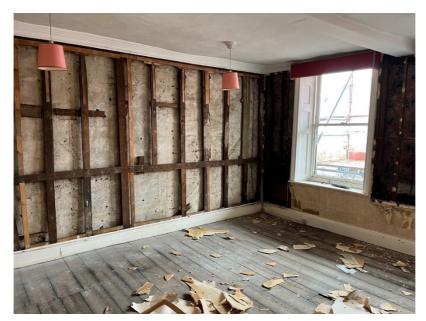
Fig 21

Figures 21 and 22 show the sold walls to the elevations to either party wall of the property at first floor level.

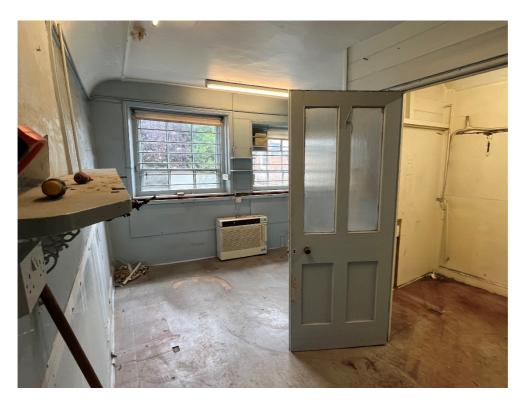
The shop had a workshop area over with modern timber partitions. (Fig 23).

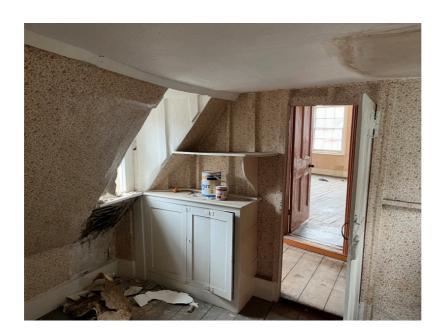
Doors to the second floor are lighter with a mixture of panel doors and latch ones. These are all to be retained. Fig 28 & 29.

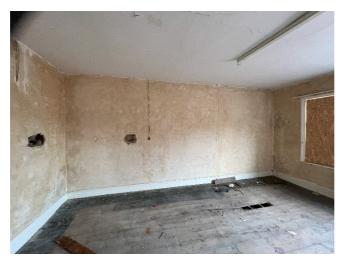
The walls are all lath and plaster and will be retained and recovered with appropriate finishes. Fig 31

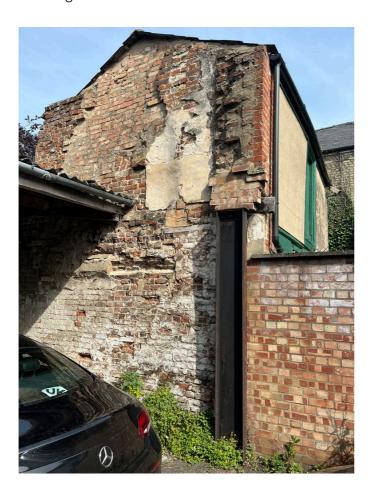
Fig 42

Adjacent building to garage now demolished.
