**CCTV REPORT FOR: 1a DURLEY AVENUE  
WATERLOOVILLE  
PO8 8XA**

**Insured:** Mr Reynolds  
**Reference:** LIV-SN-22-005818

**Site Visit:** 15-Feb-23  
**Report Date:** 27-Apr-23

Address: **1a DURLEY AVENUE, WATERLOOVILLE, PO8 8XA**

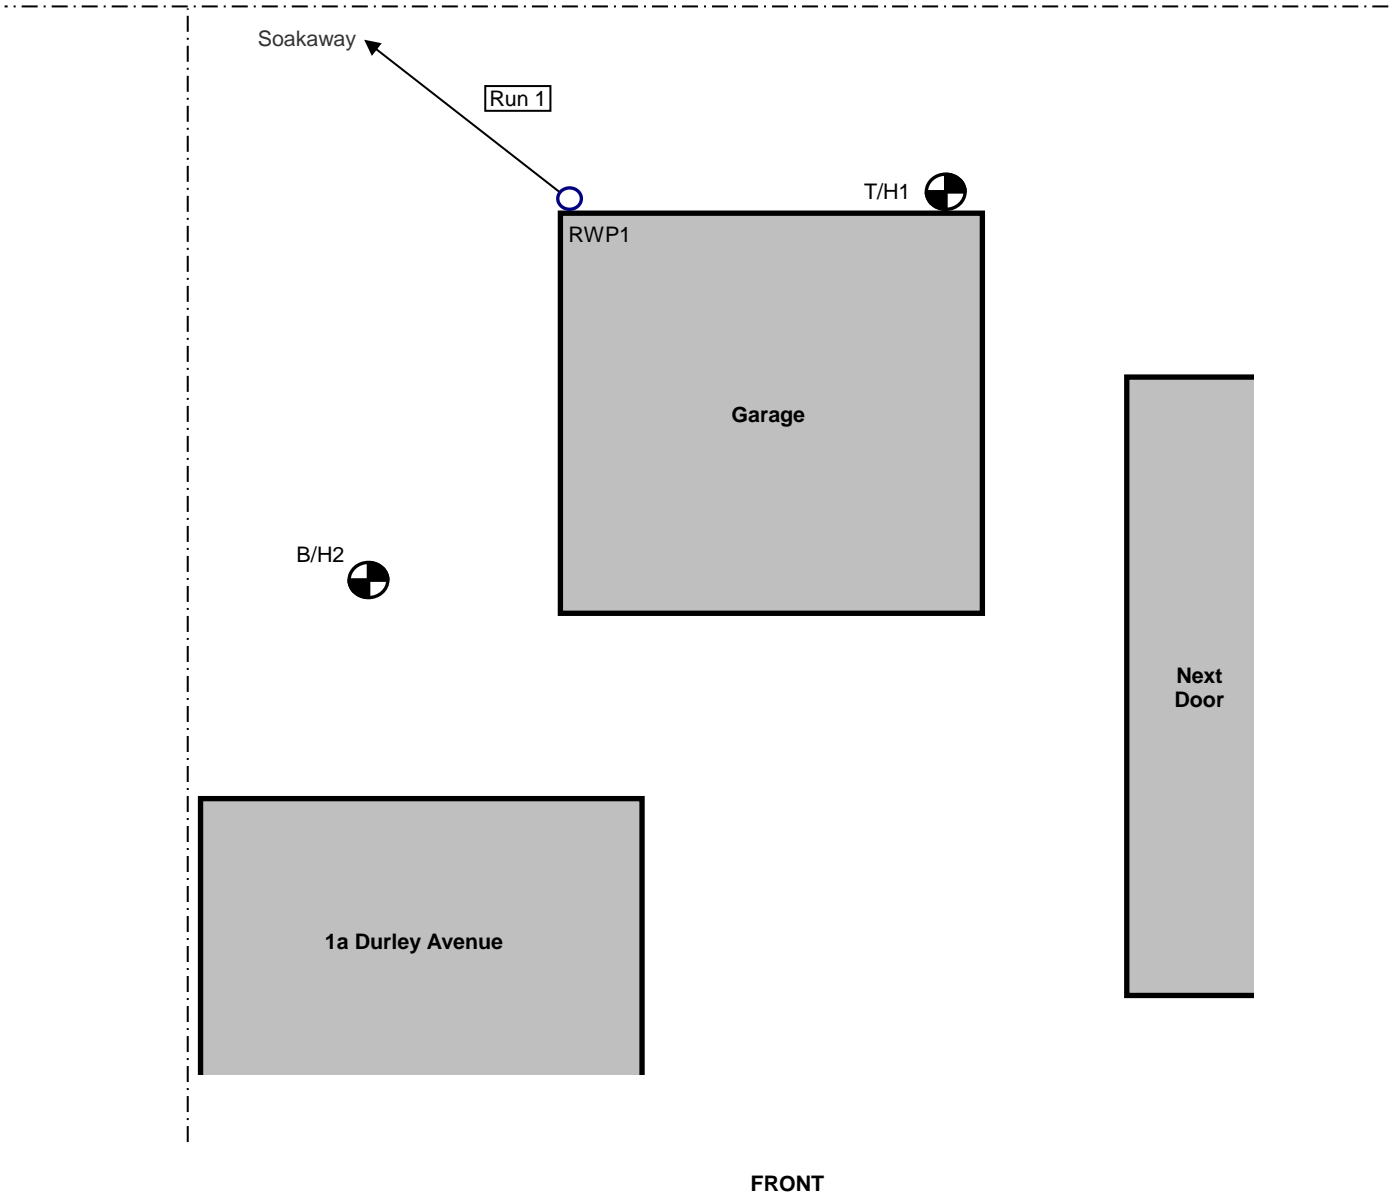
Metres	Faults / Defects	Remarks
0.00		At RWP1
1.90	Debris (Silt) 25%	
	Root Ingress	
3.20		At Soakaway
		End of survey

Some debris in the pipe and slight root ingress.  
Water flowing well from RWP

No recommendations are required.
