ARBORICULTURAL ASSESSMENT REPORT

Lychgate, Church Side, Bishop Burton, Beverley, HU17 8QB

**PRI Ref:** 273767

**Survey Date:** 11/10/2023

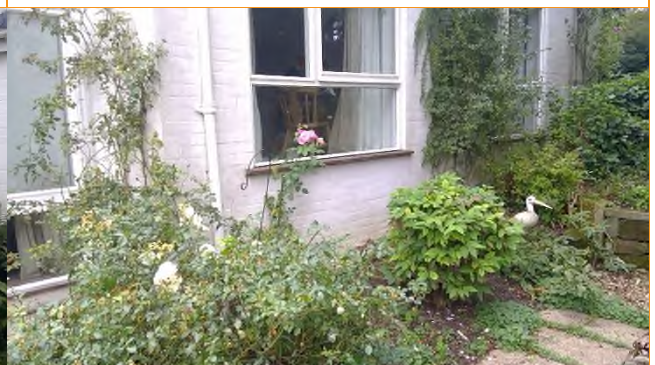
G1 - Rose

Tree No	Common Name	Age Class	Condition	Height (m)	Crown Spread (m)	Stem diam. (mm)	Dist to bldg. (m)	Roots Implicated	Pruning history	Recommendation	Tree work constraints	Notes	Owner address	Owner
G1	Rose	Young	Fair	1.5*	2*	10*	0*	Y	Subject to recent management.	No work required.		Roots have been identified but the pit was dug adjacent to the Roses. If problem persists this may be a factor.	Lychgate Church Side Bishop Burton Beverley HU17 8QB	PH
S1	Wisteria	Early Mature	Fair	3*	2	40	0	Y	Subject to past management.	Fell and treat stump with eco plugs (broadleaved).	Access through side gate.	Roots identified in the trial pit, remove and treat.	Lychgate Church Side Bishop Burton Beverley HU17 8QB	PH
T1	Beech (Common)	Over Mature	Fair	22*	18*	1013	2*	Y	Subject to past management.	Fell and treat stump with eco plugs (broadleaved).	Access through side gate.	Roots have been identified in the trial pit, Closest Beech to the property.	Lychgate Church Side Bishop Burton Beverley HU17 8QB	PH
