Willow Cottage, The Green,  
Dinton, HP17 8UP

APPLICANT: Mr & Mrs Rimell

# HERITAGE STATEMENT

## 3. INVESTIGATIVE PHOTOGRAPHS

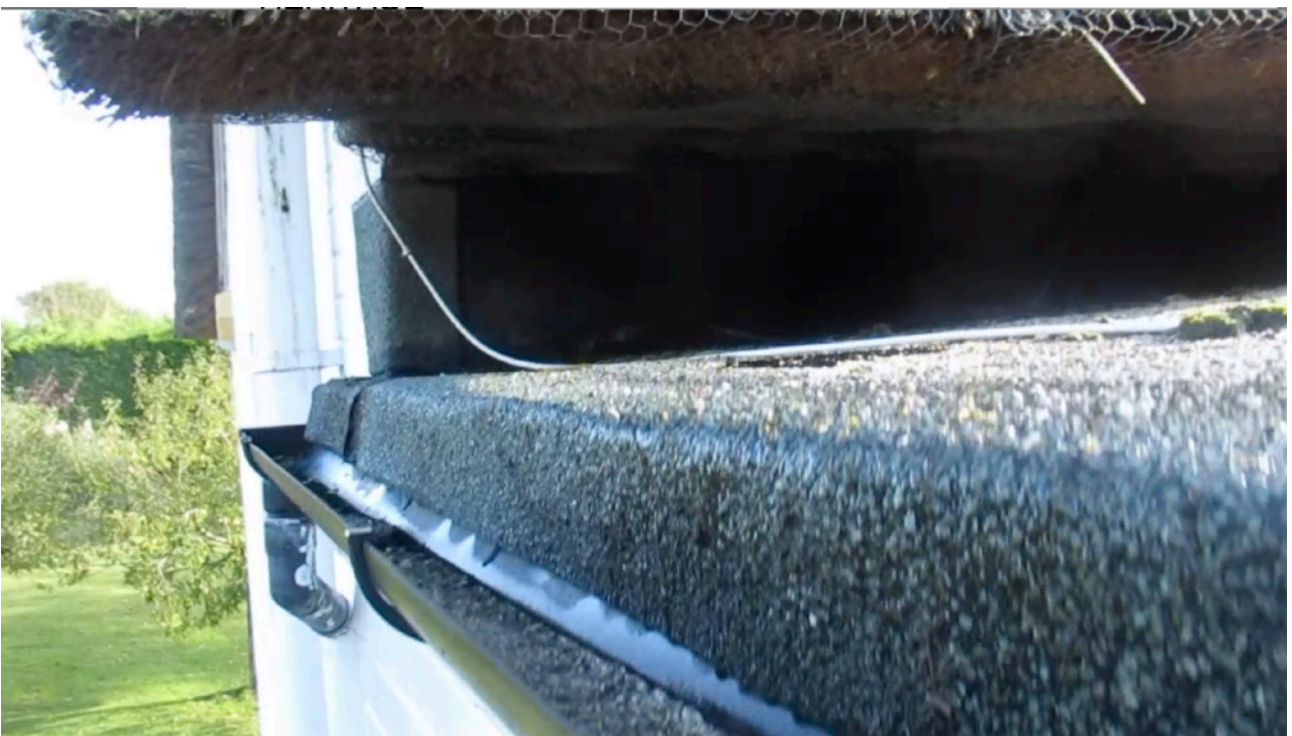
View across flat roof. Viewing from front to rear.  
Thatch to left slope sits on flat roof. Thatch to 1979 extension clear of flat roof.
