Tree Hazard Evaluation

For Mr. R. D'Costa

85 Sutherland Close, Ascot, SL5 8TE

Job Reference: 03373R

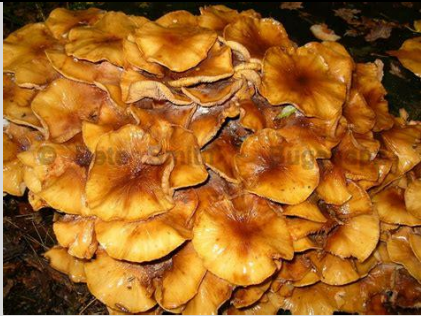
Name	Tree Species Generally Affected	Image	Significance
<i>Armillaria</i> spp Honey Fungus	All

<ul style="list-style-type: none"> • Can lead to rapid decline and death. • Upon removal all dead wood should be removed from soil (stumps ground etc.) to reduce further infections
<i>Kretzschmaria deusta</i> Cinder Fungus	Wide range of broadleaved hosts

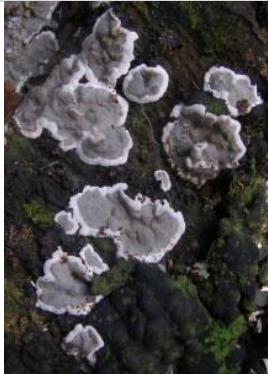
<ul style="list-style-type: none"> • Can cause brittle failure events with little prior warning. • Fruiting bodies often discreet.
Oyster Mushroom <i>Pleurotus ostreatus</i>	Wide range including Beech, Horse Chestnut & Poplar

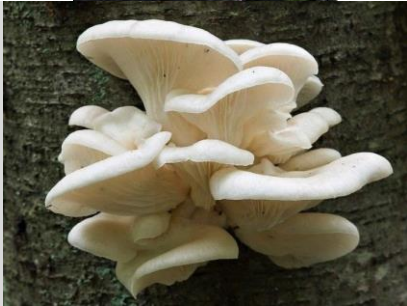
<ul style="list-style-type: none"> • Intense white rot when advanced. • Decayed wood has little strength. • If extensive brittle failure possible.
