MR E RUDDOCK  
SURVEY: BARN AT  
MANOR FARM HOUSE  
WETHERBY ROAD  
RUFFORTH  
YORK  
YO23 3QF

REPORT NO. 22040-RP-001

**Survey: Barn at Manor Farm House Rufforth**

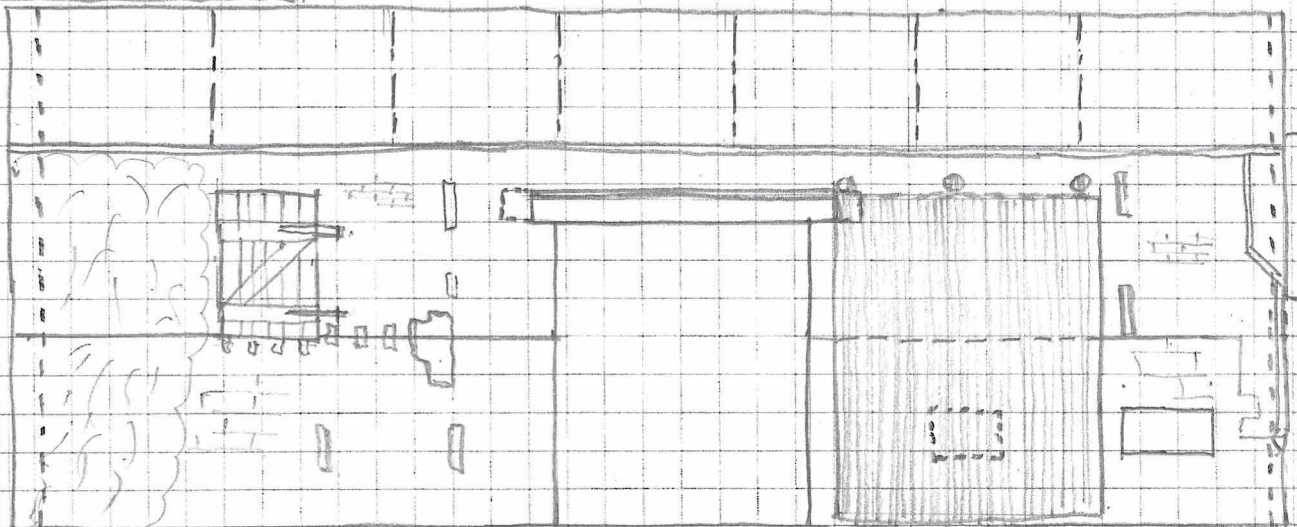
REAR ELEVATION

- 2.10 A large central door opening with sliding door to the right is the main feature of the elevation. To the right of the door at low level in the stonework is an infilled window opening. To the left of the doorway is a high-level shuttered window opening. Between the two openings there is localised damage to the stone masonry. Photo 7

**4.2** Local damage to the stonework on the rear elevation is repaired.
