Building Survey Report

The Property: Perseverance House
47 High Street
Lavenham
Suffolk
CO10 9PY

Inspected on: 14 September 2023

Survey Carried out by: Kevin R Hurley BSc MRICS

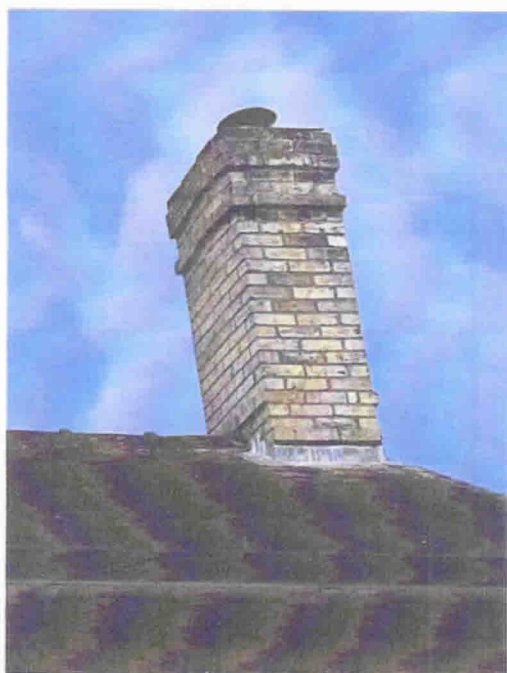
These chimneys appear in a good overall condition with no areas of concern evident.

The brickwork to the chimneys is plumb and vertical, and the brickwork and mortar jointing is in satisfactory repair. The junction of with the roof slopes is protected with a lead sheet flashing detail, dressed into stepped brick joints and free from apparent defect.

front RH side chimney

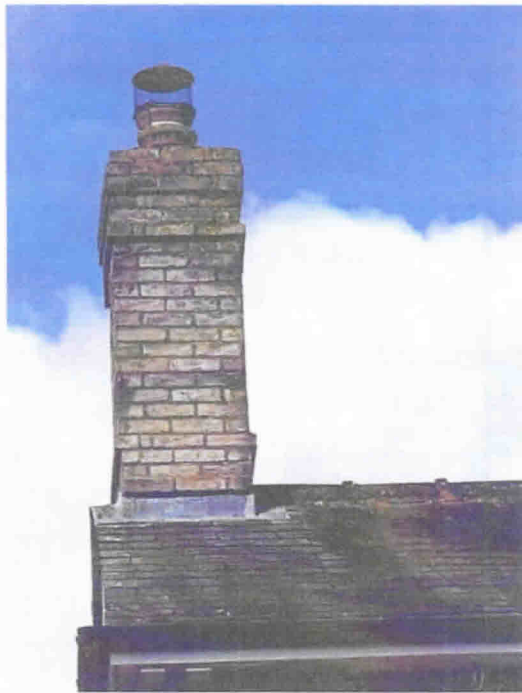
front LH side chimney

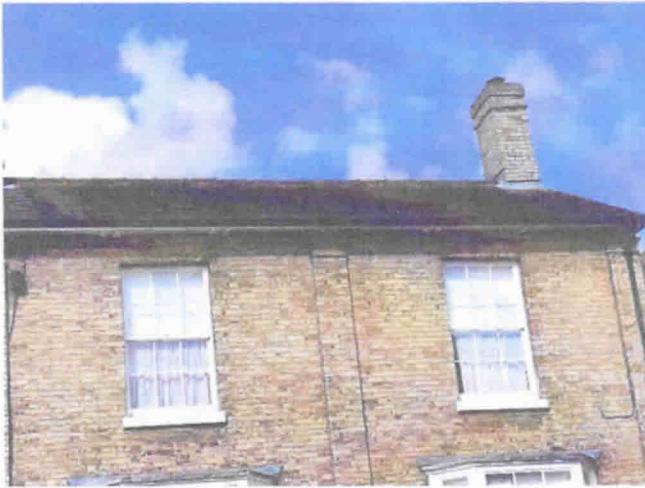
The natural slate coverings appear to be in a good overall condition with no areas of concern evident where we were able to view them. Internally, there were no signs of any water ingress or other such defects that would give rise to concern at the condition of the roof coverings.

main front roof slope

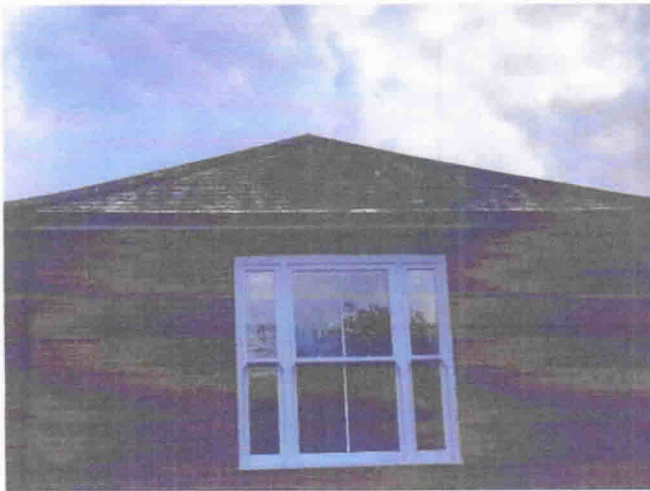
rear extension roof covering

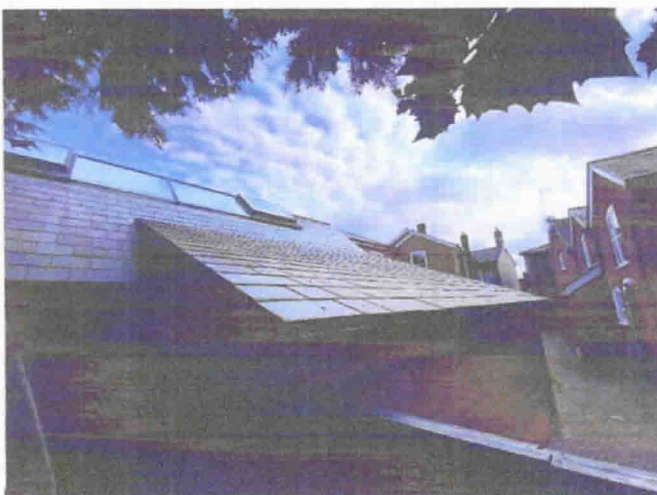
Due to the shallow pitches and shape of the roofs, we were unable inspect areas of the roof from ground level. Accordingly, we are unable to guarantee that there are no defects to those areas that are hidden from view. However, there were no indications internally of any problems with these areas.

Studio roof

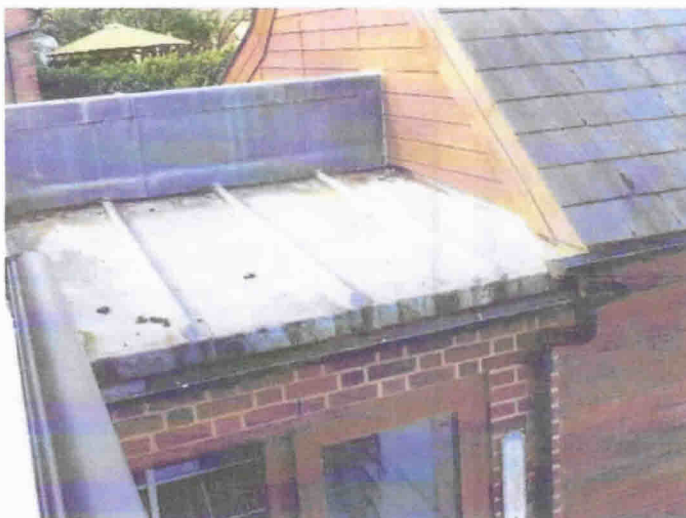
The various flat roofs are covered with a sheet lead covering. These roof coverings are in a good condition. This type of roof covering is particularly durable and long lasting. The lead appears to have been installed to a good standard and no issues or matters of concern were noted.

lead roof over link

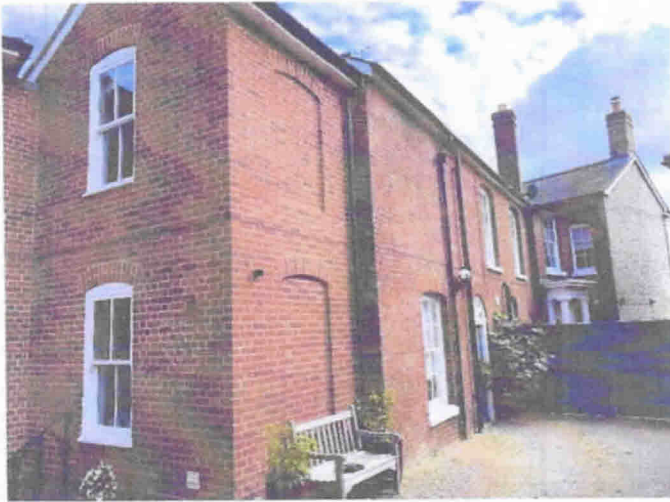
The gutters and downpipes are mainly in powder coated aluminium and of a good quality and in a good condition with no areas of significant concern evident at the time of the inspection.

general view of rainwater goods

One area that could however be improved upon is to the rear right hand side, where a downpipe discharges onto the ground. This is making the area quite dank and ideally this should be connected to the underground drains.

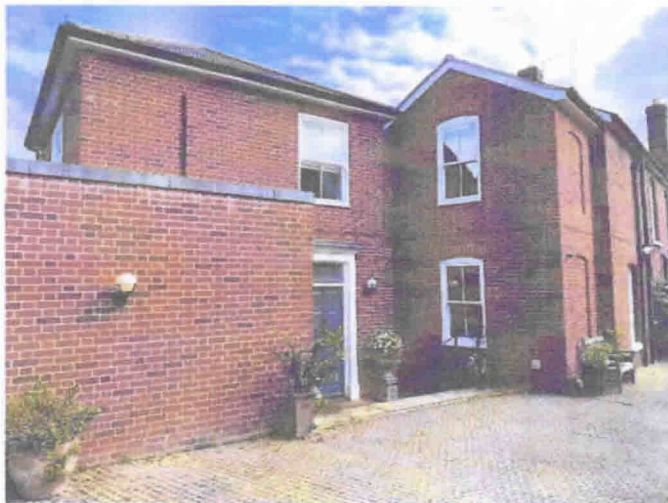
The brickwork to the recent rear extension is in a good condition with no areas of concern evident.

rear extension brickwork

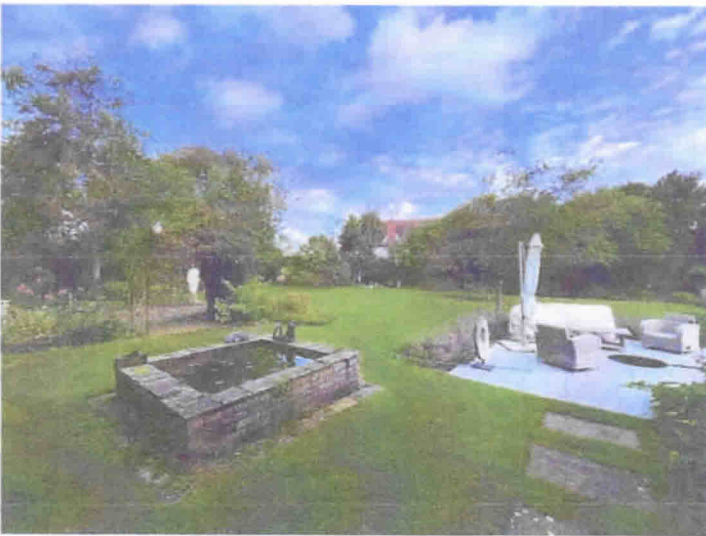
The boundaries comprise mainly brick and flint wall with a small section of timber fence to the rear RH end.

These appear in a satisfactory overall condition. However, timber fences do have a limited life and some repairs / replacements should be expected in the short term.

We advise the ownership of the boundaries is clarified by your conveyancer.

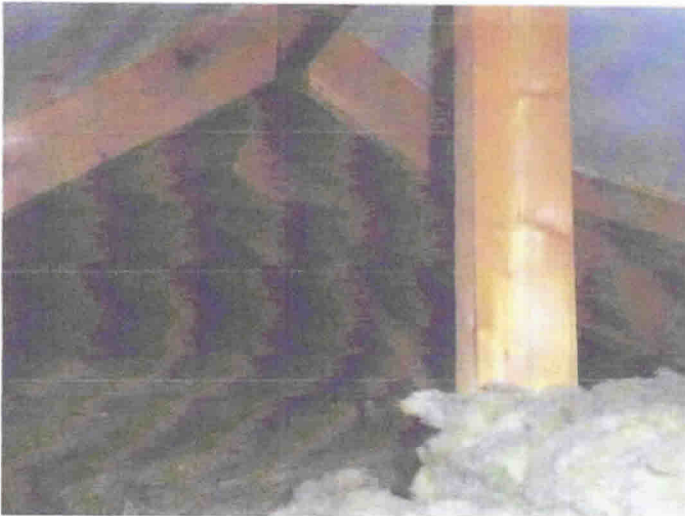
A limited inspection of these and the roof space was possible due to the low headroom. We noted this area has a breathable membrane under the slates that allows an air flow through the roof void and that the trusses appeared well fitted.

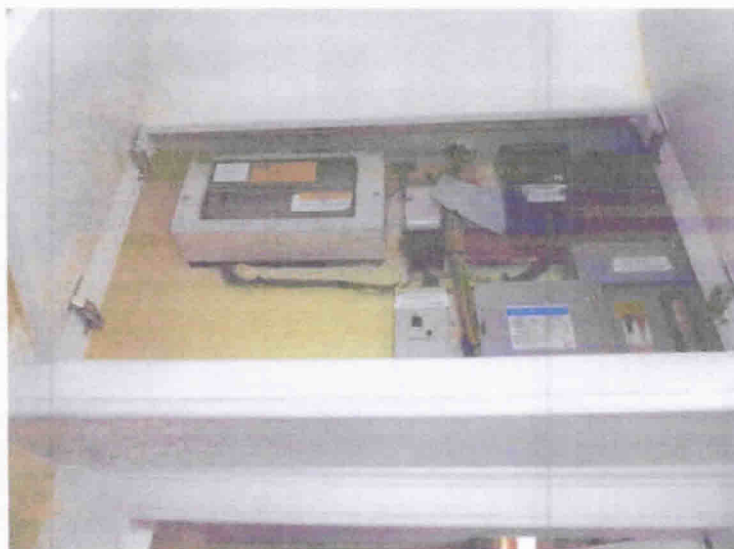
A modern RCD /MCB protected consumer unit and the meter are fitted internally, adjacent the front door.

main house distribution board

However, it is advised that electrical installations are tested every 10 years and on change of ownership and therefore this may be advisable to confirm the overall condition of the installation.

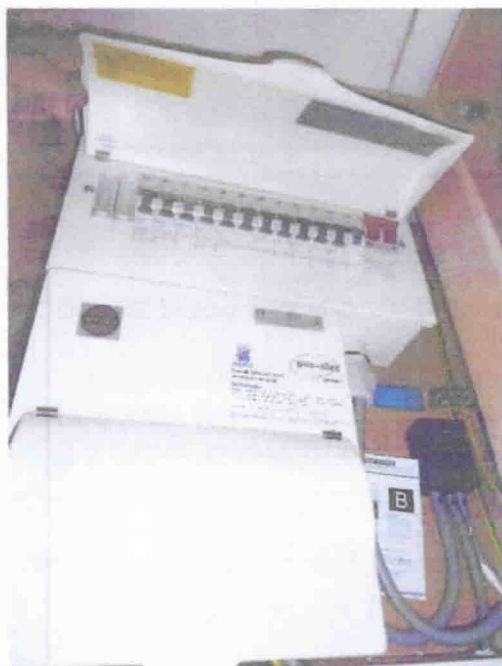
To the stable flat, the distribution board is fitted in the ground floor lobby.

Stable flat distribution board.

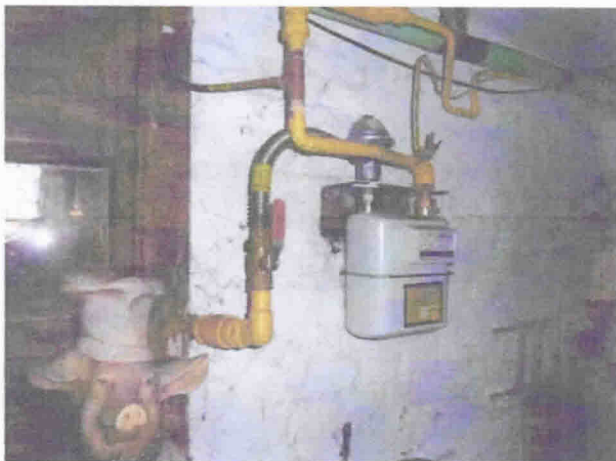
A mains supply is connected. The meter is located in the cellar at the front.

The installation appears in a satisfactory condition and there was no smell of gas evident.

We would however recommend that the installation is inspected by a Gas Safe registered engineer to confirm its integrity.
