**Site Investigation including
Quantitative Risk Assessment
Pine House
Stowlangtoft
Suffolk
104909
December 2023**

Client:
HLD Developments Ltd
Old Hall Green Farm Barn
Old Hall Lane
Cockfield
Bury St Edmunds
Suffolk
IP30 0LQ

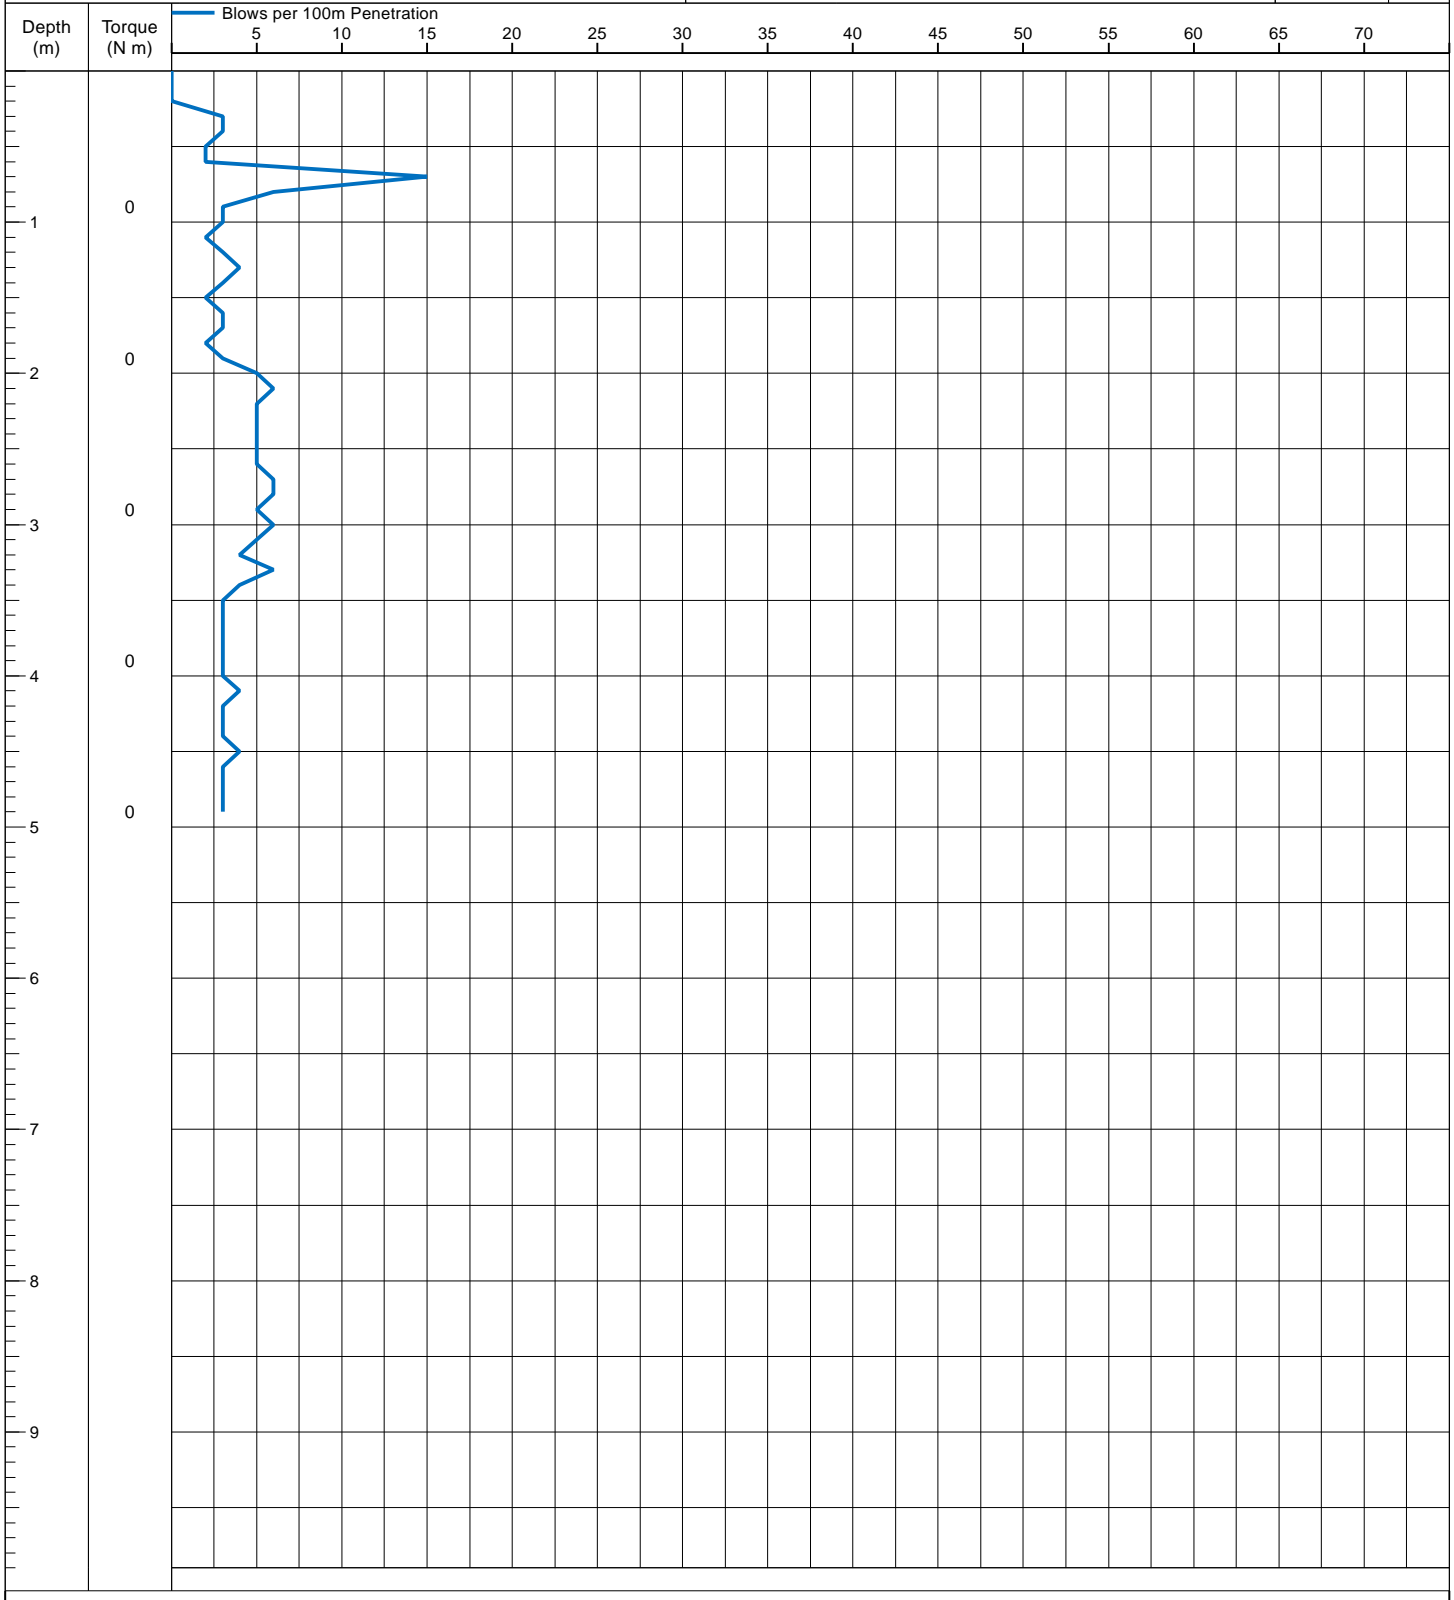
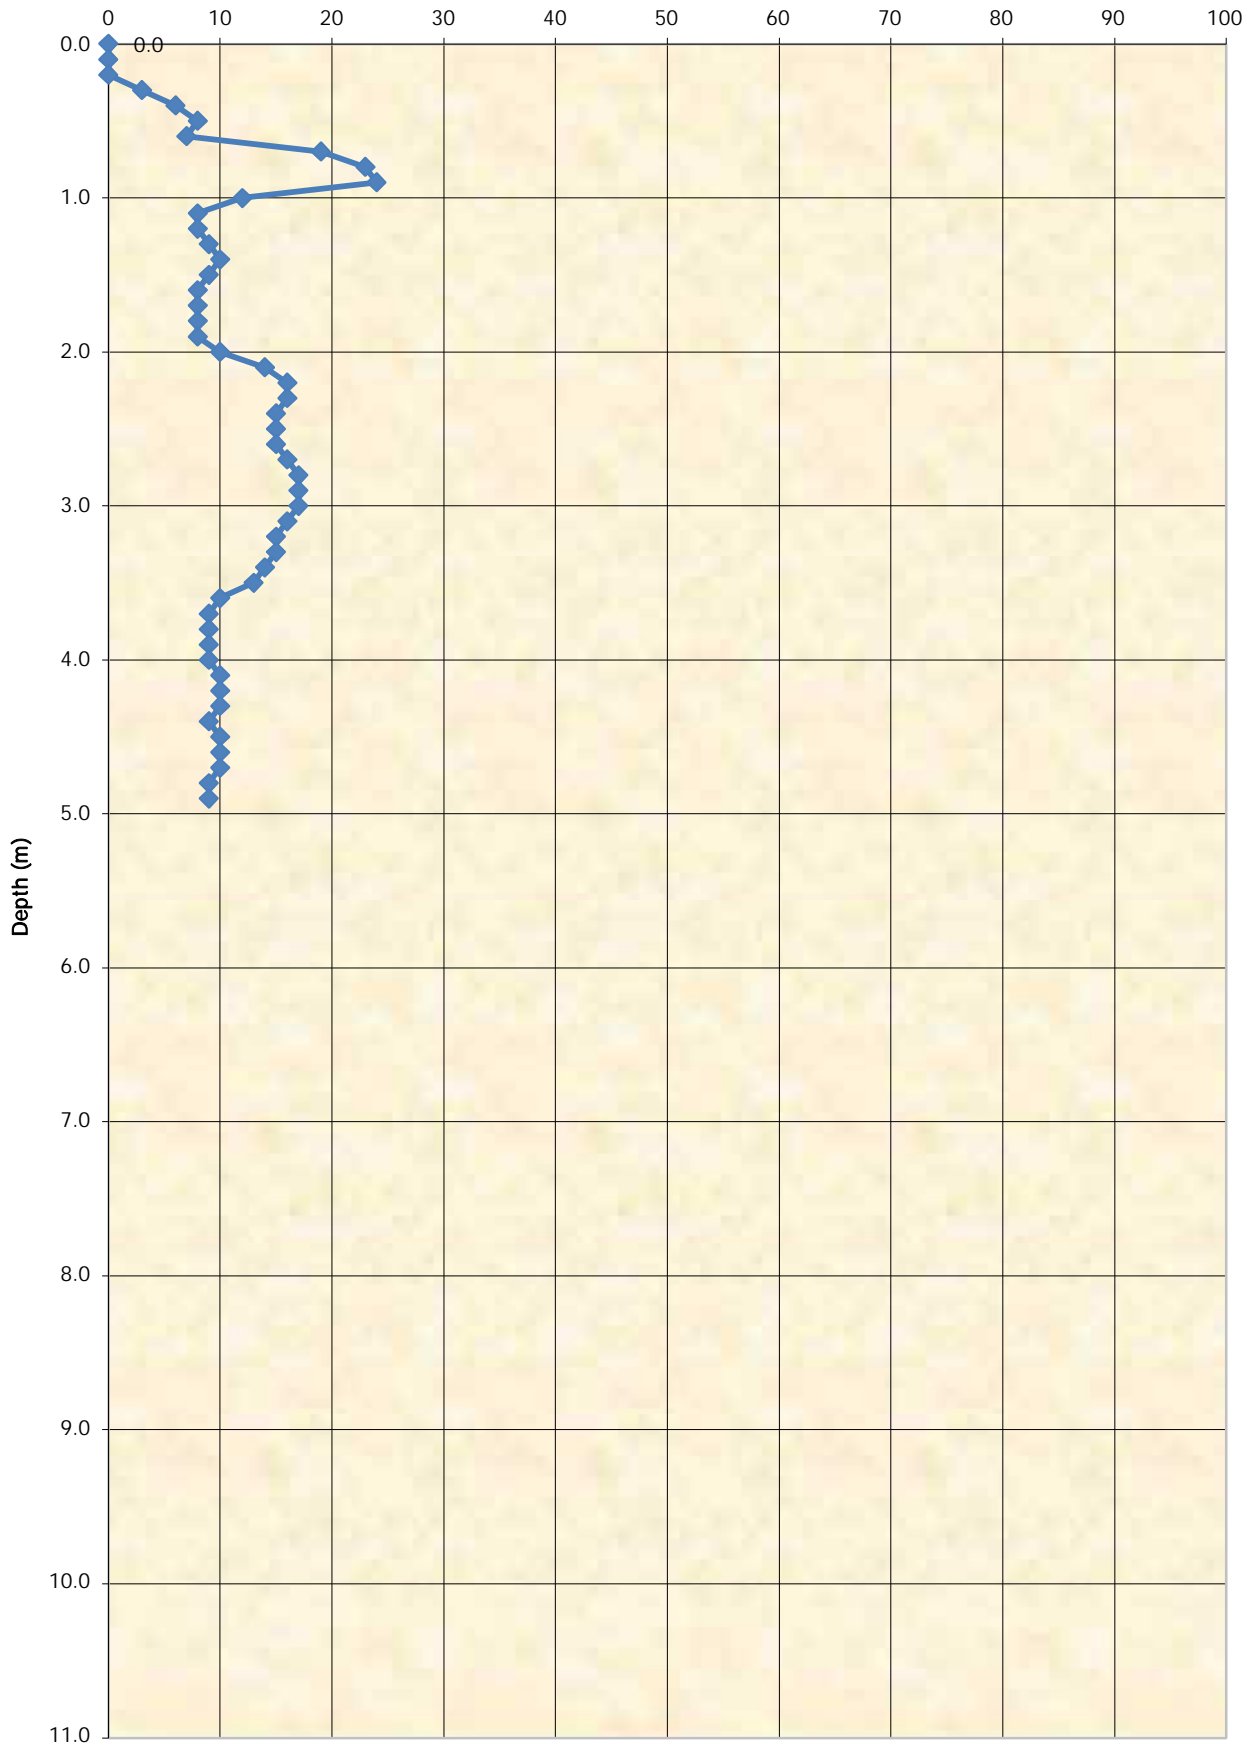
104909 Pine House Stowlangtoft
DP19

Scheme	Pine House Stowlangtoft Site Investigation	Job No.	104909	Probe No.	19
Carried out for	Lewis Tombs	Date Started	29/11/2023	Date Finished	29/11/2023
Dimension (mm)	50	Probe Type	DPSH-B	Type of Rig	Premier 110
Remarks:				Logged by	DJ
				Depth (m)	4.90
				Ground Level (m AOD)	0.00
			Co-ords	595139 - 267824	Checked by
					IDB

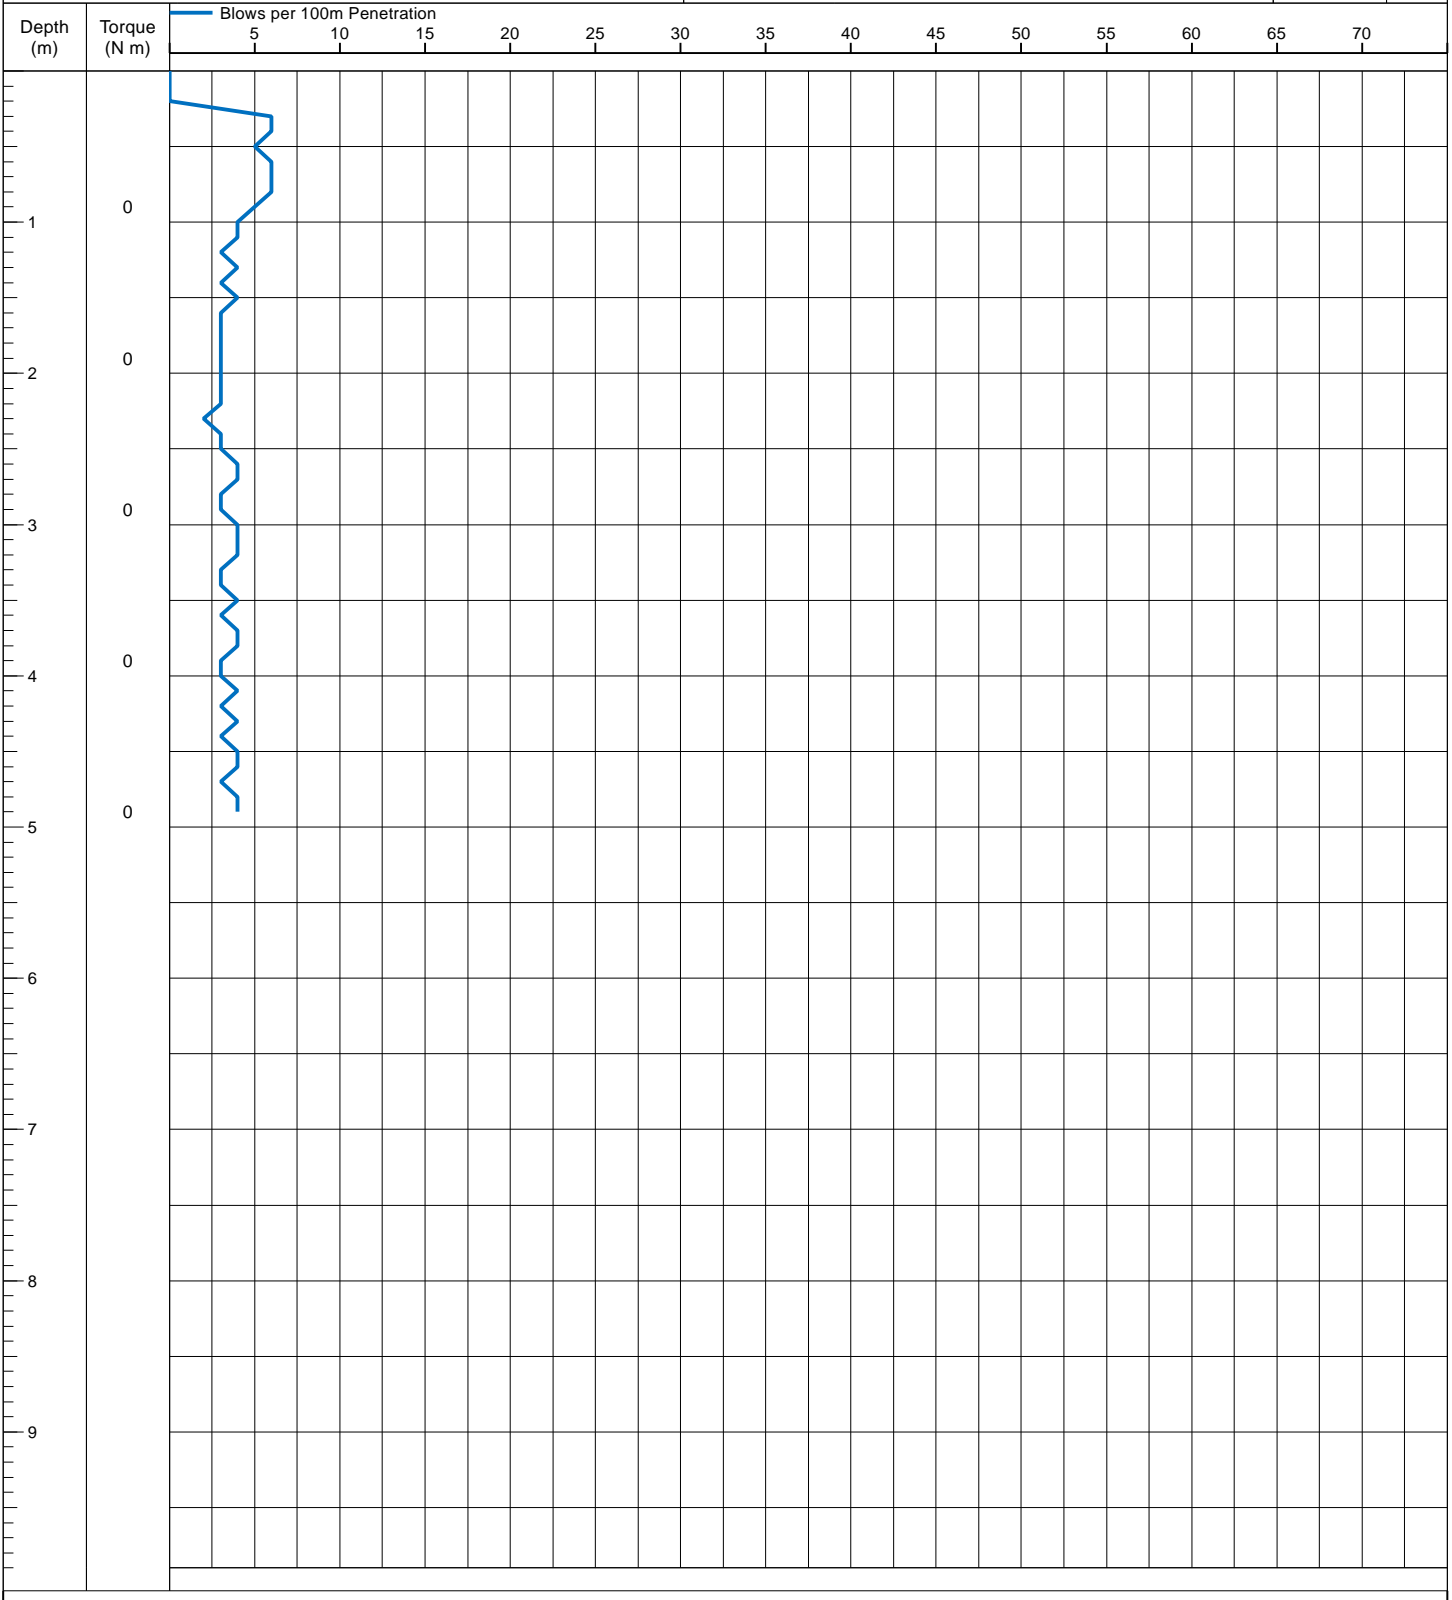
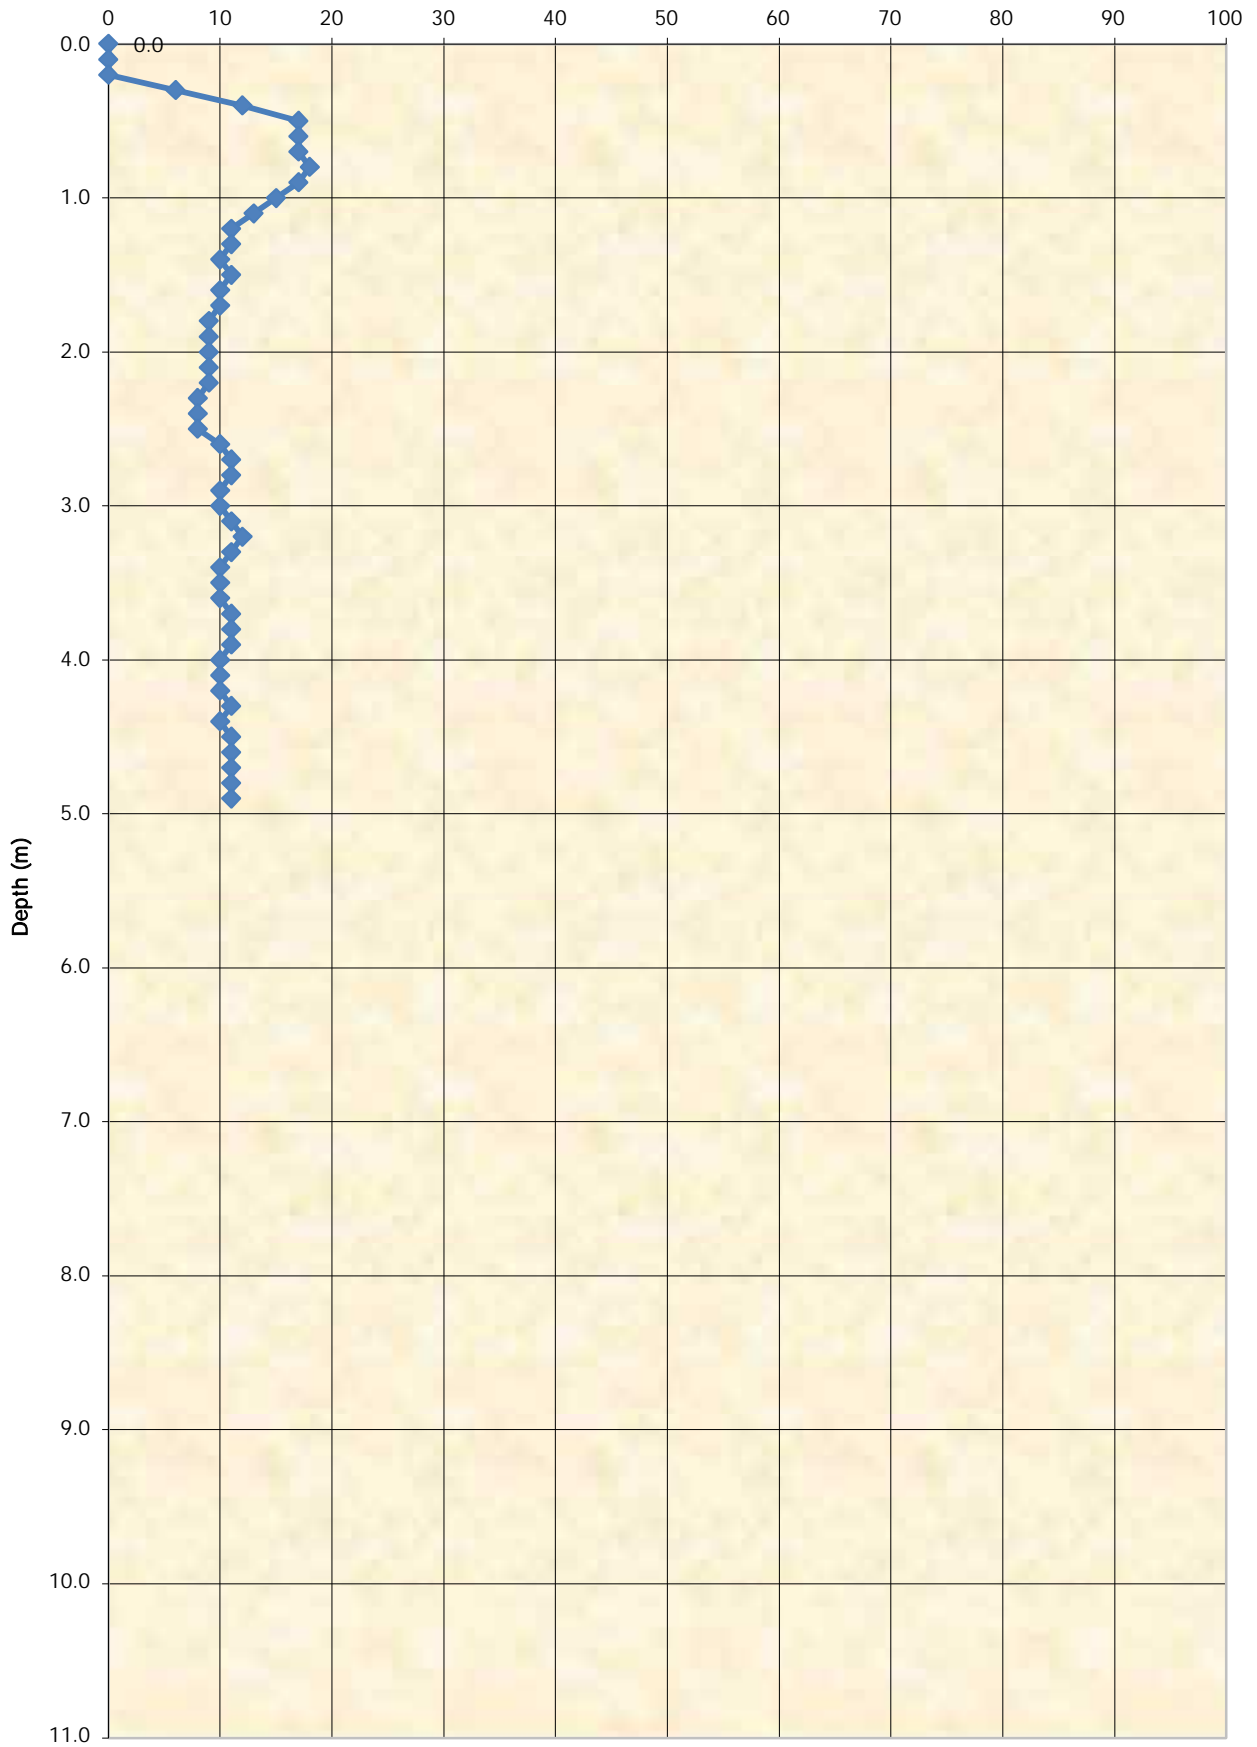
104909 Pine House Stowlangtoft
DP20

Scheme	Pine House Stowlangtoft Site Investigation		Job No.	104909	Probe No.	20		
Carried out for	Lewis Tombs		Date Started	29/11/2023	Date Finished	29/11/2023		
Dimension (mm)	50	Probe Type	DPSH-B		Type of Rig	Premier 110		
Remarks:			Depth (m)	4.90	Ground Level (m AOD)	0.00		
			Co-ords	595163 - 267829			Checked by	IDB
