BS5837:2012 Tree Survey Report

Proposed Construction of 7 Self Contained Apartments at

23 Crescent East, Hadley Wood EN4 0EY

30th August 2023

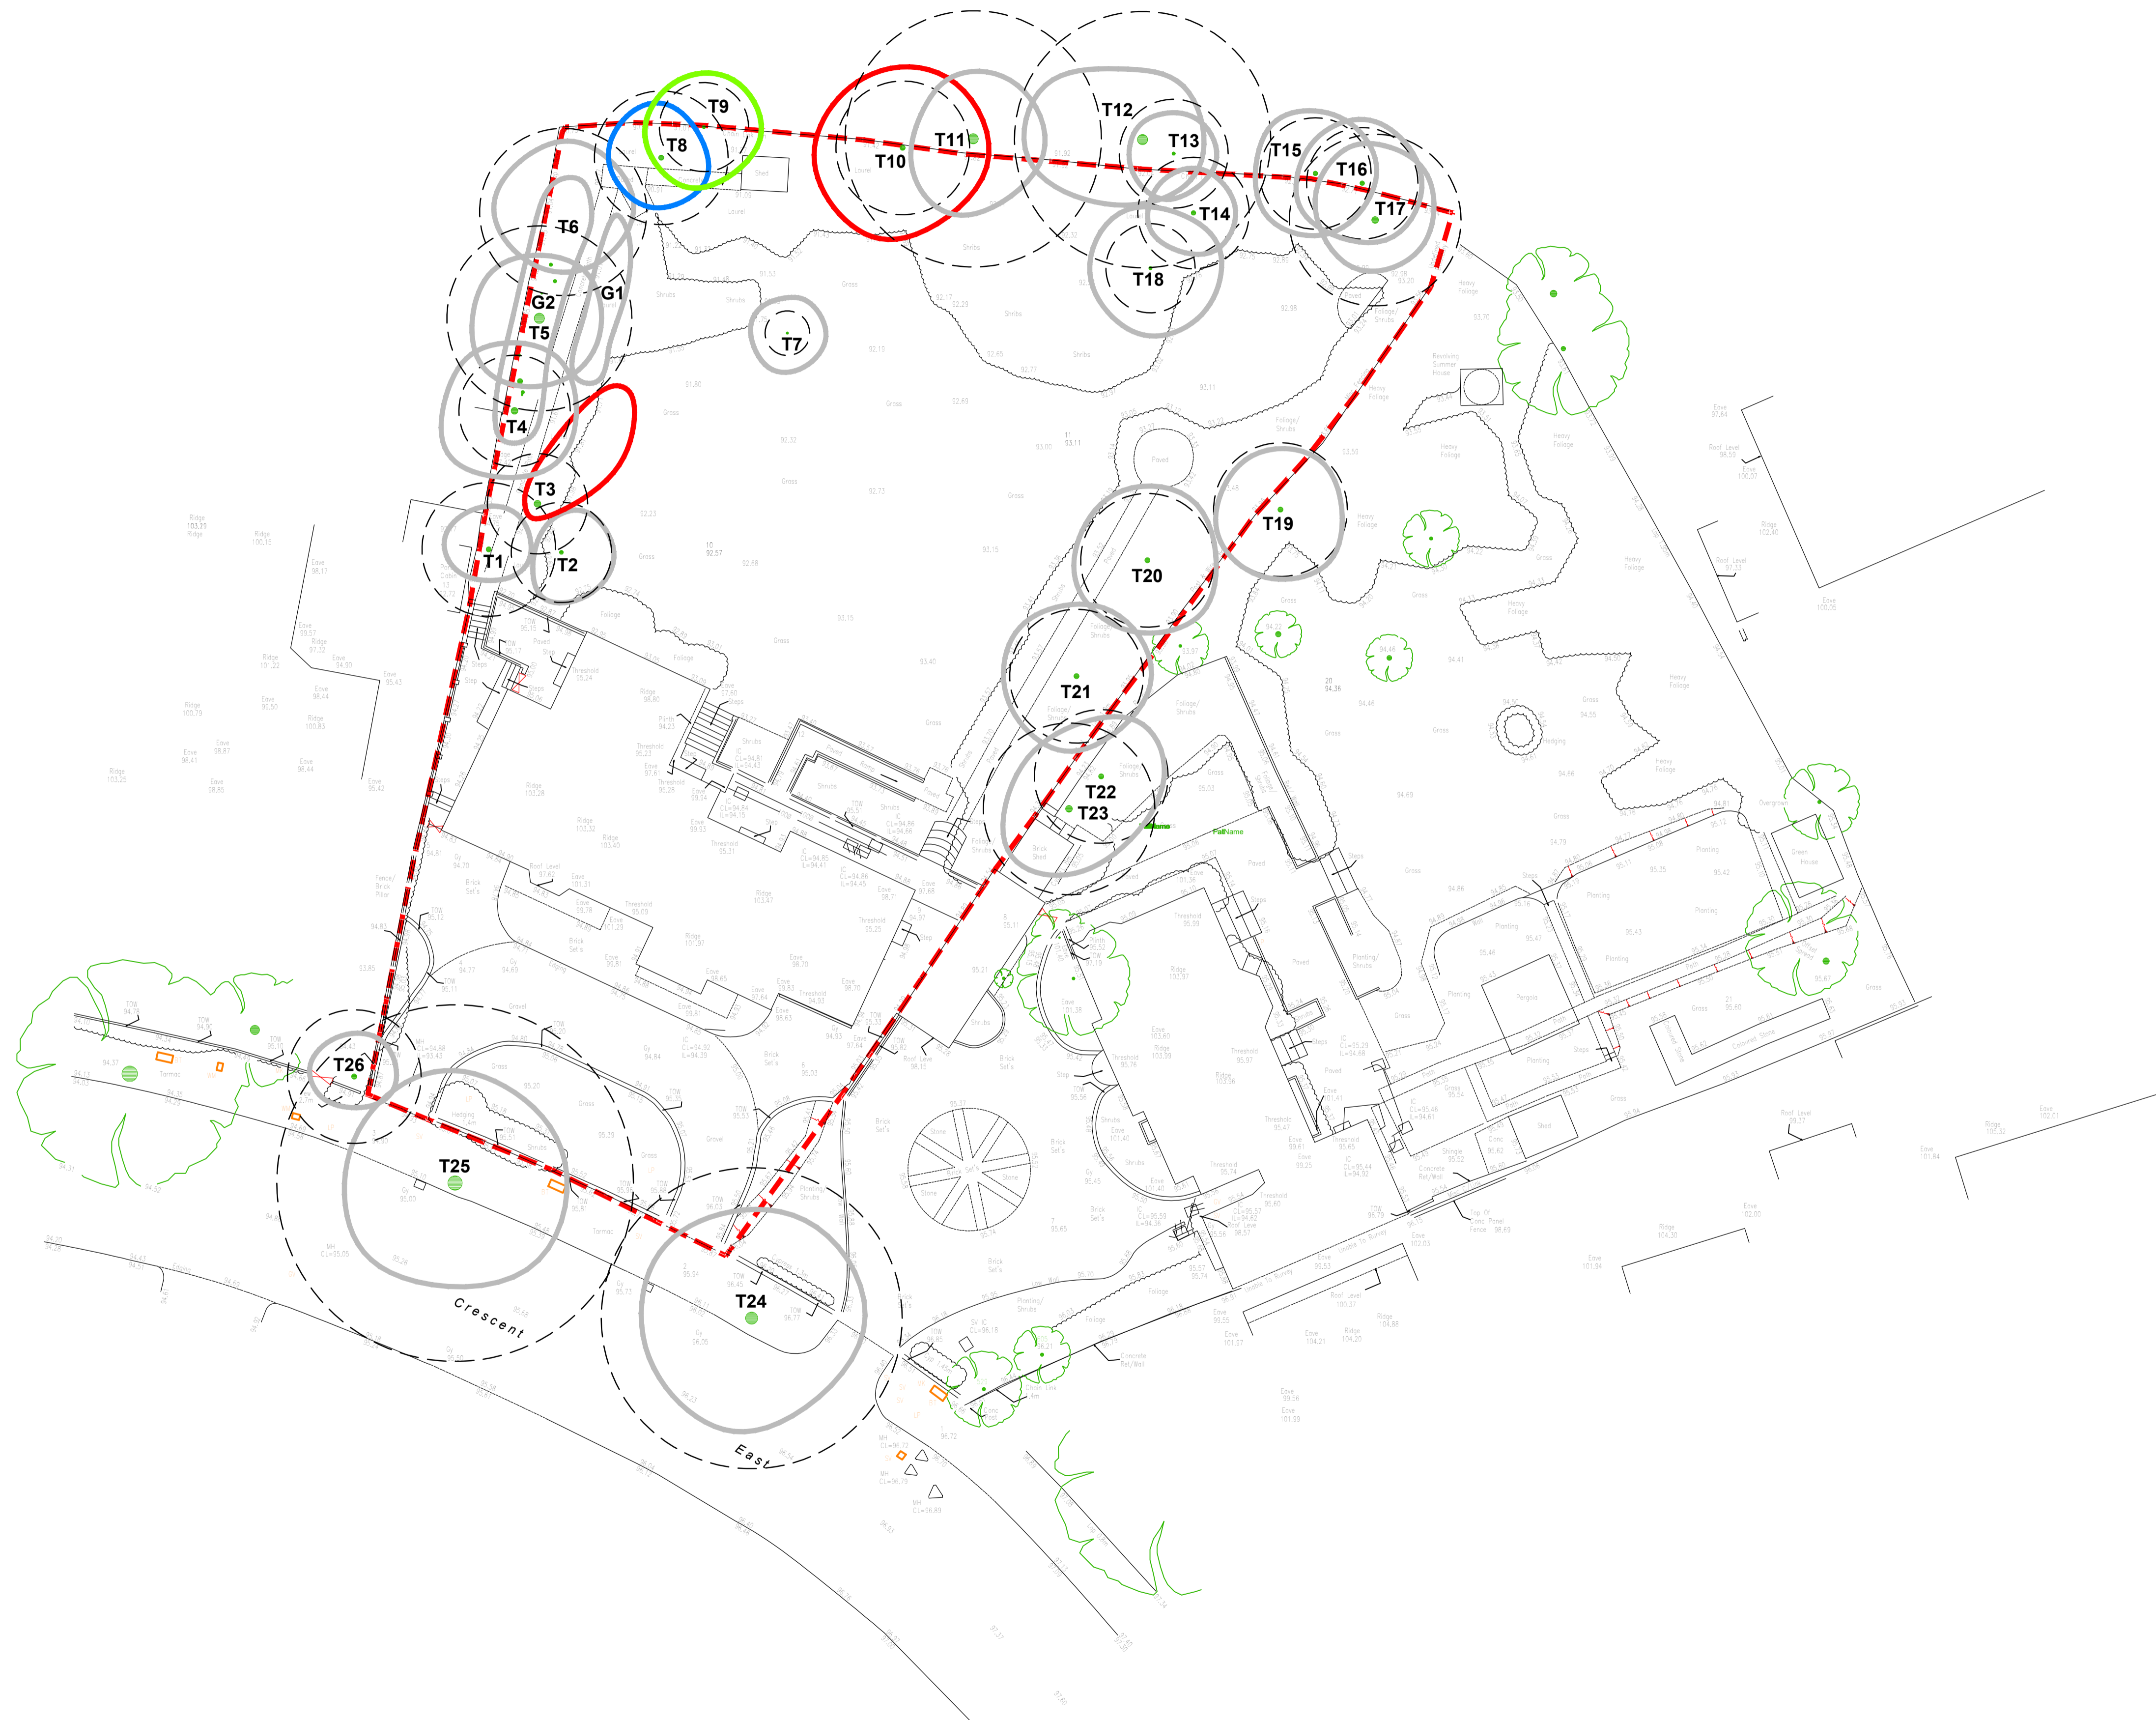
Appendix B - Tree Survey Plan & Tree Protection Plan

- 4.8 Details of the locations and Root Protection Areas (RPA) are provided on the Tree Protection Plan (TPP) appended to this report.
- 4.9 A schedule of trees and their condition including their category grading and RPA radius is attached in Appendix A.

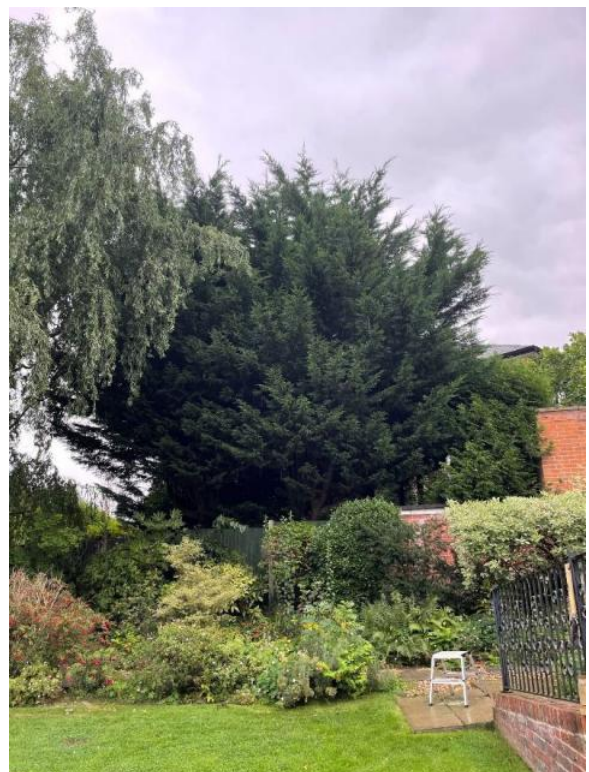
Photo 16 - View of T22 & T23

Ref	Species	Height (m)	Stem Diameter (mm)	Branch spread (m)				Height crown clearance (m)	Age class	Condition & Comments	Years left	Category grading	RPA (m ²)	RPA radius
				N	E	S	W							
T23	Cupressus leylandii (Leyland Cypress)	11	385	3.5	3.5	3.5	3.5	2.5	M	Poor. Part of a pair of conifers that appear to have been recently reduced in height and left in an unnatural shape.	<10	U	67	4.62
T24	Tilia x europaea (Lime)	17	675	6.0	6.0	6.0	6.0	4	M	Good. Located off site within highways verge. Roots extend under footway and existing driveway.	20+	B2	206	8.10
T25	Tilia x europaea (Lime)	18	800	6.0	6.0	6.0	6.0	4	M	Good. Located off site within highways verge. Roots extend under footway and existing driveway.	20+	B2	290	9.60
T26	Cupressus leylandii (Leyland Cypress)	16	300	2.0	2.0	2.0	2.0	1.8	YM	Good. In neighbouring property	20+	B2	41	3.60
