3.0 Results of Inspection

3.1 General Site Description

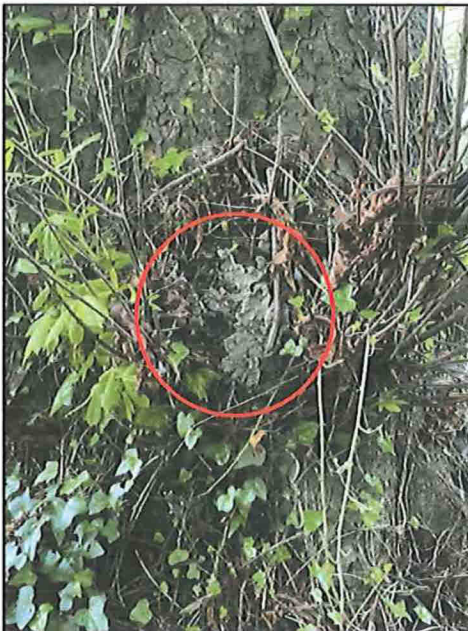
- Common beech trees are susceptible to a decay fungus called *Kretzschmaria deusta*, which starts off as a grey crust - see below

Fig.3 - library image of *Kretzschmaria deusta* fruiting body on a Horse chestnut tree circled red

- Principally affecting the lower stem and principal roots of the host tree, the fungus forms a soft rot in its early stage which eventually makes the wood brittle; in advanced stages, it can lead to catastrophic failure
