BS5837:2012 Tree Survey  
 Land at 51 Main Street  
 Wilsford  
 Lincolnshire  
 NGR TF00217 43129

Report prepared by: C Barker	Date Issued: 04 November 2021
	Reviewed by: KLB	Report Version: V1
	Report ref: <b>P2343 /1121 /01</b>	C B E Consulting Highbank, 5 Grantham Road, Navenby Lincoln. LN5 0JJ. Telephone (01522) 810086. <a href="http://www.cbeconsulting.co.uk">www.cbeconsulting.co.uk</a>

# BS5837 Tree Survey, Land at Main Street, Wilsford

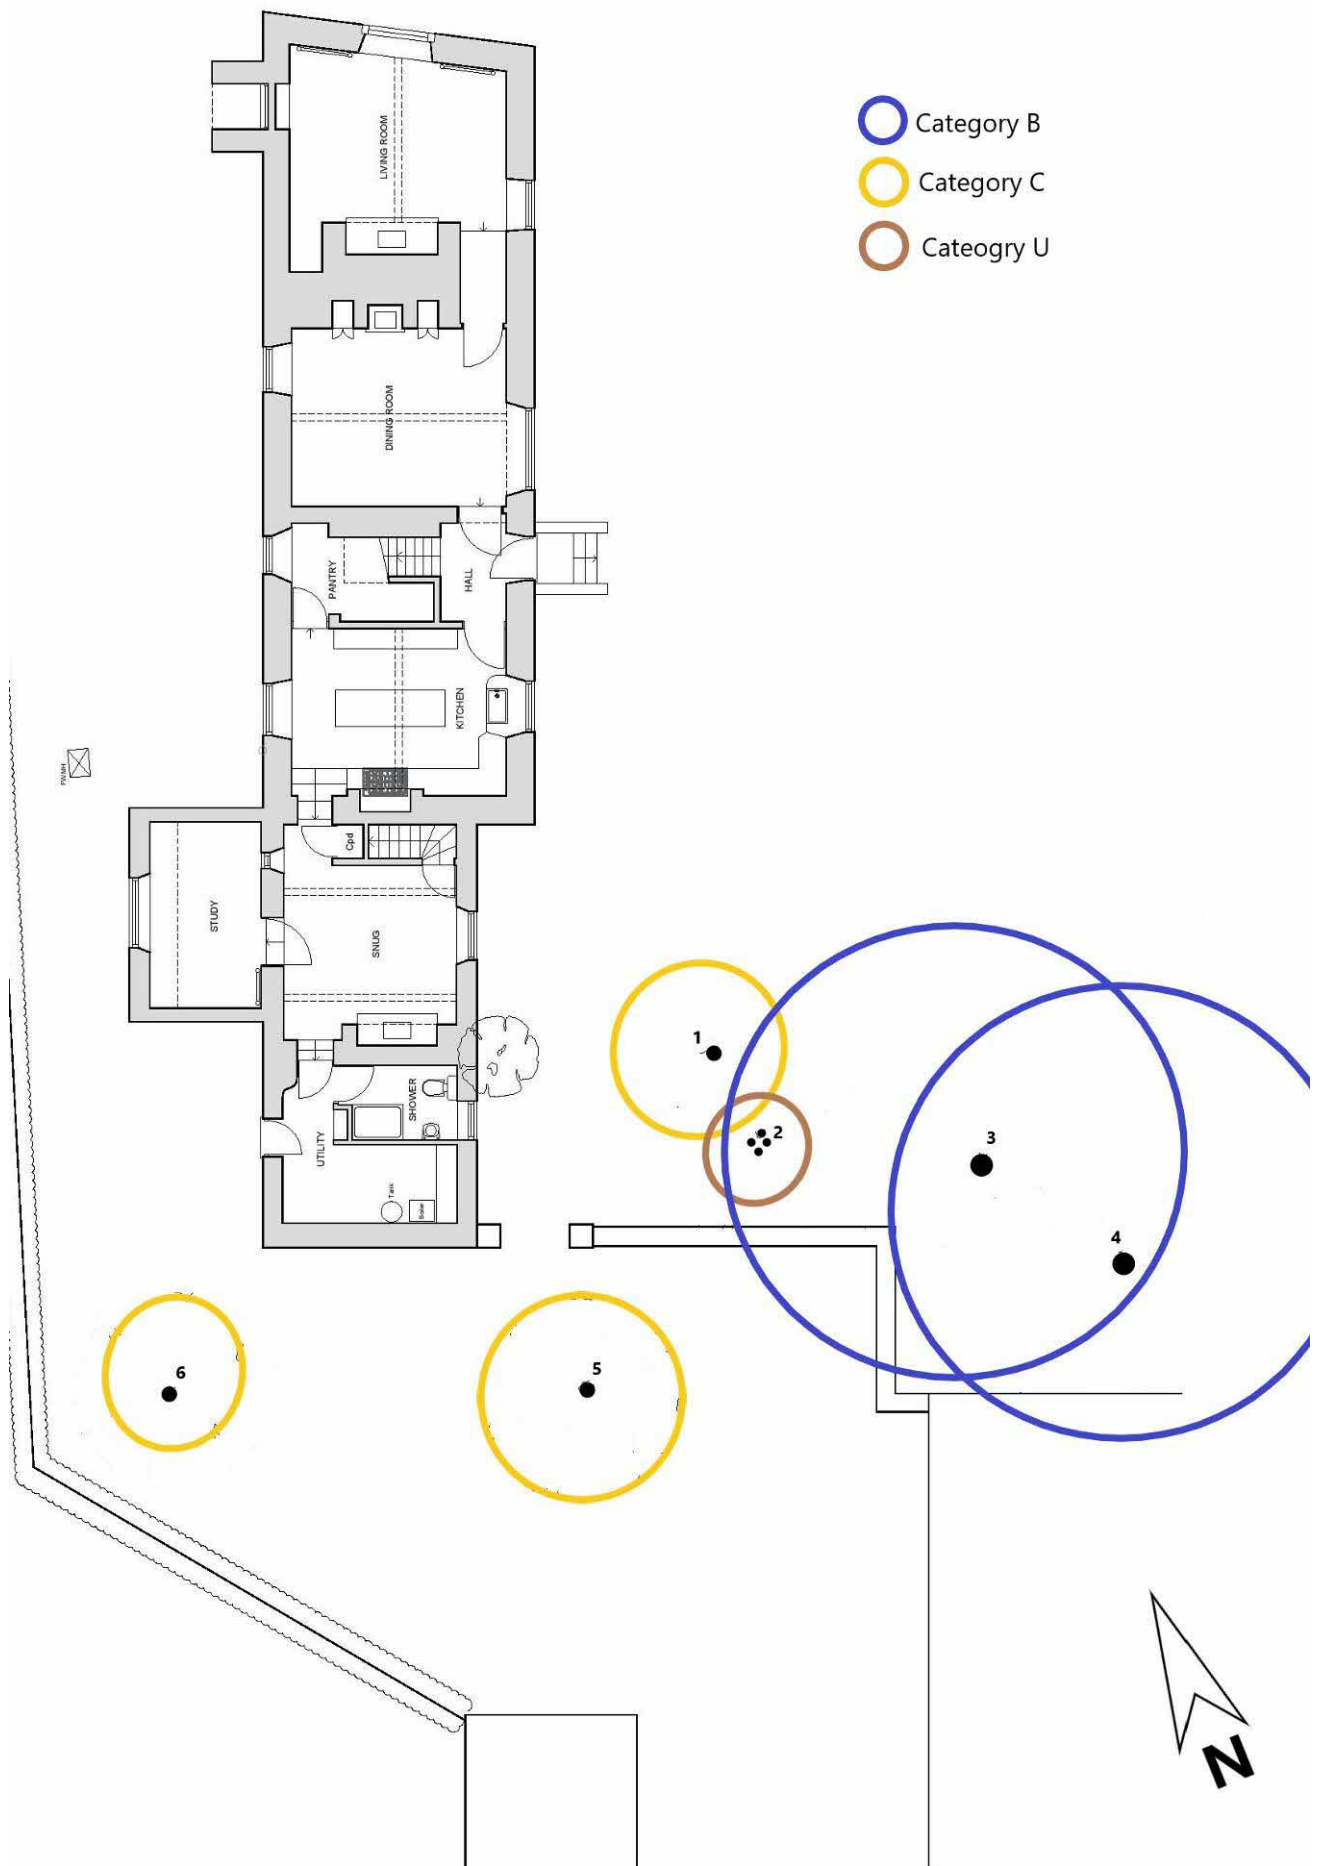
Figure 3 – Tree Category Plan

The position of significant individual trees or groups of trees measured out on the site is shown on the Tree Location Plan **Figure 3**. Within the summary table (**Appendix 1**) a calculated corresponding radius of the circle for each RPA has been calculated. The Root Protection Areas are formulated to assist when designing layouts in relation to trees and the calculated RPAs in Appendix 1 should be used to inform the design layout of this site. A proposed development plan has been provided and this has been used to show the impact on the trees within **Figure 4**.
