## REPAIR OF WOOD WINDOWS AND EXTERNAL DOOR

The Mill Cottages, Mill Lane, Empingham

Client : Mrs M. Griffin

February 2024 V1

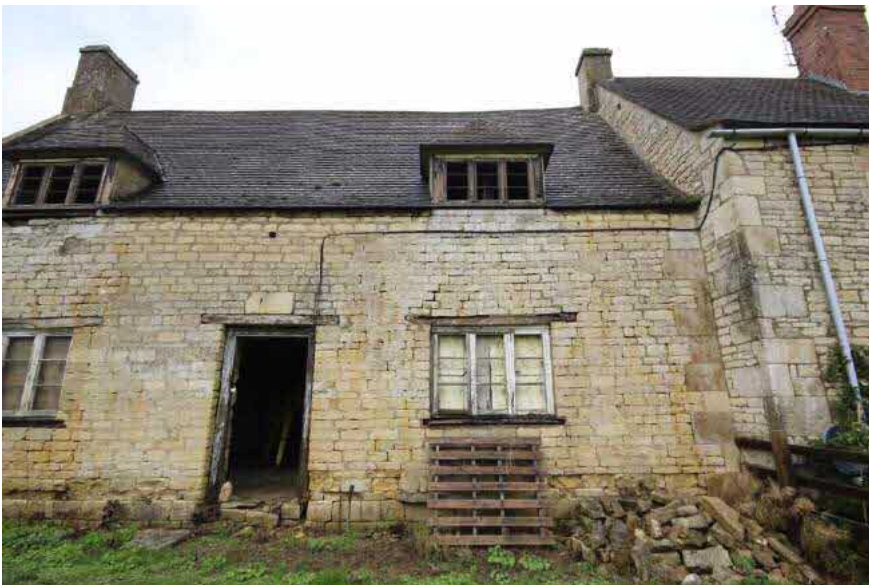
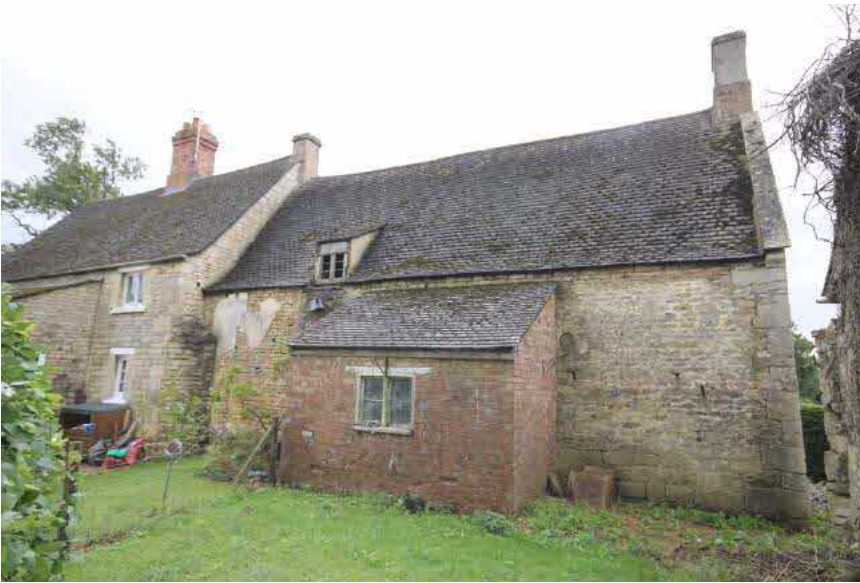
All of the windows and the plank front door serving the property were found to be in a poor condition and it is the purpose of this document to set out how said identified windows are to be restored.

\* All windows are considered capable of repair and restoration (none or the original glass remains)  
The front plank door is also considered capable of repair and restoration.

All restorative works to existing timber mullion/casement windows to be carried out in full accordance with the guidance set out in SPAB Technical Advice Note - Repair of Wood Windows.

**\*The same approach to the restoration of the front door in relation to timber entrance door will apply.**
