ARBORICULTURAL ASSESSMENT REPORT

Henham Village Hall, High Street, Bishop's Stortford CM22 6AR

PRI Ref: 264862

Survey Date: 30/06/2023

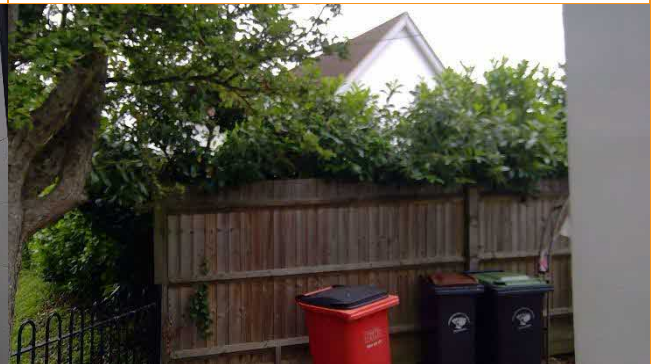
H1 - Laurel (Cherry)

Tree No	Common Name	Age Class	Condition	Height (m)	Crown Spread (m)	Stem diam. (mm)	Dist to bldg. (m)	Roots Implicated	Pruning history	Recommendation	Tree work constraints	Notes	Owner address	Owner
H1	Laurel (Cherry)	Mature	Fair	3.2	1.8*	60*	1.2	N	Managed as a hedge.	No work required.			Saffron House High Street Henham Bishop's Stortford CM22 6AR	P3P
T1	Hawthorn	Mature	Poor	6.3	7.0	320	2.68	N	Subject to past management. No significant recent management.	Fell and treat stump with eco plugs (broadleaved)..	Phone/Power lines through crown.		Henham Village Hall High Street Henham Bishop's Stortford CM22 6AR	PH
T2	Lime	Mature	Fair	17.0	13.8	610	15.21	N	Subject to past management. No significant recent management.	No work required.			District Land Registry Search Required	UKN
T3	Lime	Mature	Fair	15.6	14.8	770	12.95	N	Subject to past management. No significant recent management.	Fell and treat stump with eco plugs (broadleaved).	Phone/Power lines through crown.		Henham Village Hall High Street Henham Bishop's Stortford CM22 6AR	PH
