ARBORICULTURAL REPORT

Ardleigh Oaks, Old Ipswich Road, Ardleigh, Essex, CO7 7QR

H T Industrial Ltd

OUR REF: SHA 1720 Rev A

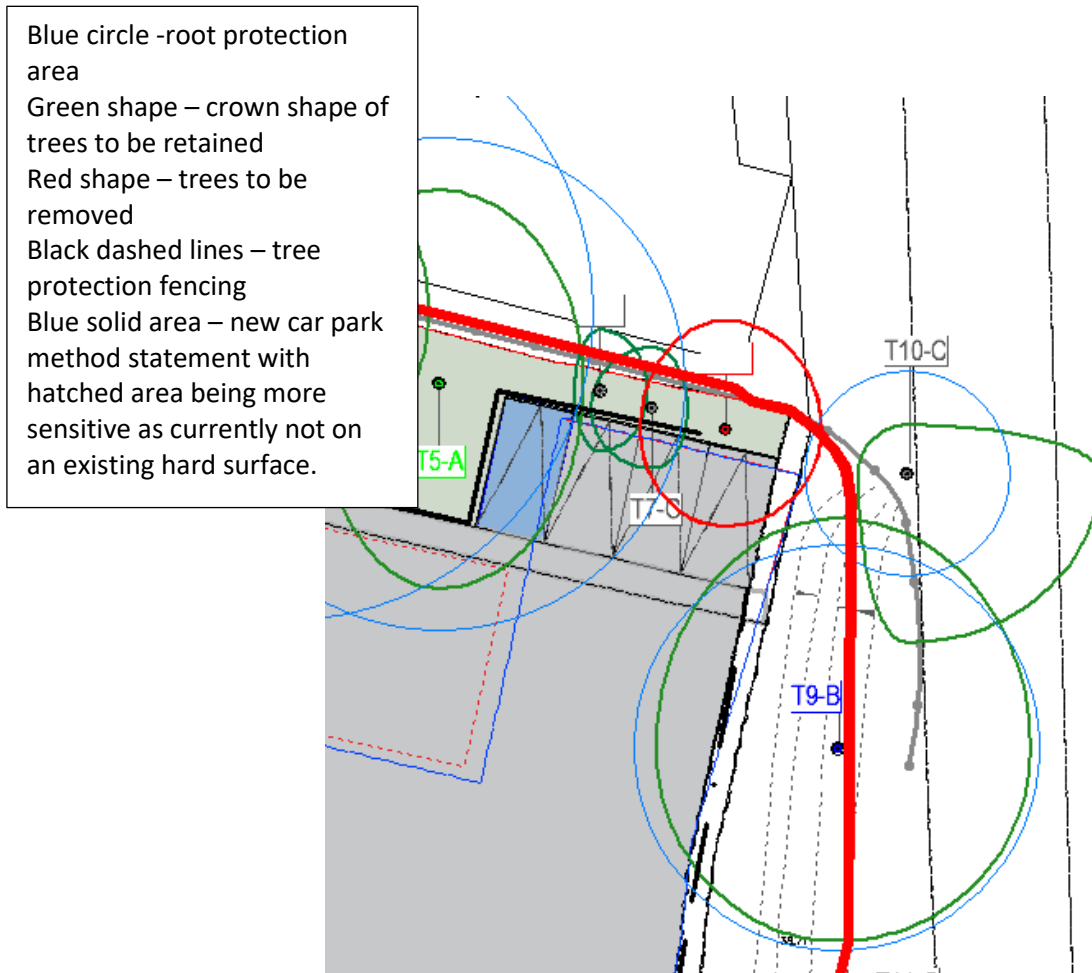
Plan 2 – extract from SHA 1730 TPPA. Do not scale, north is vertical.

Crown lifting and dead wood removal will take place over the hard surfaces, but not where the trees are growing over open ground. Two small trees, T6 (C) and T7 (C) will be pruned back to ease parking. All tree works are detailed in appendix 4 – Tree Surgery Schedule.

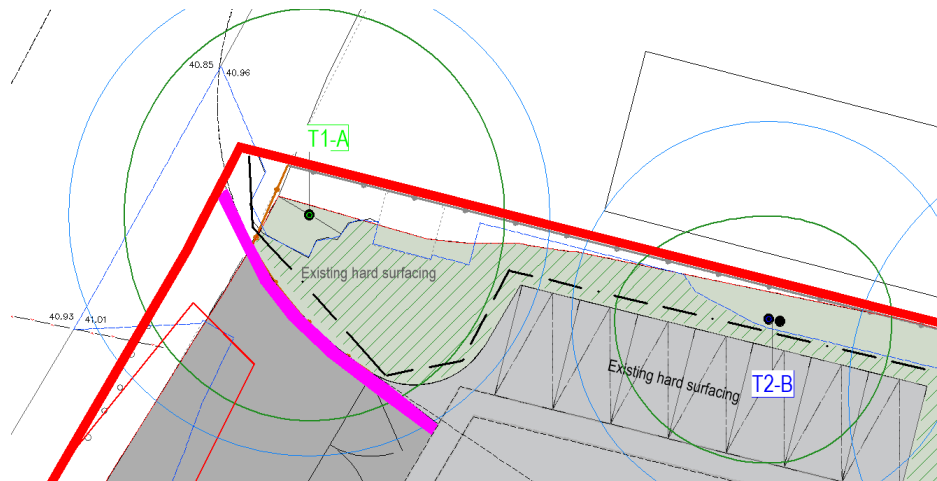
T5 oak (A), T20 ash (B) and T22 oak (B) – the installation of the parking will be carried out using minimal/do dig construction and porous tarmac with timber or steel edge treatments in the root protection areas of these trees.

Plan 3 – extract from SHA 1730 TPPA. Do not scale, north is vertical. Pink is the kerb installation and green diagonal hatching is the area where Arboricultural Method Statement applies for lifting hard surfacing.

A draft Arboricultural Method Statement at appendix 6 section 10 addresses this, and will be developed further post planning.

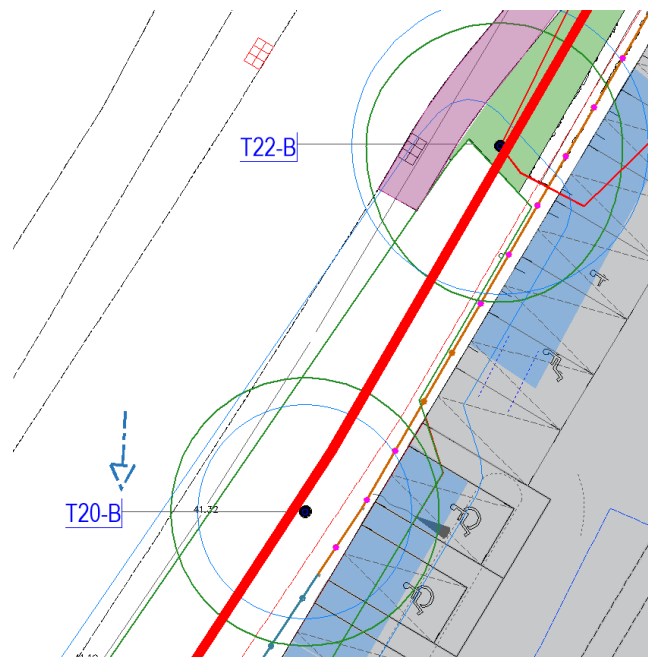
T20 and T22 (B) - will have new security fencing. Where the posts are within the root protection areas, the method statement at appendix 6 section 12 applies. The footpath on the highway within the root protection area of T22 will have to be constructed to ECC standards who (at the time of writing) do not accept porous construction and have a standard specification. Arboricultural supervision will ensure minimal dig to retain any rotos that may be growing under the proposed footpath.

Plan 4– extract from SHA 1730 TPPA. Do not scale, north is vertical. Blue area is for new hard surfacing (porous tarmac) and the purple area if for the new tarmac footpath.

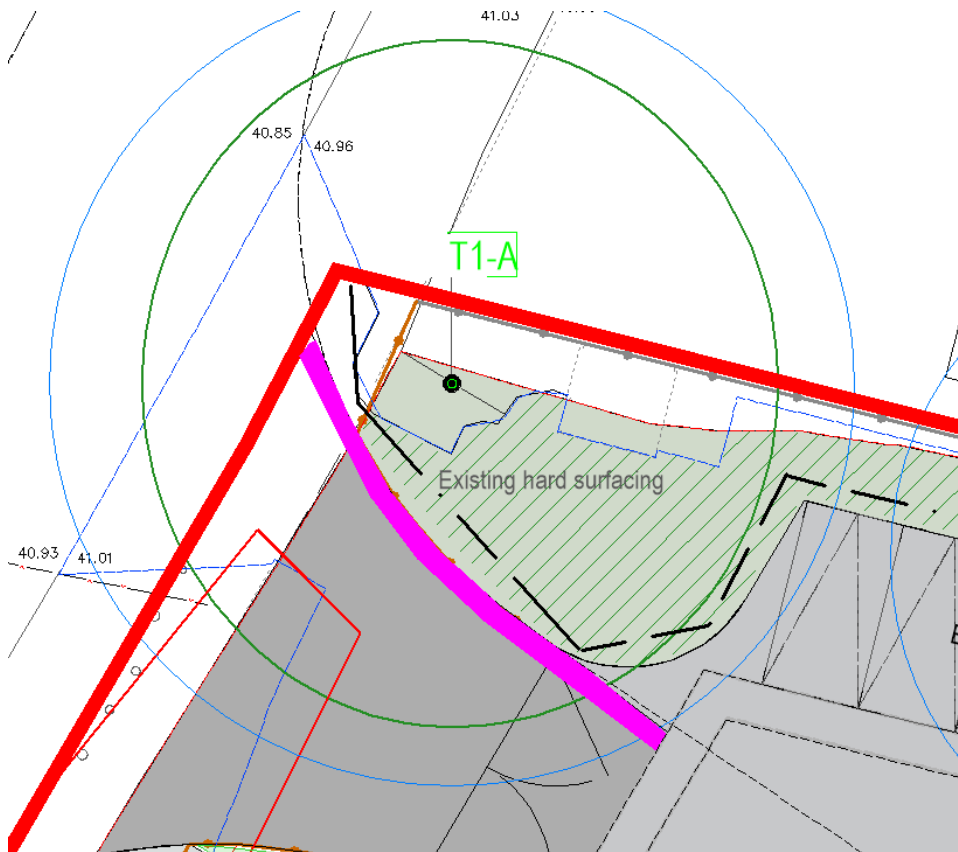
Plan 5 - extract from SHA 1720 TPPA. Do not scale, north is vertical.

Pink area is for the kerb method statement (if a kerb is required). Green diagonal for the removal of hard surfacing and replacement with soft surfacing

10.0 **New hard landscaping:** All hard landscaping is within the existing hard landscaping and is likely to be a matter of top dressing. Where the new road access alignment comes in, if there is a kerb, the kerb area shown pink on the plan SHA 1720 will be dug under arboricultural supervision and sleeved with polythene to prevent the alkalinity of concrete from scorching roots. The principle is that all roots with a diameter greater than 20mm will be retained.

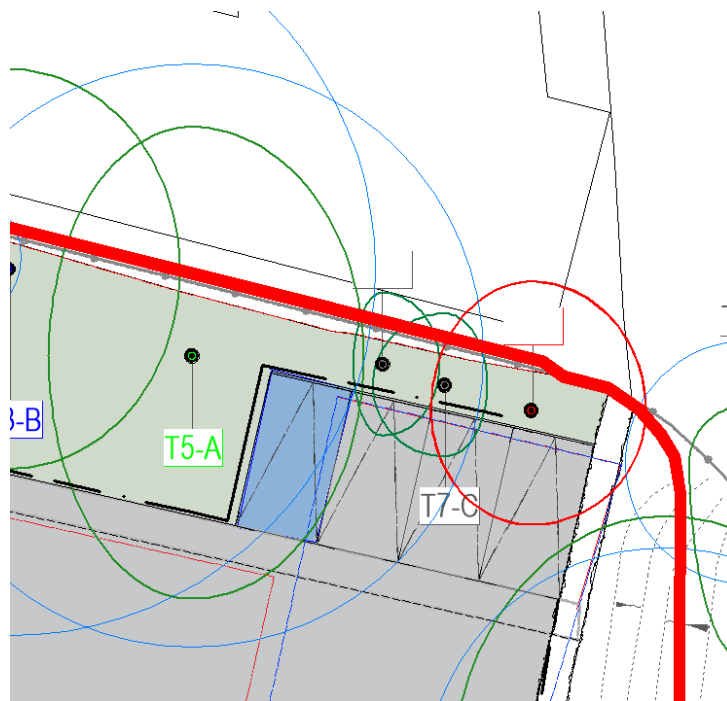
Plan 6 - extract from SHA 1720 TPPA. Do not scale, north is vertical. Blue diagonal hatched area is for the hard surface method statement where currently it is semi-soft landscaped.

The purpose of the method statement is to ensure that tree roots are retained and that they can function. Therefore, digging down, compacting the soil and creating an impermeable surface will be prevented. A method to spread and support the load of the hard surface and anticipated usage without causing compaction of the soil structure beneath will be used. The sub-base will be porous to enable gaseous exchange and water infiltration. A suitable material is washed angular stone with a diameter between 20 – 40mm with no fines. Aggregates or stones must have a near neutral PH. The surface material will be permeable paving.
