# Gale Tree Consultancy

## Tree Condition Report

New Grove Petworth

Ref: TCR/292/21

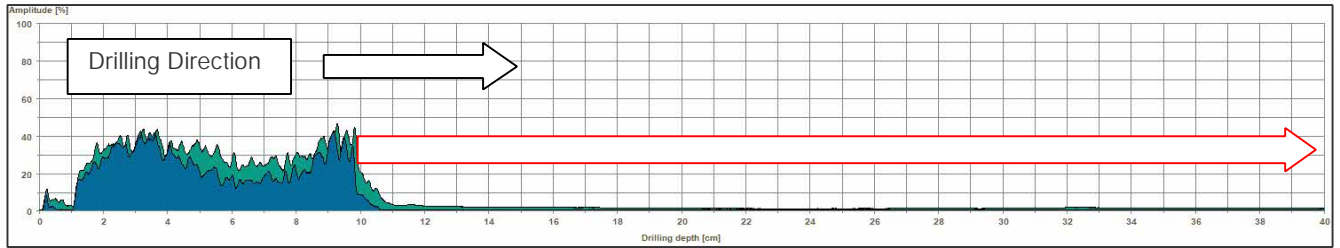
On the example overleaf, extensive decay is indicated from a depth of 10cm through to the end of the assessment

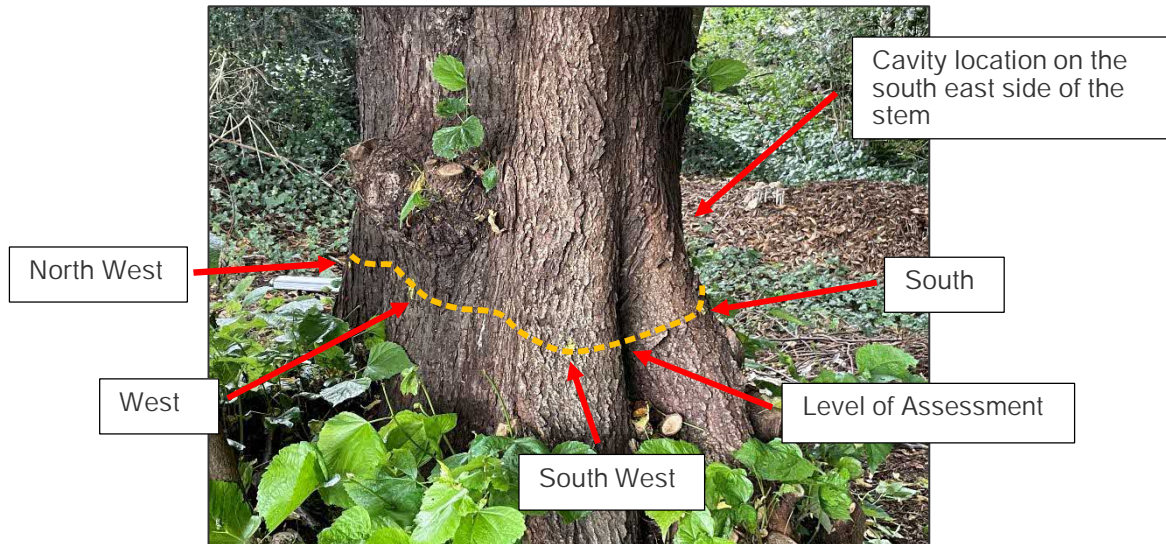
To confirm the extent of any decay, the Resi PD400 microdrill was used in six locations around the lower stem

The height of the assessment was 30cm above ground level where the approximate stem diameter was 92cm
