Introduction & Purpose of the Statement

Heritage, Design & Access Statement

Listed Consent Application PP-12751763

Submitted: 09 February 2024

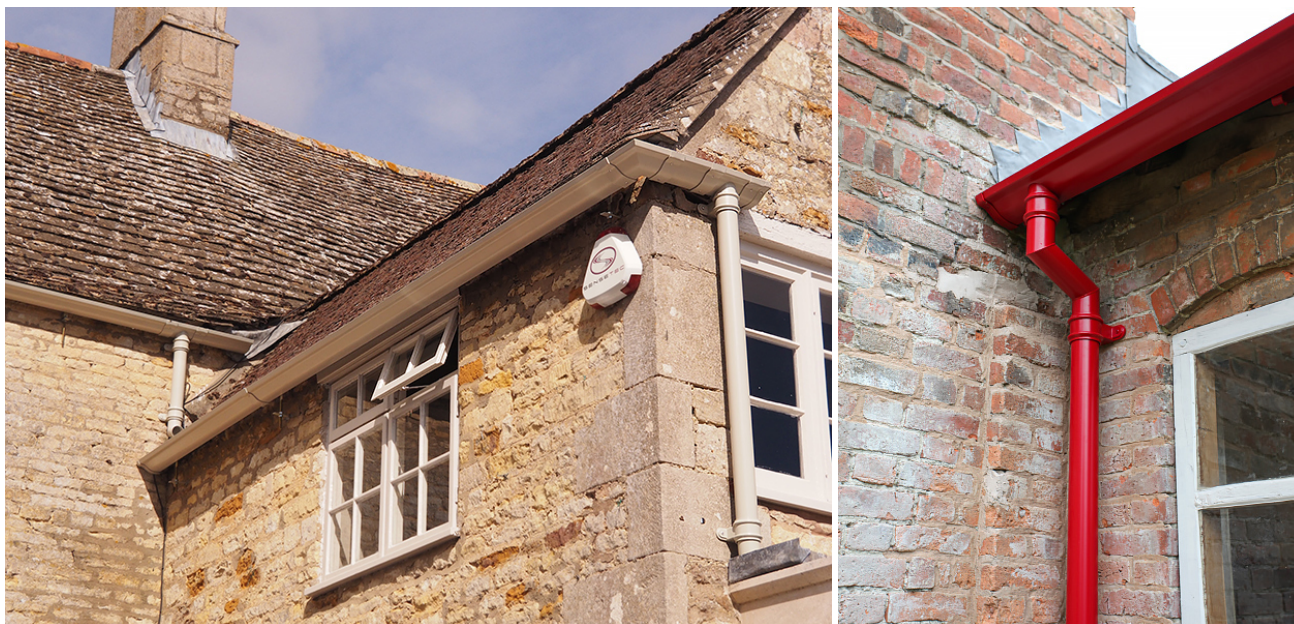
Images 04 & 05 – Examples of new cast aluminium guttering & downpipes in the traditional OGEE style

- The existing, cast iron goods are in the traditional Ogee style (see Images 01, 02 & 03) with a depth of 110 mm, along with corresponding round downpipes. The Applicant proposes new cast aluminium Ogee guttering, hoppers and downpipes to replicate the existing system both in style and in size in order to retain the original character and intended aesthetic of the building (see example images 04 & 05).

The Applicant proposes replacing the mixture of plastic and cast iron goods with cast aluminium goods. Cast aluminium requires little maintenance compared with cast iron as it has higher corrosion resistance – cast iron is prone to rust, more brittle at low temperatures and requires painting more frequently. Environmentally, cast aluminium products are lighter than cast iron, producing a lower carbon footprint, as less energy is required for its production and transportation.

The proposed new cast aluminium rainwater system will be black, to match the existing and will correspond with the rainwater systems among the same grouping of listed properties on Newcomen Road.

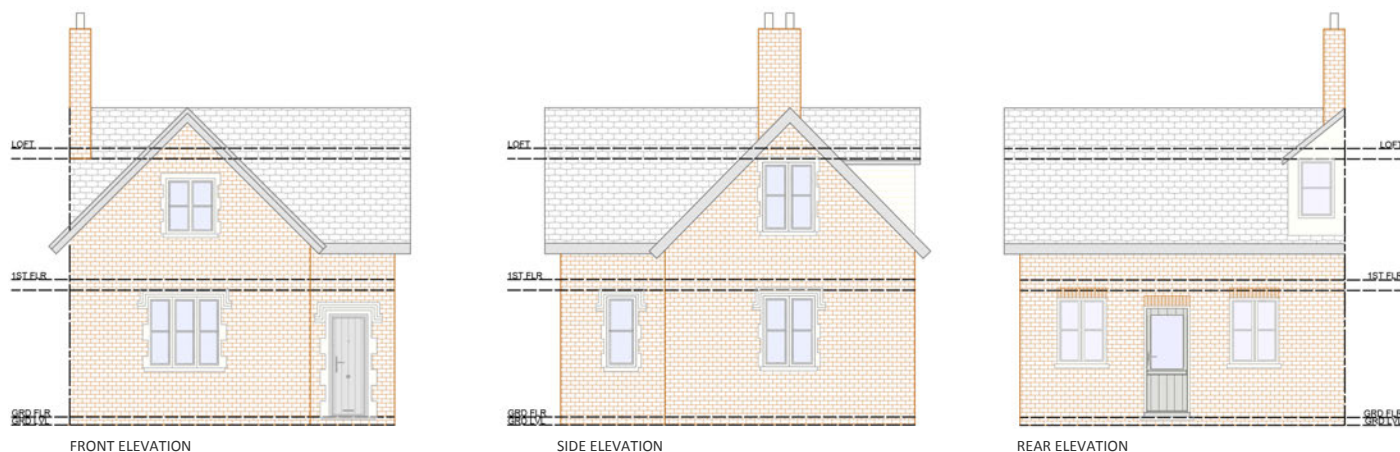
Elevation 01 – Five of the property’s windows and the front door feature decorative stonework surrounds. These have matching stone cills (excluding the front door which has steps). This does not apply to the windows on the rear elevation but the dormer window has a stone cill

- When the Applicant purchased the house in June 2021, the stonework was decorated with multiple layers of white paint (see Images 06 & 07). Evidently the paint had cracked and flaked over time. There was also evidence of stone repairs in many areas, involving fillers consisting of unknown material.

This application proposes the restoration and potential redecoration of the decorative stonework surrounding the street facing windows and front door, most of which are visible from the street. This includes the stone cills to these windows and the stone cill to the dormer window on the rear elevation.

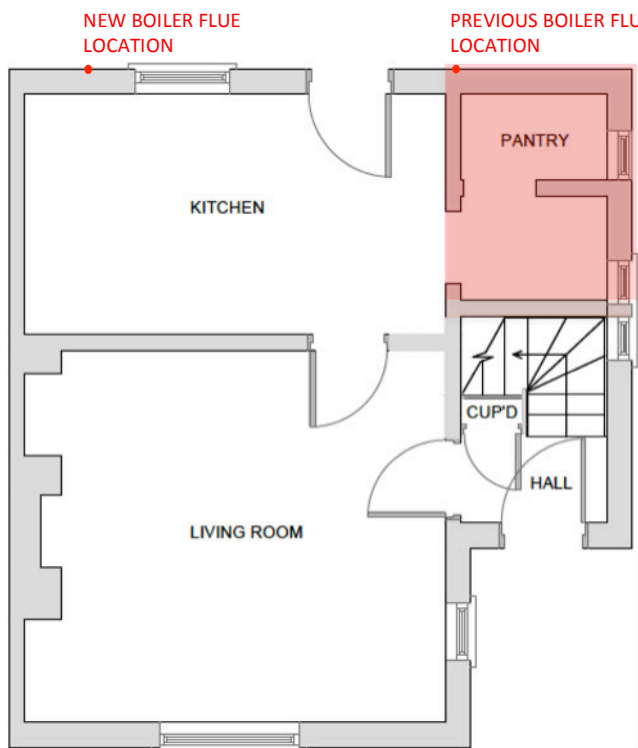
Plan 01 – Previous ground floor plan

Listed Consent Application PP-11229984 proposed the removal of two internal, non-load bearing partition walls separating the kitchen and pantry, to create a kitchen diner (see Plans 01 & 02).

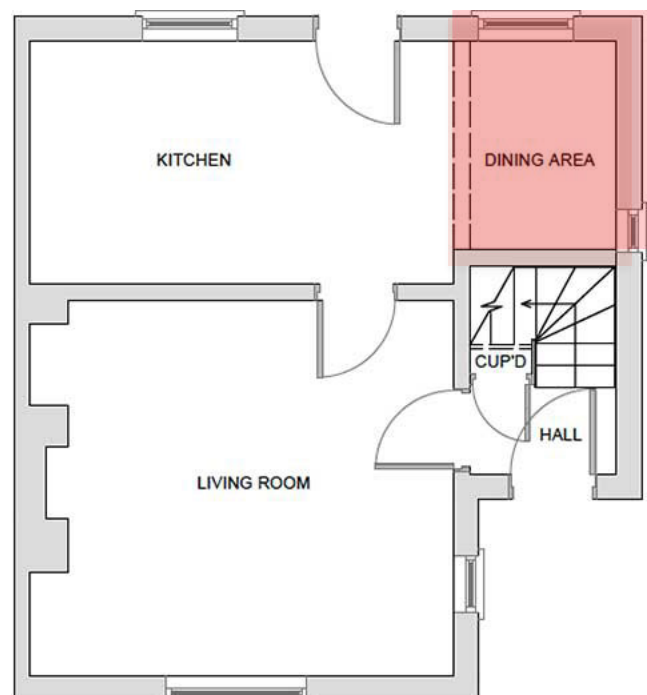
Plan 02 – Proposed new/current ground floor plan

The proposal suggested retaining a visual downstand to preserve information as to the original division between kitchen and the pantry. As a result of a structural survey undertaken before the work began, it was known that the partition walls to be removed did not directly support the floor above. However, a shallow steel channel beam was proposed to support the retained downstand and act as a precautionary measure to safeguard against any potential risk from the pressure a filled bath in the bathroom above could assert on the joists, considering the room above would originally have been a bedroom, with no bath.
