Heritage Impact Assessment  
(including Design and Access Statement)

Goddards Green  
Angley Road, Cranbrook TN17 3LR

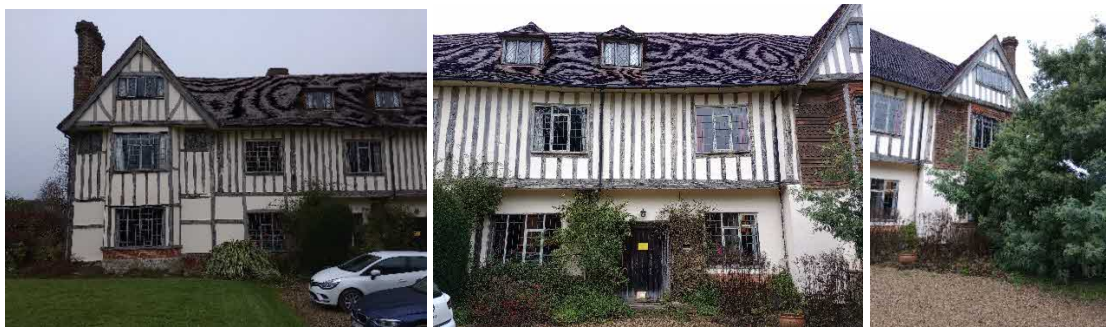
Front (South-east) elevation: South end centre East end

An historic photograph, from a book published in 1907 (although the photograph may be earlier) shows the framing protected by hanging tiles. The tiling has, mostly, been removed and is now only retained to the [East] end bay of the South-east elevation, the South-west elevation to the right of the projecting chimney stack and the North-east elevation where there is also an area of feather edged weatherboarding.
